MINES BRANCH INVESTIGATION REPORT IR 66-15

**INVESTIGATION INTO THE FAILURE
OF A PTO DRIVE SHAFT OF A
RCAF ALVIS CRASH TRUCK**

MARCH 8, 1966

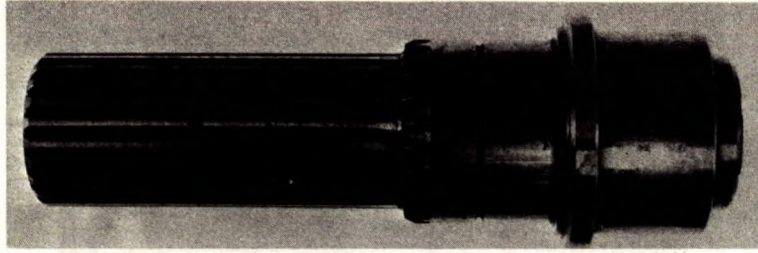
Figure 1 illustrates No. 1 shaft, as-received. There were no visible signs of damage other than the fracture at the right hand end. Fluorescent magnetic particle inspection showed no evidence of incipient cracks. Figure 3 shows the fracture face. Post-fracture damage obscured the fracture markings to some extent but sufficient evidence remained to show clearly that there was but a single origin at the base of a circumferential groove. From this origin a fatigue crack traversed about 90% of the section. The final shear failure area was located almost diametrically from the origin and touched the surface of the section.

Figure 1. Drive shaft No. 1 as-received. Break is at right hand edge.

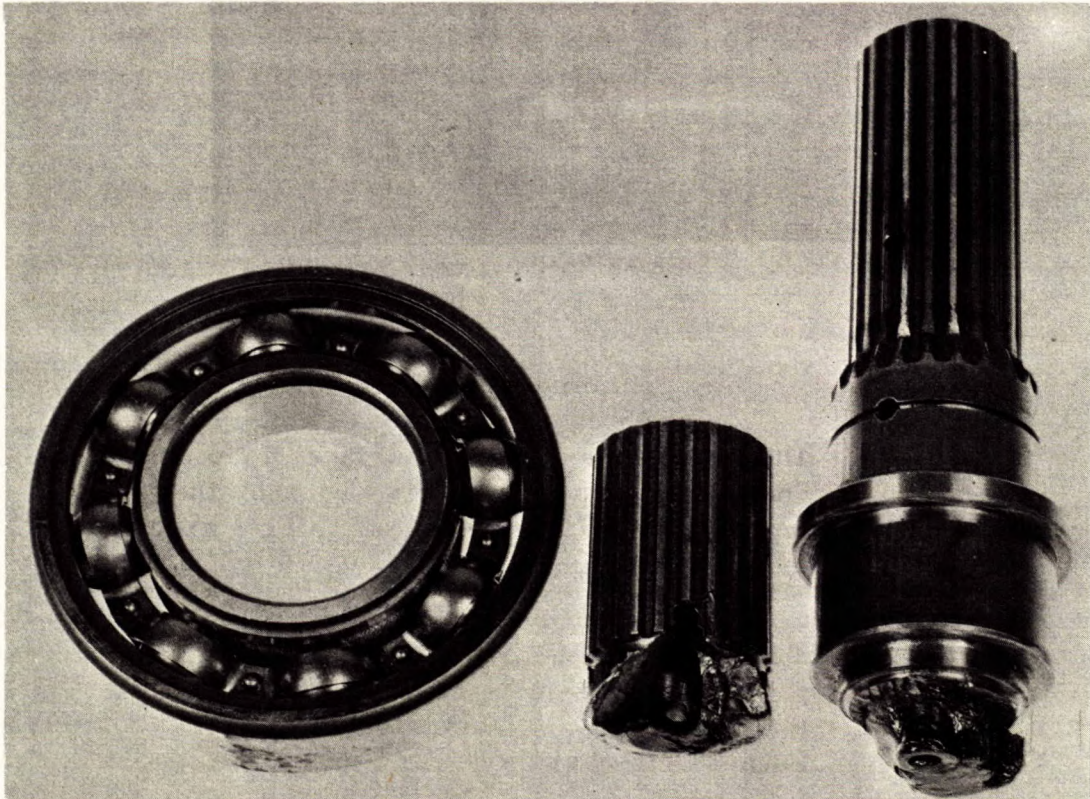
Figure 2. Drive shaft No. 2 and associated ball bearing.

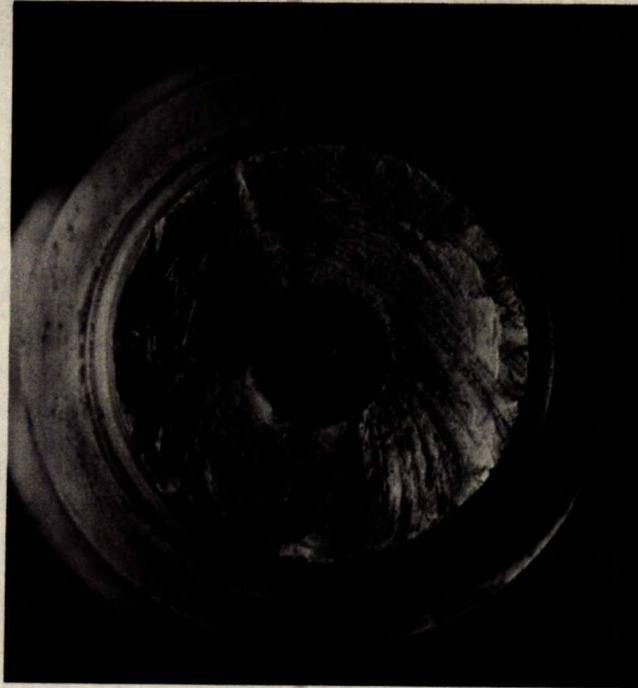
The hardness of Rc 21 at the fracture origin indicates a local tensile strength of about 110,000 psi. The normal ratio of notched fatigue limit to ultimate tensile strength would indicate a fatigue limit of about 27,000 psi. This is three times the calculated maximum stress derived from the engine load. Since fatigue failure did occur, additional stresses must have been imposed. This confirms the visual assessment of fracture surface characteristics, i.e., that bending stresses were the principal stresses leading to the fatigue failure.

Figure 3. Illustrating the fracture surface of No. 1 shaft. The fatigue crack origin is shown by the arrow, upper right. The final shear failure area is shown by the inked lines, lower left.

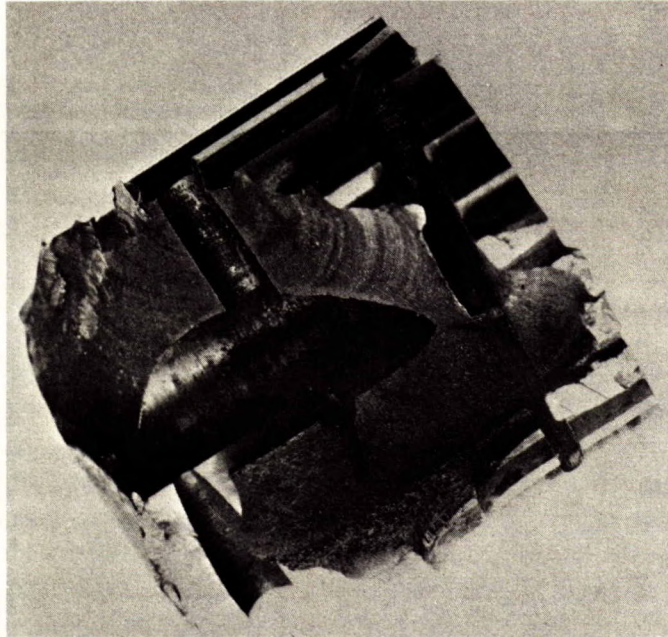
Subsequent examination of No. 2 shaft showed that fracture originated in a radial oil hole, the point of calculated maximum stress. A fatigue crack propagated on a plane at 45° to the shaft axis. Approximately half the section was penetrated by the fatigue crack before final shear failure.

Figure 4. Fracture surface of No. 2 shaft, illustrating origin of fatigue crack at the oil hole.

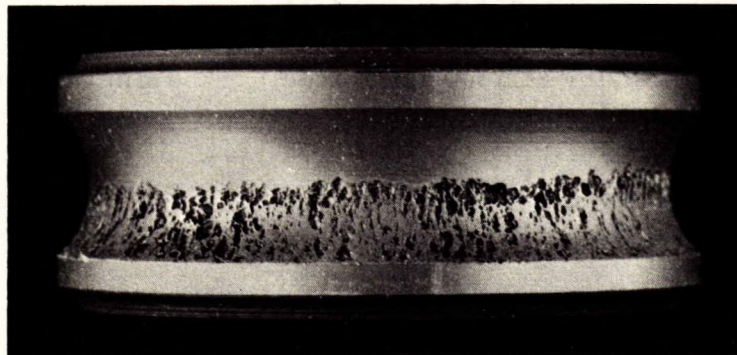
The two ball bearings submitted with No. 2 shaft were the same size and must, therefore, have been in service with two different shafts. The inner race of one bearing had spalled severely on one side of the groove, Figure 5. The balls and outer race of this bearing showed only minor damage. The inner race of the other bearing showed much less spalling. The balls and outer race showed no evidence of significant damage.

Transverse sections of both races of both bearings were examined. As expected, a multiplicity of cracks were observed underlying the severely damaged areas. These cracks appeared typical of overloaded bearings. No cracks were noted in any other part of the sections. The microstructure appeared typical of quenched and tempered AISI 52100, the standard ball and roller bearing grade of steel. No significant metallurgical deficiencies were found.

Figure 5. View of inner race of ball bearing.

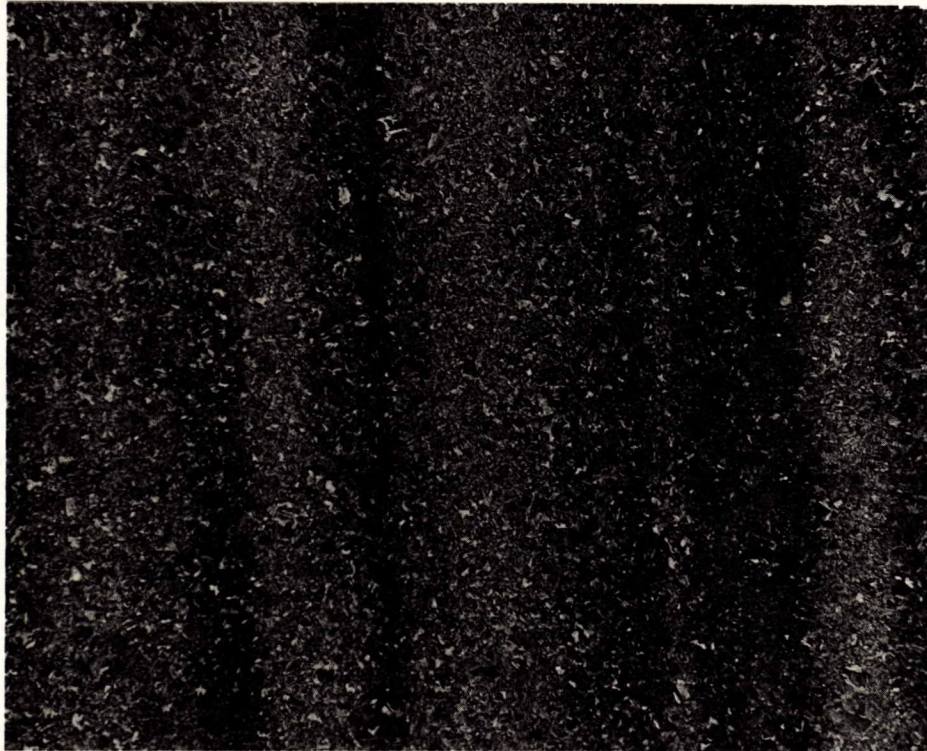
Microhardness tests using the Knoop diamond indenter with a 500 g load showed the hardness of the dark bands to be about Knoop 300 (approximately Rc 29), that of the light bands to be Knoop 254, (approximately Rc 21).

Figure 7. Longitudinal section, near fracture origin, illustrating banded appearance due to differential etching which is a consequence of compositional heterogeneity.
