MINES BRANCH INVESTIGATION REPORT IR 66-16

**EXAMINATION OF FAILED
PROPELLER TAP BOLT FROM
M. S. 'PRINCE NOVA'**

EXAMINATION OF FAILED PROPELLER TAP BOLT
FROM M. S. "PRINCE NOVA"

SUMMARY OF RESULTS

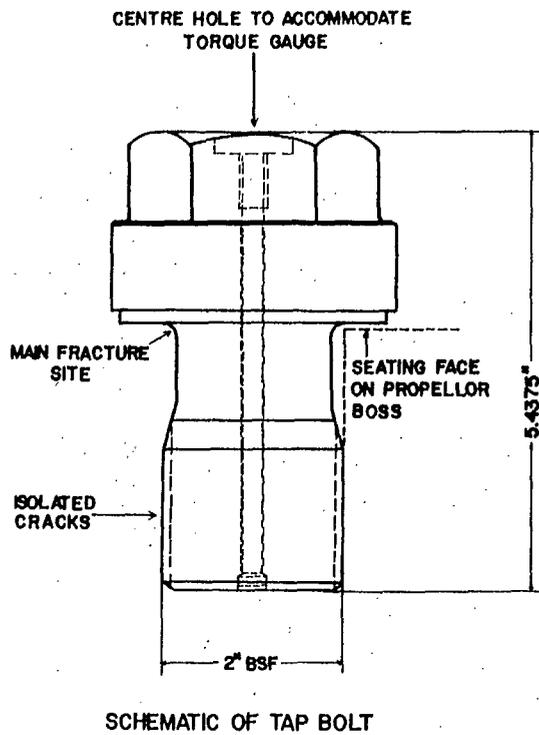
A schematic diagram of the bronze bolt is shown in Figure 1, indicating its general features and the main sites of fracture just below the head of the bolt. It should be noted that the central axial hole is intended to accommodate a device for measuring torque during assembly of the blade to the propeller boss, and contained a close-fitting mild steel pin and a screwed end closure. Two pictorial views of the fracture are shown in Figure 2. There was no evidence of corrosion products or discoloration anywhere in the bolt material itself, although the steel pin insert was considerably rusted by the ingress of sea water along the crack path. There were no visible indications of metal deformation near the fracture and the outside surfaces were free from any signs of abuse.

Figure 1. Engineering sketch of bolt showing failure centre.

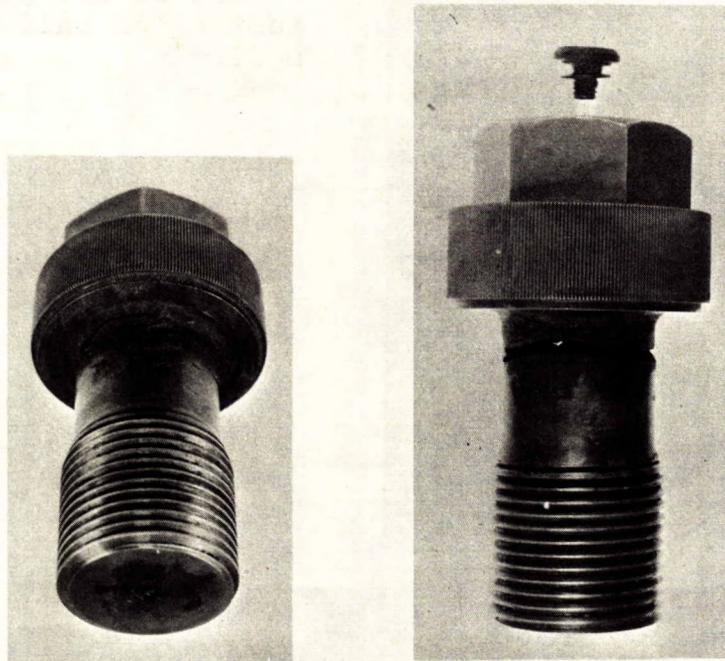
Clearly, the metal failure in this material is not nearly as localized as might be suggested by Figures 1 and 2. A large network of cracks extend radially from sites in and just below the bolt head, while smaller hairline cracks were observed in the bolt shank. This generally widespread metal failure is of significance in discussing the causes of cracking.

Figure 2. Two views of failed bolt.

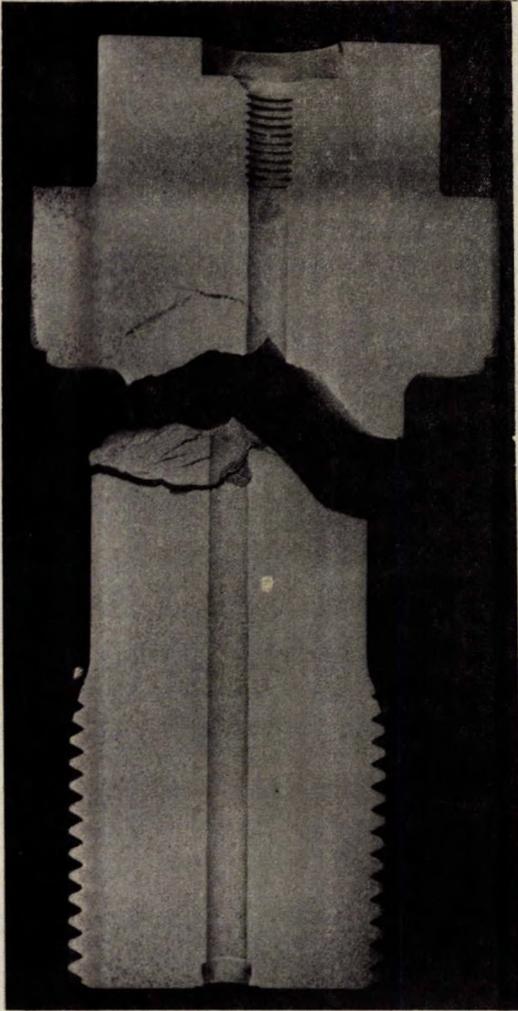
The bolt was sawn into two parts along its longitudinal axis in such a way as to complete the separation of the bolt-head from the shank. One half thus obtained was ground and crack-tested using a dye penetrant. An illustration of this crack-revealing test is shown in Figure 3 and a close-up detail of the

fractured area is shown in Figure 4. Several small cracks, not illustrated, were observed in the threaded part of the shank. These fine transverse cracks appeared to run from the root of the thread at right angles to the bolt axis and were approximately $\frac{1}{4}$ in. to $\frac{3}{8}$ in. long.

Figure 3. Illustration of the result of dye penetrant crack testing on half section of bolt.

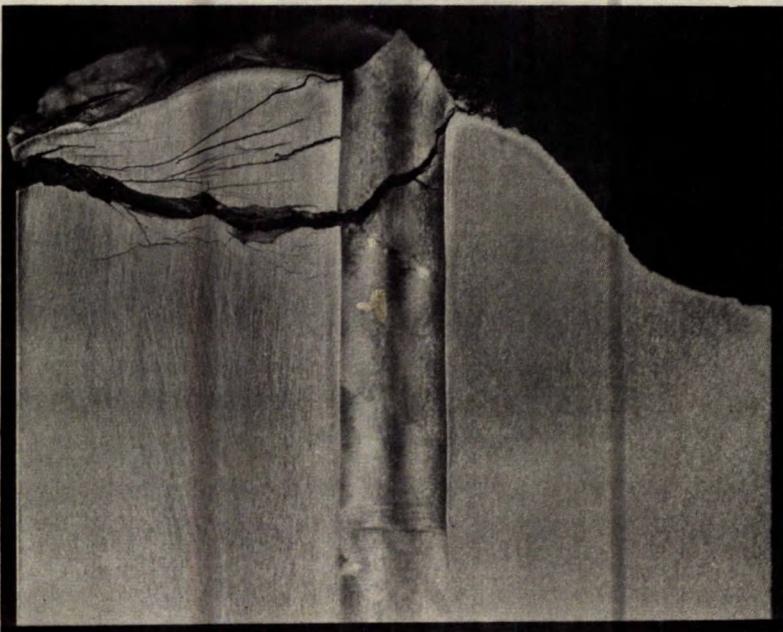
The large number of branching cracks around the site of failure suggests the presence of an extremely active corrosion component, since the propagation of the primary crack path would have reduced the high state of stress in the area of failure.

It will be noted that the larger cracks, i.e., those first produced, tend to run normal to the bolt axis, while a larger number of smaller branch cracks are seen to lie at about 45 deg to the bolt axis. This may be related to the change in the vectors of the stress system in material adjacent to the primary crack path after initial failure. The nature and action of the corrosion component presents some problems in interpretation since it appears to have been generally active both at the bolt head and lower down in the screwed portion of the bolt, yet has produced no evidence of chemical attack on fracture surfaces or on uncracked portions of the shank. In addition, it appears from a drawing of the propeller assembly that the air space around the shank of the bolt was protected from exposure to sea water by the seating between the bolt head and the propeller hub. Thus, the seepage of sea water into the air space would have resulted in a virtually closed environment of sea water and air. Alternatively, there exists the possibility that seepage could have occurred through the end closure, although the good condition of the steel pin insert, and the indications that cracks moved in from the bolt surface suggest that this was not so. Finally, it must be considered that no seepage of sea water occurred at all, and that the corrosive agent was present in the air space after dry-dock fitting of the propeller.

Figure 4. Macro-photograph of area near primary crack showing extensive secondary cracking.

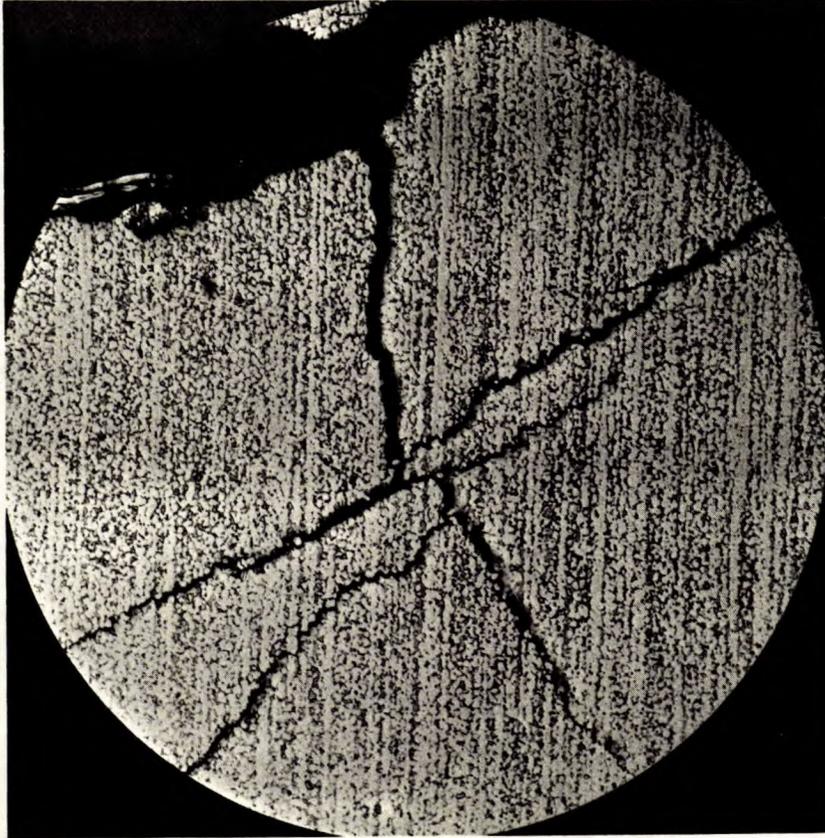
Sections parallel to the bolt axis were cut from the main fracture area, polished and examined. The microstructure was revealed as a fine-grained oriented alpha-beta structure containing a small number of very fine spheroidal particles. This duplex constitution is typical of complex Al-Mn bronzes of the 12% Mn type. Of chief interest were the crack paths themselves, since these reflect the mechanism of cracking and, hence, the cause of failure. One area of the large network of fine cracks extending from the primary fracture surface is shown in Figure 5. It will be noted that this field illustrates the tendency for cracks to run at 45 deg to the extrusion direction and bolt axis, and suggests the intergranular type of crack path shown in more detail in Figure 6. The cracks appear to run

The brittle nature of the failure, and the multibranch cracking associated with it, are clearly identified characteristics of stress corrosion cracking, and it is instructive to consider how the stress system in the bolt, and a corrosive agent with access to the bolt shank, together combined to produce cracking. The loaded bolt contained tensile and torsional stresses, which compounded to give high stress concentration in the radiused part of the shank just below the bolt head, and at the bottom of screw threads. The corrosive agent, apparently having access to the whole of the shank surface, has produced cracks normal to the tensile stress axis of the bolt at both of these regions of high tensile stress concentration. It is probable, therefore, that the loading stress, as opposed to any residual, internal stresses in the bolt, has contributed to the failure. It should be noted that the designer has taken all possible steps to reduce stress concentrations in the bolt, by the provision of ample radii, and "waisting" the shank between the head and the threads. In addition, provision has been made for some form of measuring device to be inserted in the bolt so that it is not tightened excessively during assembly, which would, of course, raise the stresses in the bolt. It is presumed that these precautions were taken during assembly, and that the propellers were not put into service with excessive stresses in the bolts, which would, of course, make them much more vulnerable to stress corrosion attack.

Figure 5. Secondary crack system extending in from primary fracture surface (typical of the multi-path cracking in stress corrosion embrittlement).

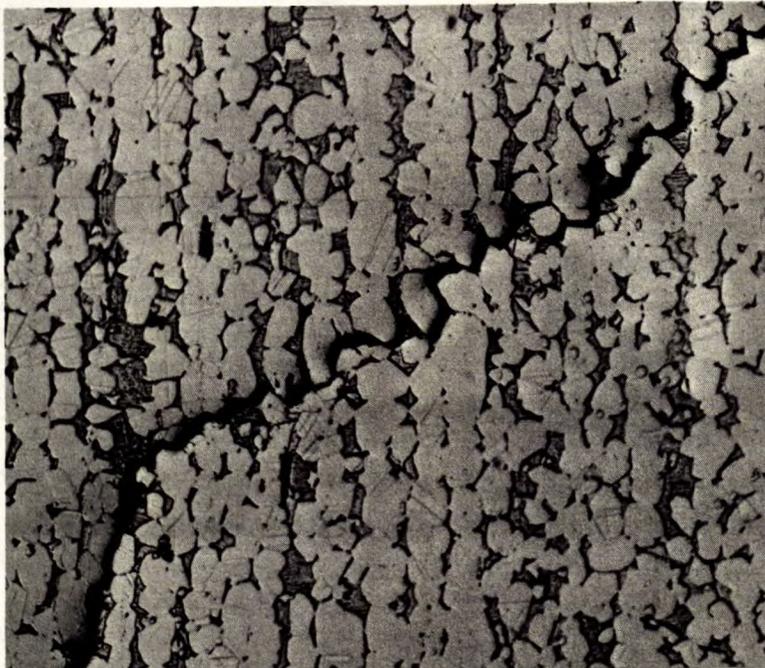
intergranularly along alpha-beta boundaries, with some evidence of transgranular cracking in the beta phase. Close examination of the outside surface of the bolt both near and remote from the source of crack paths failed to reveal any products of corrosion action, pitting or de-aluminization.

Figure 6. Detail of intergranular crack path.
