MINES BRANCH INVESTIGATION REPORT IR 66-23

**FAILURE OF BRASS FITTINGS IN
COBALT 60 IRRADIATOR**

PHYSICAL METALLURGY DIVISION

MARCH 21, 1966

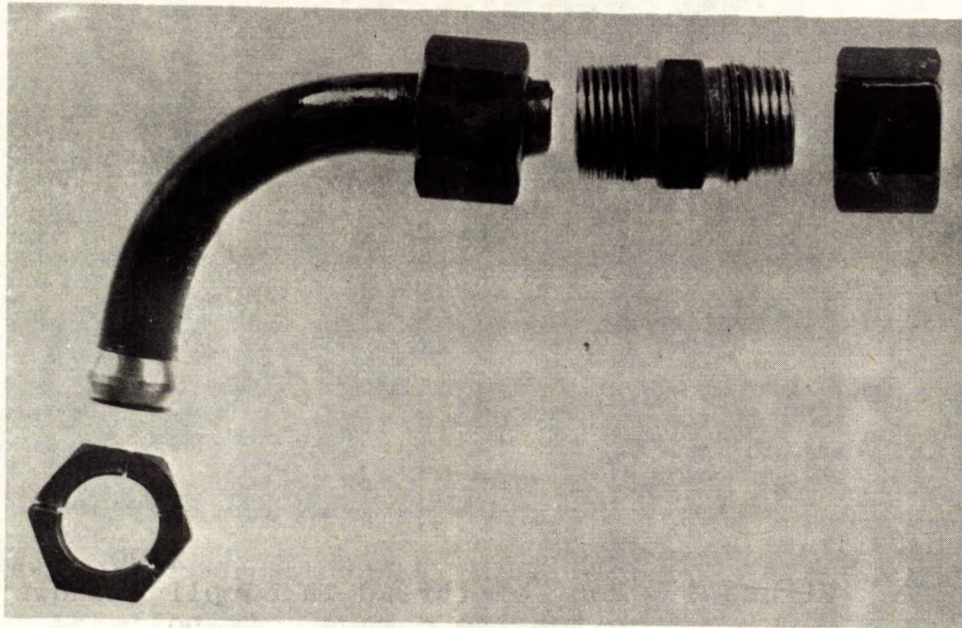
The fittings supplied for examination are shown in Figure 1. The nut at the bottom of the photograph has five cracks of various widths from hairline to wide open, three going through the flat part of the hexagon and two through the corners. The other two nuts have one crack each through one of the corners of the hexagon. The examination at low magnification of the coupling shown at the top of the photograph did not reveal the presence of any crack.

Figure 1. Fittings sent for examination. Nut at the bottom has five cracks, other nuts have one crack each. Coupling is not cracked. Approx. $X1\frac{1}{4}$

It is recommended that the actual brass fittings be replaced by suitable fittings or by soldered joints wherever feasible and practical.

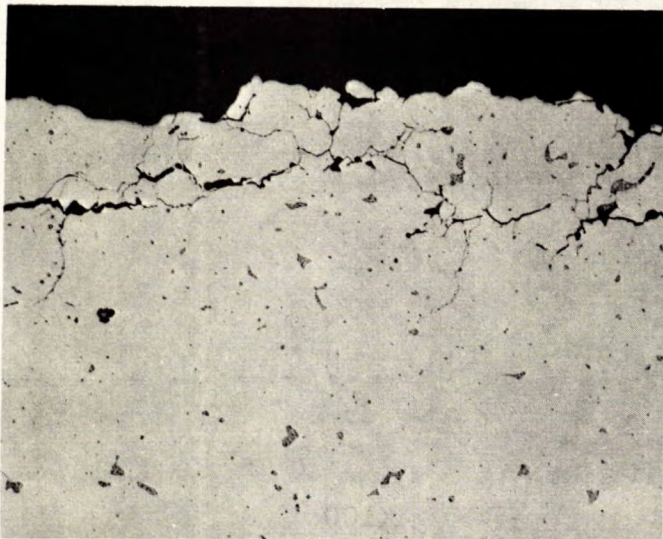
The three nuts shown in Figure 1 were cut and polished at right angles to the path of the cracks and two examples of such cracks are shown in Figures 2 and 3. Cracks are, in general, branched and intercrystalline (at least where their path can be ascertained by comparison of the same field in the "as-polished" and etched conditions). Some cracks appear reasonably clean like those of Figure 2 while others contain a compound or compounds having the appearance of cuprous oxide as in Figure 3. Others are intermediate between those two extremes. The presence of oxide in the cracks would suggest that the crack walls were exposed for some time to an oxidizing medium. However, whether the cracks are lined or not with a compound, they all have the same general configuration.

Figure 2. Crack wall at top shows numerous branched cracks commonly found in failures by stress-corrosion cracking. As-polished.

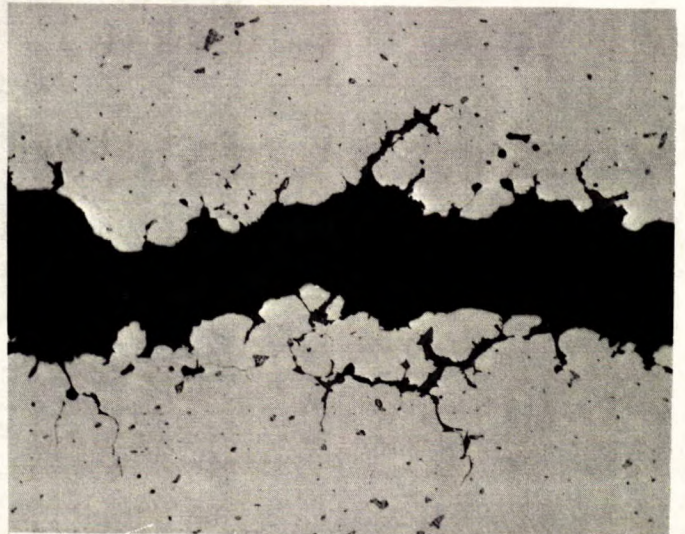
Figure 3. Cracks tend to branch out from the main crack. Cracks contain a compound, which is probably cuprous oxide. As-polished.

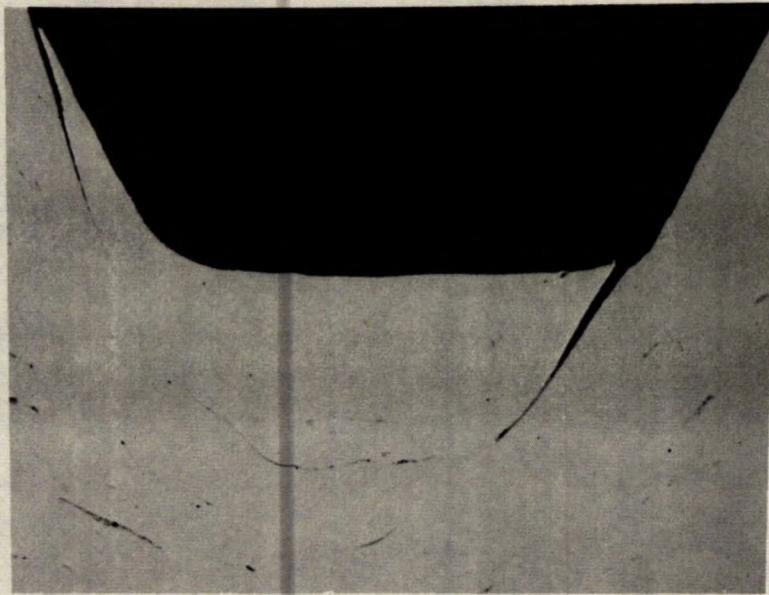
The coupling shown at the top of Figure 1 was split longitudinally into two halves and metallographically examined. The threads of one end of the coupling were sharply cut and the metal in their vicinity showed no evidence of deformation. On the other hand, most of the threads of the other end of the same coupling show the defect represented in Figure 4. The metal at the sides of the threads was heavily worked and, in some cases, did not adhere at all to the underlying material at the root of the thread. As can be seen in the etched condition (Figure 5), flow lines are curved inwards along both walls of the thread and some of this material had been smeared and indented into the root. It is therefore concluded that such a deformation was caused by a blunt tool upon machining, whereas, a better tool having been used to machine the threads of the other end, no evidence of tearing or deformation could be found.

Figure 4. Root of thread in coupling shows extensive damage. As-polished.

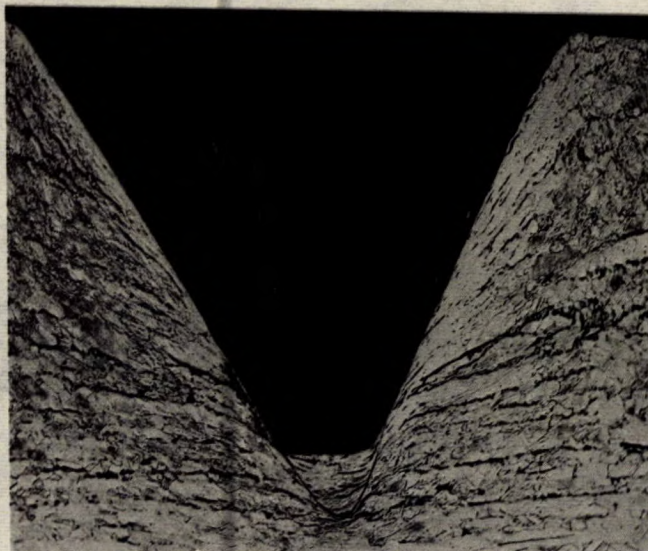
Machining the coupling with a blunt tool would introduce unnecessary stresses in the metal and, although in the case under investigation such additional stresses were obviously not detrimental as the coupling did not crack, this might lead to stress-corrosion cracking under certain conditions; this emphasizes the possible effects of prior history on the susceptibility to stress-corrosion cracking (c.f. Weatherhead vs Swagelok). To this end, it may be noted that many of the cracks passed through the corners of the nuts where the section thickness was much greater than at the flats. This suggests that residual stresses from the manufacturing operation, as well as the assembly stresses of the joints, were a large factor contributing to failure.

Figure 5. Extensive metal deformation in thread vicinity is probably due to blunt tool. Etched in alcoholic ferric chloride.
