MINES BRANCH INVESTIGATION REPORT IR 66-39

**EXAMINATION OF A COLD PUNCH
FOR HORSESHOES
(T.I.S. 60864)**

PHYSICAL METALLURGY DIVISION

MAY 31, 1966

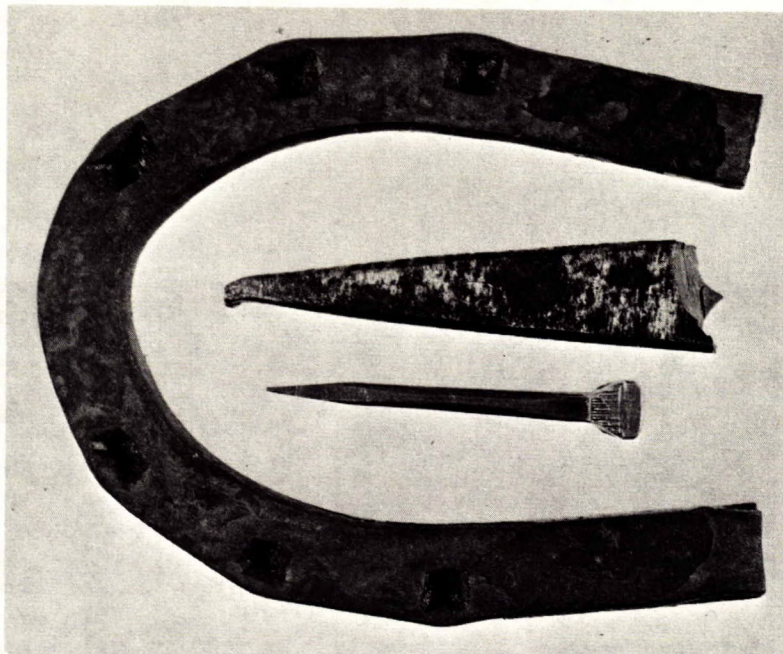
The "as-received" articles - an unfinished horseshoe, a nail and a punch - are shown in Figure 1.

The punch failed in a manner typical of tool steels that have undergone bending probably accompanied by impact. The pointed end of the punch had bent quite severely.

Figure 1. Unfinished horseshoe, nail, and cold punch "as-received".

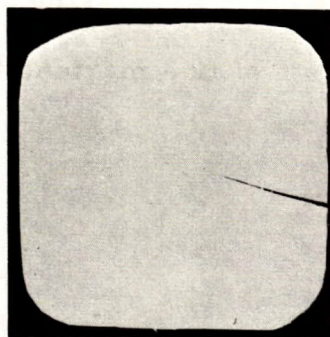
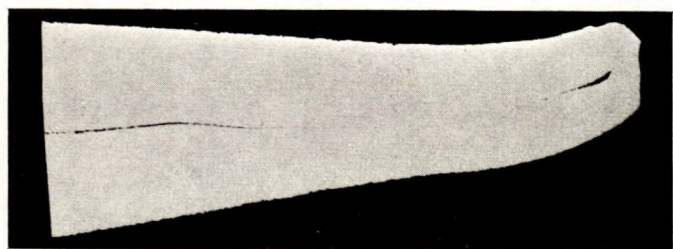
Transverse and longitudinal sections of the punch were mounted and polished. These are shown in Figure 2.

The punch contained a defect in the form of a crack extending down one side and penetrating inward to the centre. The origin of the crack was either a centre defect in the ingot (known as pipe or shrinkage) which had not welded during hot processing operations, or a forging split resulting from too low a forging temperature. There was no evidence that this defect contributed to bending of the point, or to the fracture. It is, however, an undesirable defect which could cause or contribute to a punch failure.

Figure 2. Polished sections of cold punch showing location of defect.

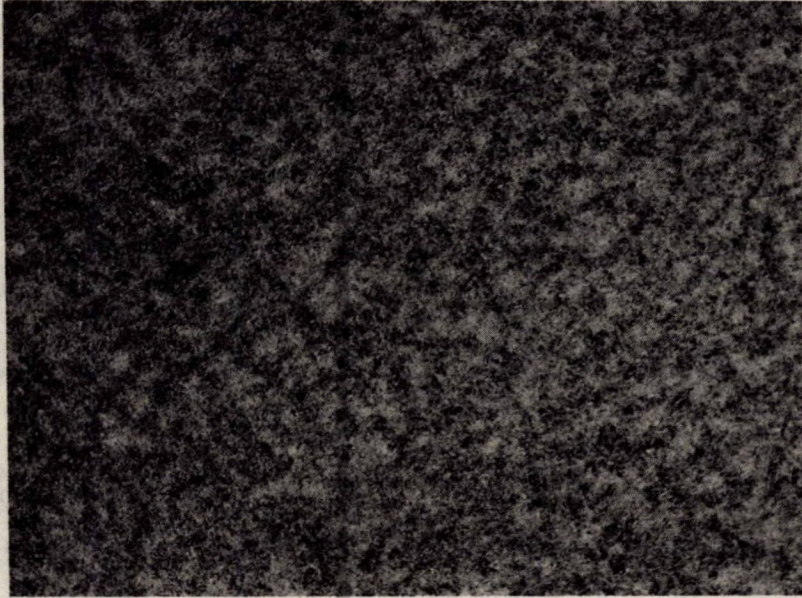
The polished specimens were etched in 2% nital revealing the fine martensitic microstructure shown in Figure 3. There was little or no evidence of decarburization.

The first half inch of the punch appears to have been tempered at a higher temperature than the remainder. This could account for the lower hardness reading of 55 R_C in that region. An improvement should be evident if the heat treatment is designed to maintain the hardness near 60 R_C. This should be attainable with an oil quench from 1680°F (915°C) followed by a 300 to 350°F (150 to 180°C) temper.

Figure 3. The microstructure consists of fine martensite.
