MINES BRANCH INVESTIGATION REPORT IR 66-41

**SURFACE OXIDATION OF ALUMINUM
PIPE AND SHEET EXPOSED TO AIR
AND GAMMA RADIATION**

W. A. POLLARD

PHYSICAL METALLURGY DIVISION

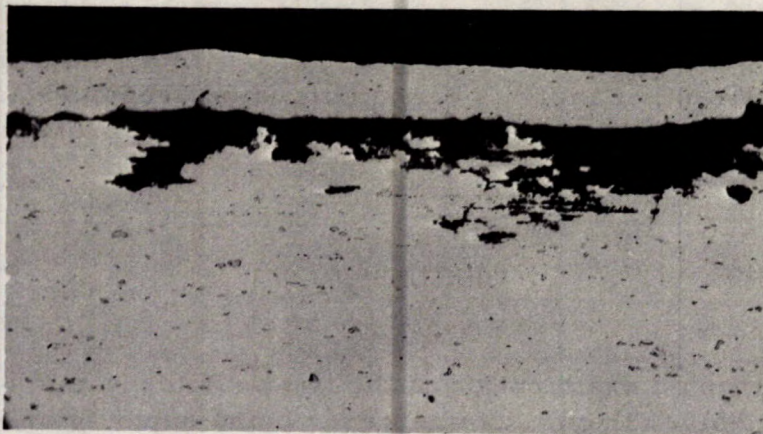
The Sample Wall Chamber showed extensive intergranular pitting on the inside surface (see Figures 1 and 2). The maximum pit depth in the sections examined was about 0.0055 in. No pitting was observed on the outside surface of the tube.

As mentioned earlier, the effect of gamma radiation on air is to produce oxides of nitrogen and ozone. In the presence of moisture, nitrous and nitric acids would, therefore, be formed in small amounts and it is thought that these would be sufficient to account for the attack observed.

Figure 1. Pitting attack in Sample Wall Chamber (inner surface) showing intergranular nature of corrosion. (Unetched)

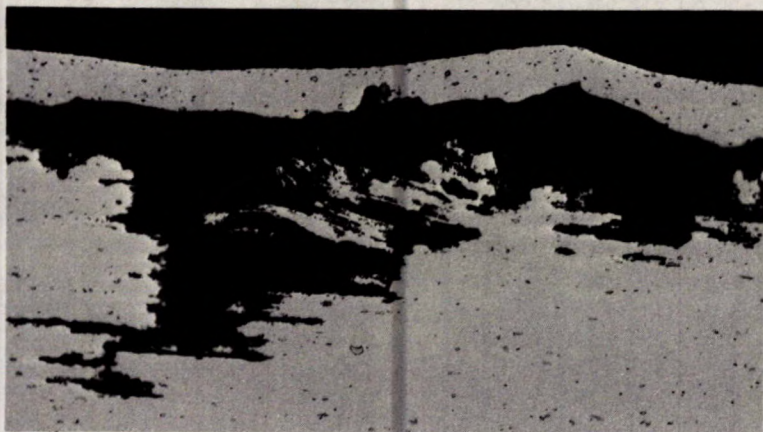
Figure 2. As Figure 1, showing deepest pit found in sections examined. (Unetched). (The thin section at the top of each of the figures is of the aluminum foil used to protect the surface of the specimen during mounting and polishing).
