MINES BRANCH INVESTIGATION REPORT IR 66-48

EXAMINATION OF BROKEN DAVIT SCREW FROM C.C.G.S. "SIR HUMPHREY GILBERT"

PHYSICAL METALLURGY DIVISION

JUNE 22, 1966

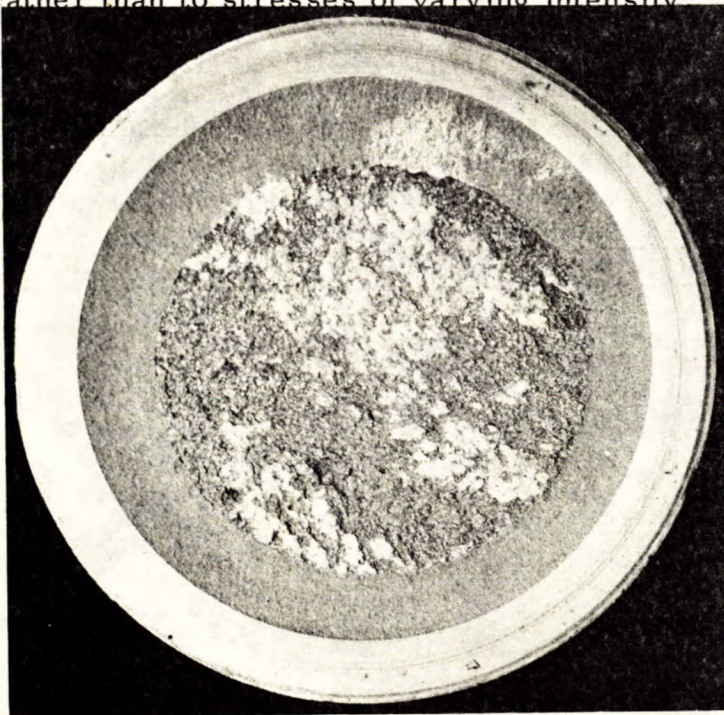
The appearance of the fracture is illustrated in Figure 1. The appearance of the fracture is typical of a low-cycle, high-stress, fatigue failure located at a sharp notch coincident with the first thread. The absence of well-defined rings on the surface of the fatigue crack suggests that failure was due to a repetition of stresses of the same magnitude rather than to stresses of varying intensity.

Figure 1. Fatigue Fracture at First Thread Root of Ship-Davit-Screw. Hardness of material (RB 92) soft annealed condition. Fatigue failure occurred at a sharp notch at the first thread in annealed AISI-1040 carbon steel.

Failure of the shaft appears to be due to fatigue of annealed steel in the presence of a sharp fillet. No evidence of corrosion was observed on the broken shaft examined. The appearance of the fracture indicates that failure occurred after relatively few cycles and after formation of a relatively shallow (1/4 in.) circumferential crack located at a stress-raiser (sharp notch) at the entry to the first thread.

- (1) The shaft failed in fatigue after application of low-cycle, high but uniform stress. The metal was annealed AISI-1040 steel having relatively low endurance limit at Rockwell B 92.
- (2) There was no evidence that corrosion had reduced fatigue life of the shaft.

This failure renders the other davits suspect and indicates the need for modification of the design for use of stronger metal having higher endurance limit (higher safety factor) and for redesign to replace sharp notches with adequate fillets. One suitable grade of steel for replacement would be AISI-8640 used in the oil-quenched and tempered condition at Rockwell C 32-38.

Eliminate the sharp notch stress-raisers and use liquid-quenched, tempered, through-hardened steel at Rockwell 32-38. Protect the metal from corrosion and use adequate section.

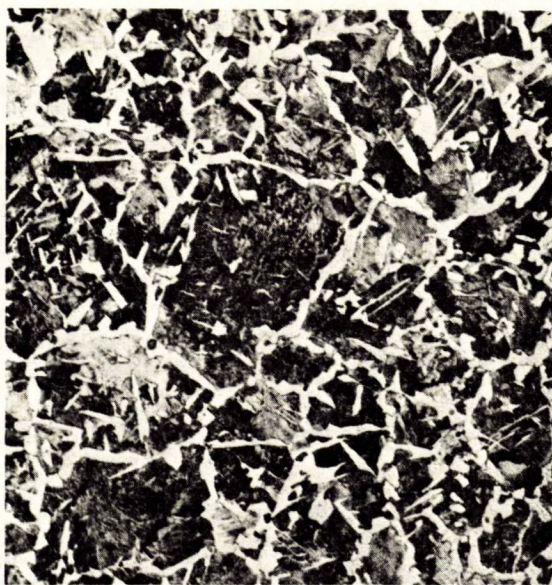
The microstructure of the shaft consisted of lamellar pearlite and proeutectoid ferrite, showing that the metal was in the soft, furnace-annealed, (unhardened) condition. In the soft condition, the endurance limit in fatigue is approximately 40 kpsi (for polished bars), whereas in the liquid-quenched tempered condition at 38 R_C (BHN 352) the endurance limit should be above 80 kpsi in the absence of any stress-raiser (notch) and providing the steel is adequately protected from salt water corrosion.

Figure 2 illustrates the annealed microstructure of the failed shaft.

Figure 2. Microstructure of Failed Shaft. (Hardness R_B 92).
The microstructure consists of fine pearlite and proeutectoid ferrite, showing that the metal is in the annealed condition.

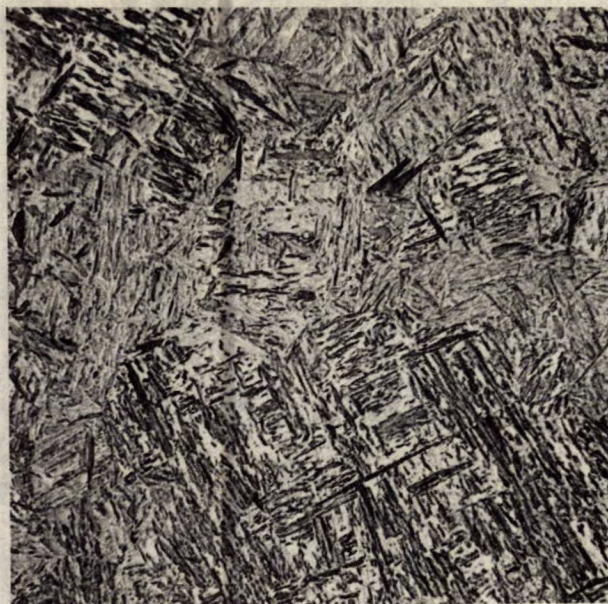
Figure 3. Sample, Water-Quenched 1550°F, Rockwell C 54_c
(for 1/2 in. depth).

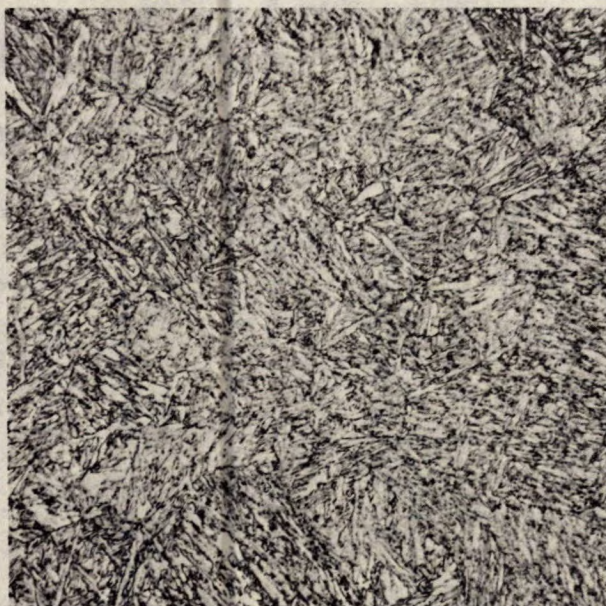
Figure 4. Sample, Water-Quenched 1550°F, Tempered 1 hr
1000°F, R_C 30 (for 1/2 in. depth).
