DEPARTMENT OF MINES AND TECHNICAL SURVEYS

MINES BRANCH INVESTIGATION REPORT IR 66-49

**EXAMINATION OF TWO C.S.F.
ICEBREAKER PROPELLER CASTINGS**

JUNE 21, 1966

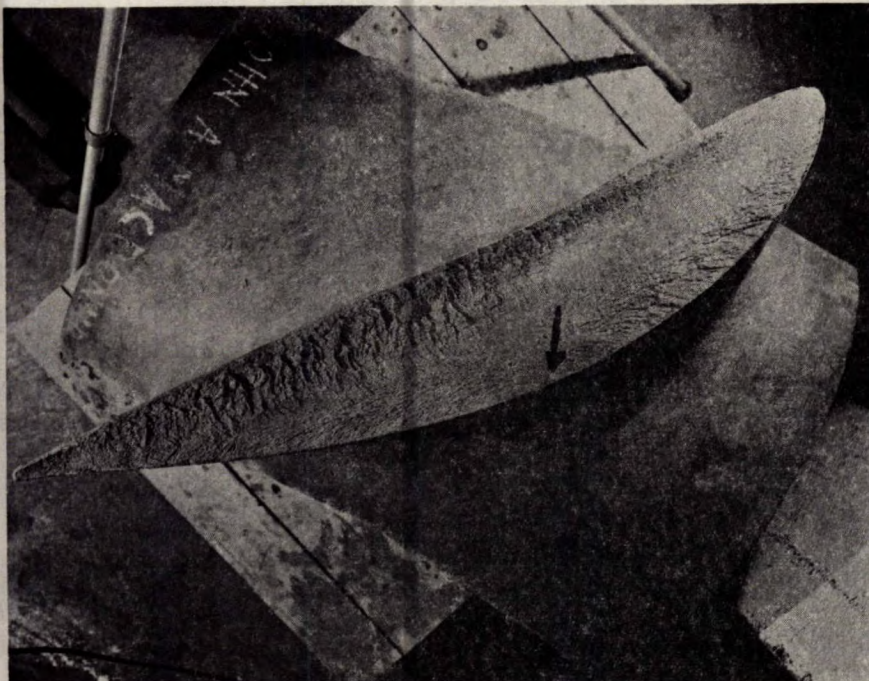
Figure 1. Broken "Blade-Stub", C.C.G.S. Sir John A. MacDonald.
As-received. The origin of the fracture is shown by the
arrow.

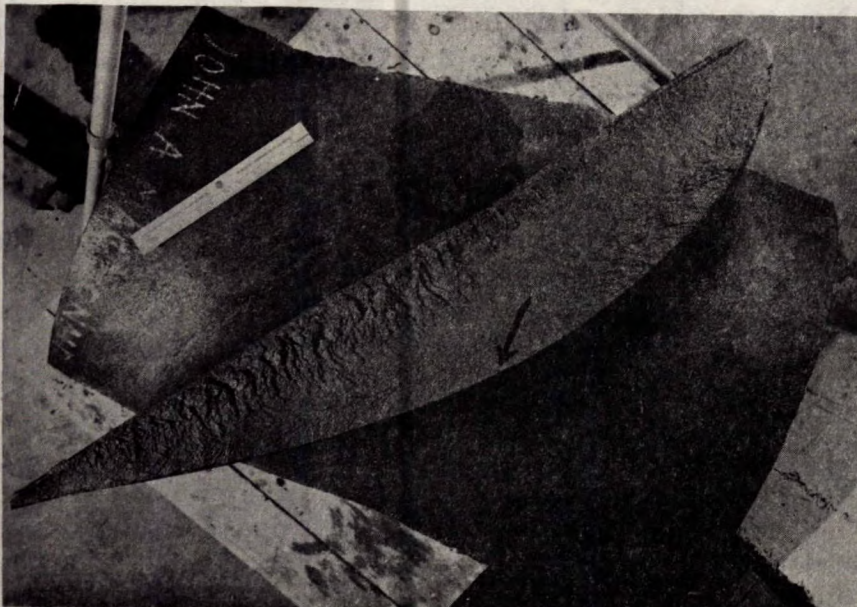
Both propellers were cast nickel-vanadium steel manufactured at Canadian Steel Foundries Division, Hawker Siddeley Canada Ltd., Montreal, P.Q., Order No. 11975-65. The blade-stub sample is illustrated in Figure 1, as-received, and in Figure 2 after the fracture had been cleaned and derusted. The fracture surface was slightly pitted as a consequence of the broken propeller remaining in service for a period of three weeks after fracture. There is a clearly defined origin (arrow) indicated by the chevron markings. The fracture is fine-grained and uniform but without evidence of shear or deformation during failure so that failure appears to be due to brittle fracture caused by impact at sea water temperature.

Figure 2. Broken "Blade-Stub", C.C.G.S. Sir John A. MacDonald.
Cleaned and Derusted. The fracture surface is uniform
and fine-grained but does not show evidence of deforma-
tion. The chevron pattern and origin suggest that failure
occurred by brittle fracture under impact at sea water
temperature.

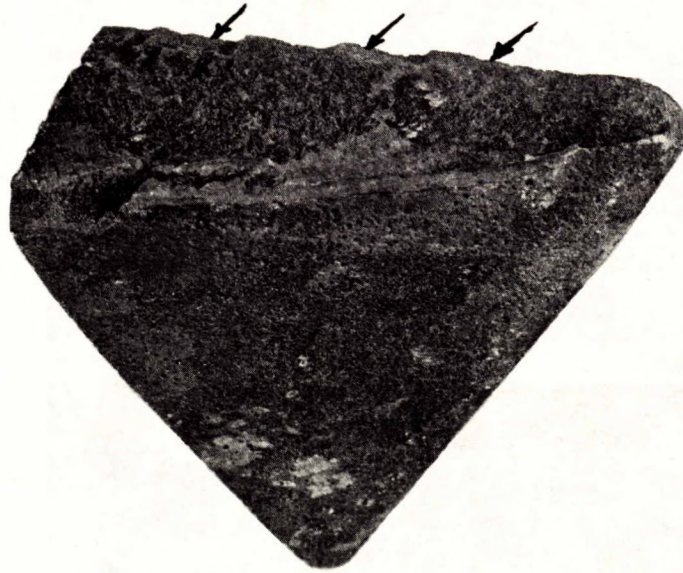
Figure 3. "Blade-Tip" Sample Submitted in January 1966,
C.C.G.S. Sir John A. MacDonald. This picture
illustrates part of a second broken blade from
this ship. This blade exhibited more deformation
during fracture as indicated by formation of a
1/8 in. shear-lip along the surface (arrows).

Examination of the fracture indicates that both the "blade-stub" and "blade-tip" fractures were due to impact. The "blade-stub" fracture had chevron markings, a well-defined origin and showed little deformation; the part of the "tip" fracture observed showed a shear lip indicative of considerable ductility at fracture.

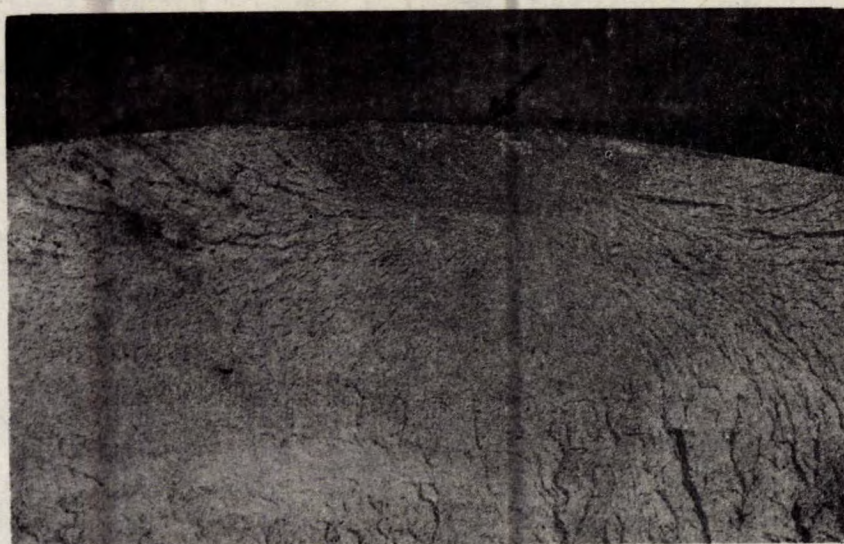
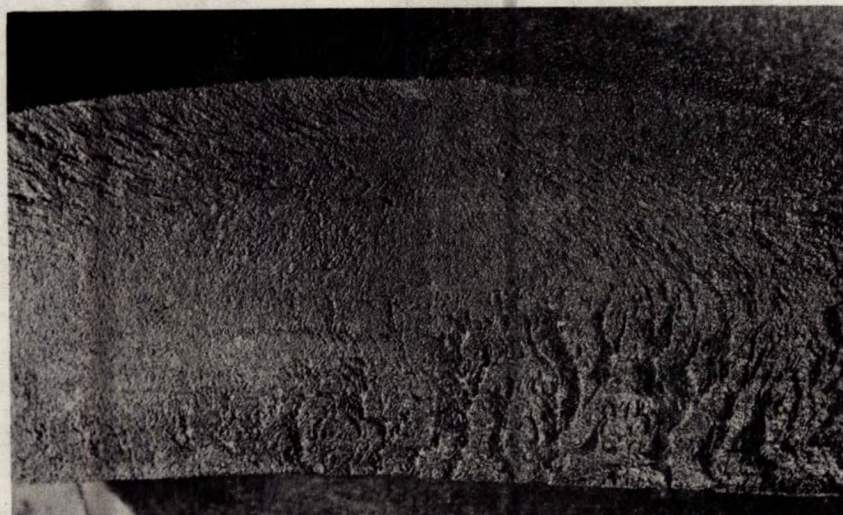
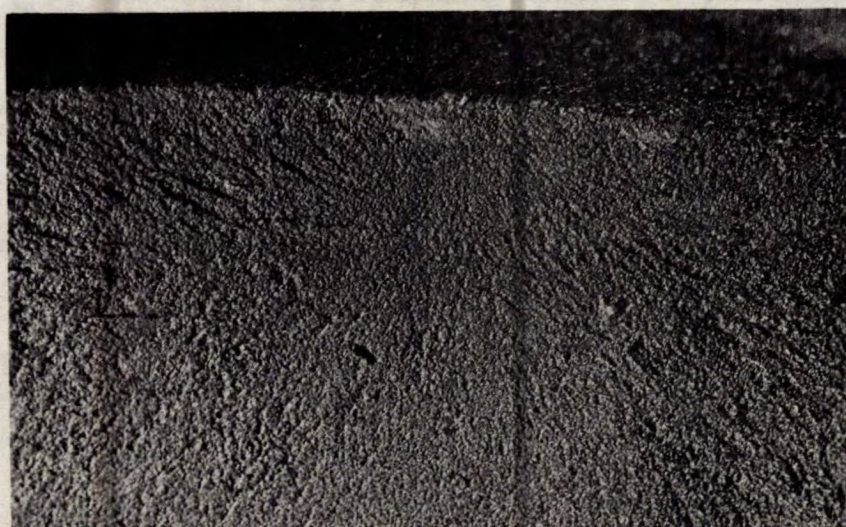
Figure 4(a) illustrates the "as-received", appearance of the fracture origin. Figures 4(b) and 4(c) illustrate the origin after cleaning of the fracture with $SbCl_3$ derusting solution. A chevron pattern pointing to the origin is illustrated. The presence of chevron markings is suggestive of brittle fracture under application of impact load. The surface has been slightly altered by pitting since fracture, due to operation of the blade-stub in sea water after failure of one blade and by subsequent outdoor storage.

Figure 4. Fracture Surface, Blade, Showing Fracture Origin
(a) as-received; (b) (c) derusted.

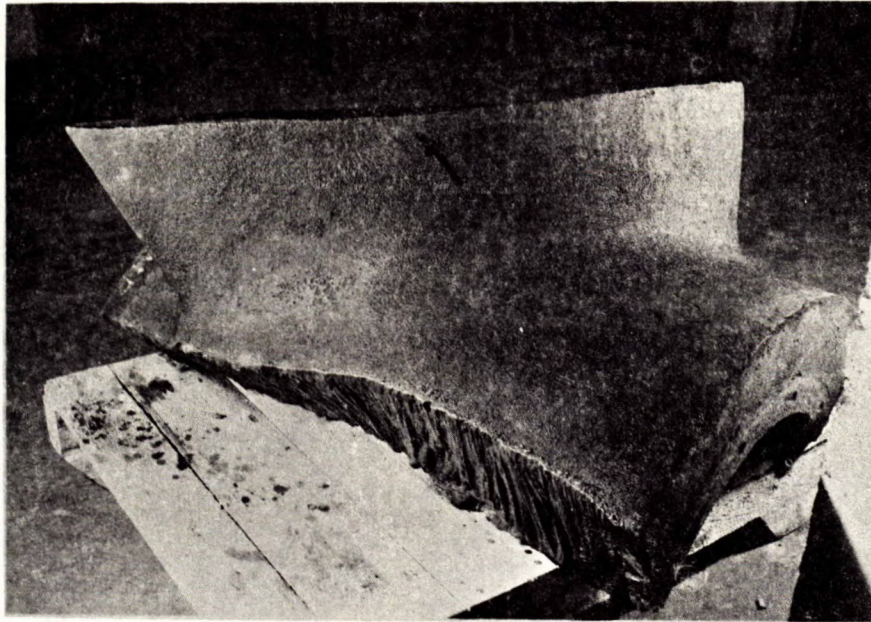
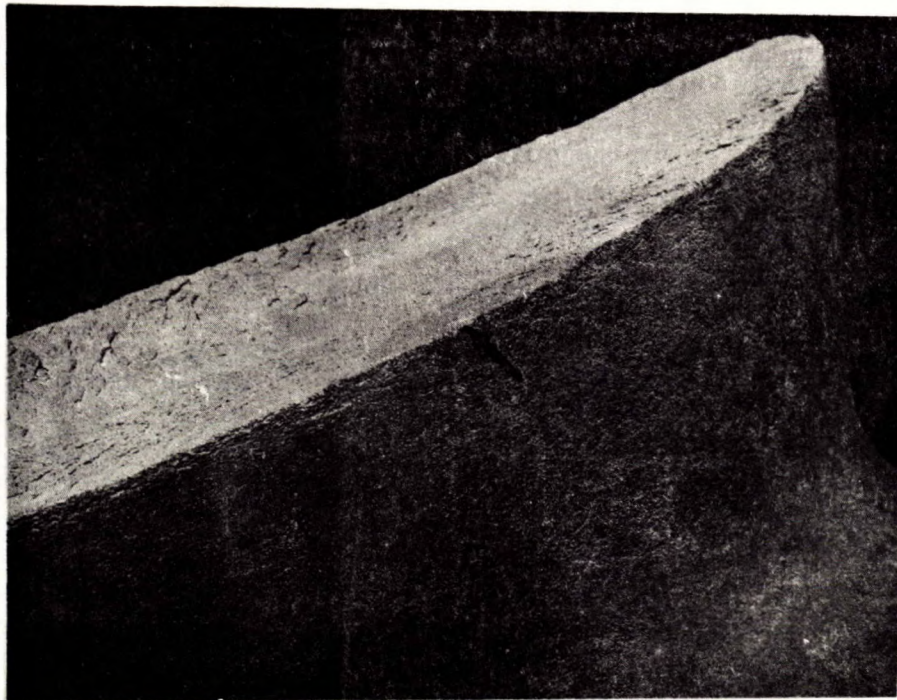
Figure 5 illustrates a side-view and oblique surface view of the side surface of the propeller stub casting with the origin of the fracture marked by the arrows.

Figure 5. Convex Surface of Casting with Origin marked (arrow).
Figure 5(a) shows the stub surface in elevation;
Figure 5(b) shows the same surface at the origin with
the origin visible on the fracture surface.

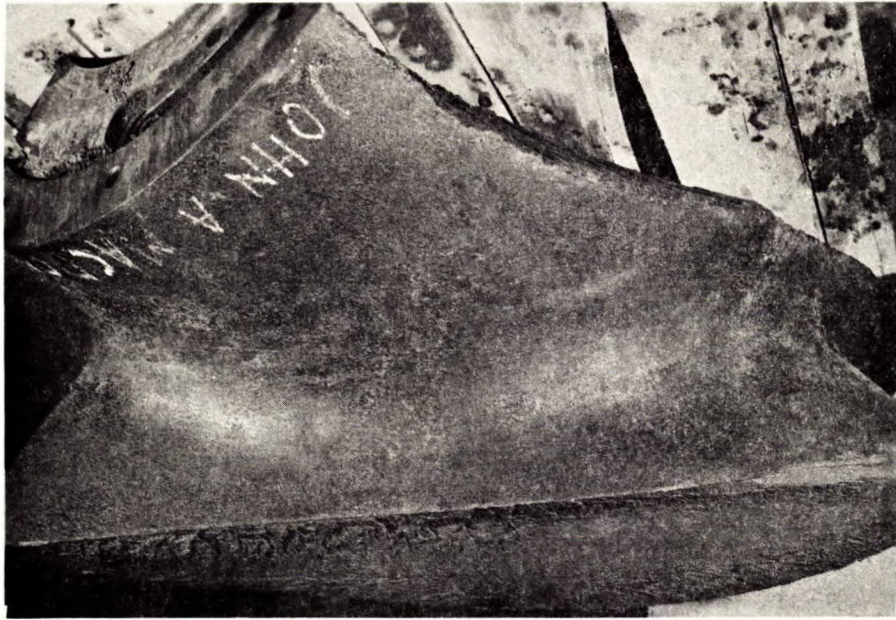
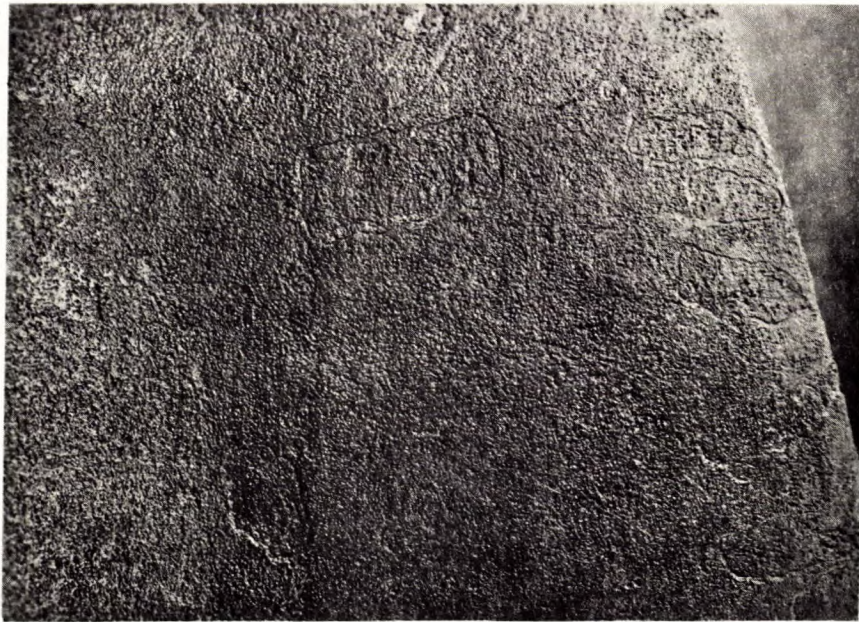
Figure 6(a) illustrates the concave surface of the blade-stub casting opposite to the failure surface. Figure 6(b) illustrates welds in the hub region which are visible as a result of etching by sea water. Unlike the welds illustrated, welds in the critical root area were not delineated by etching or metallography but were only visible on sulphur prints since the sulphur content of deposited weld metal was lower than that of the casting.

Figure 6. Concave Surface of Broken Blade-Stub. Figure 6(a) Welds are visible in the hub region; Figure 6(b) as etched by service in sea water.

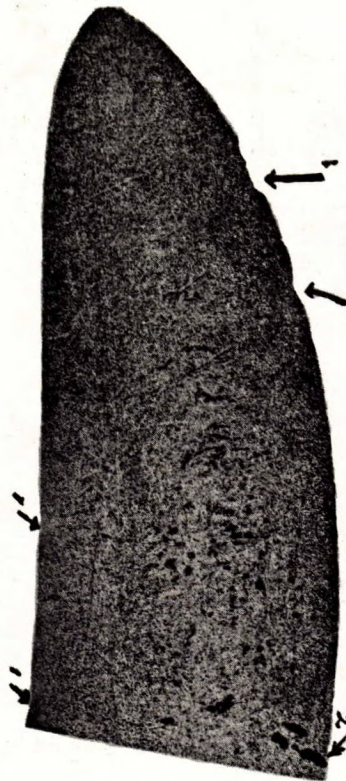
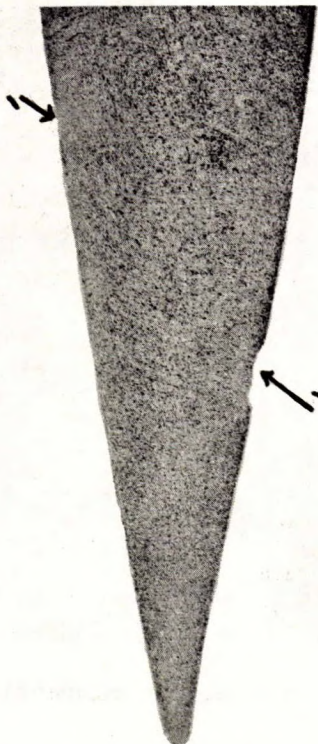
Figure 7 illustrates a sulphur print taken on the ground section 1/2 in. beneath the fracture (i.e., the fracture is directly beneath the section illustrated.)

The welds are marked by arrows (No. 1); these are visible because of the extra low sulphur content of the weld deposit. No cracks or defects were observed at the welds. These welds had been made prior to heat treatment and were only detected by sulphur printing since the weld microstructure closely matched that of the casting and, unlike the superficial hub welds, the weld deposits had not become etched or differentially attacked during salt water service.

Figure 7 illustrates part of a self-welded, hot-tear (arrow No. 2) which connected with a 3/8 in. diameter shrinkage cavity 2 in. beneath the casting surface. This was the only shrinkage cavity observed in any of the sections and in this instance appeared to result from last-freezing, segregated metal, filling a hot-tear (self-welding).

Figure 7. Sulphur Print of Section Directly Beneath Fracture Surface.
Welds are shown (arrows, No. 1). Part of a "healed" hot-tear, having a diameter of approximately 1/2 in. and a length of 2 in. is illustrated, (arrow No. 2). Figures 16 to 19, inclusive, also illustrate this hot-tear in the polished and etched condition. Chemical analysis showed phosphorus segregation in this area.

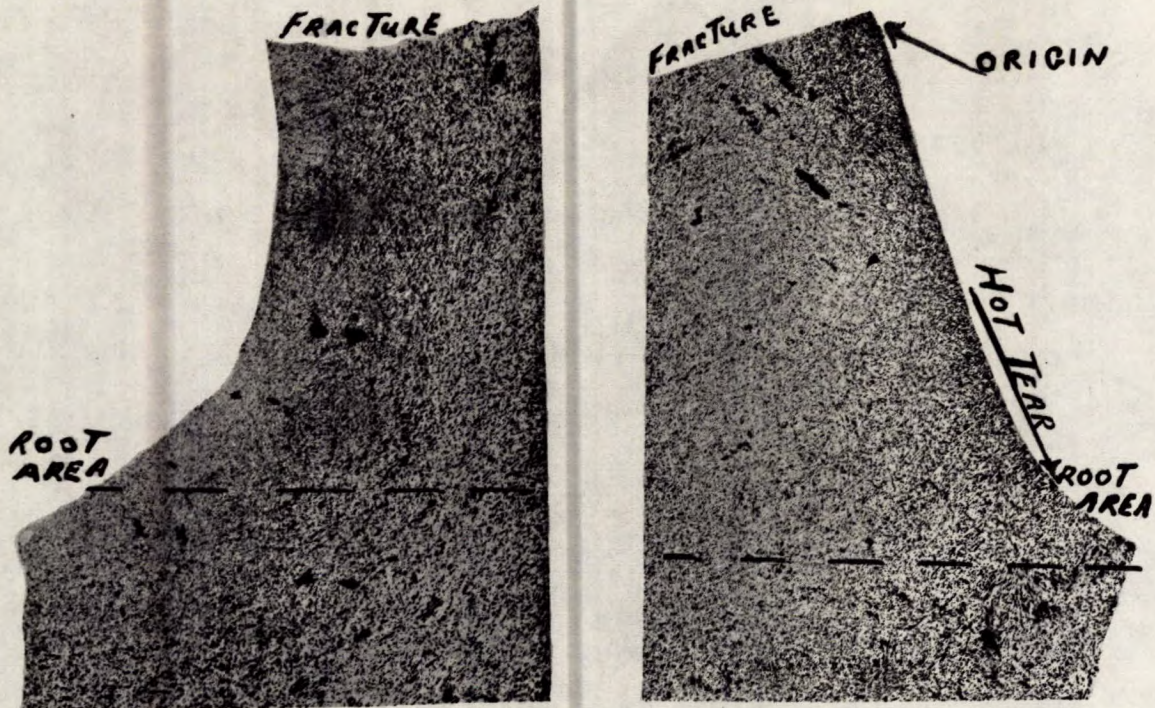
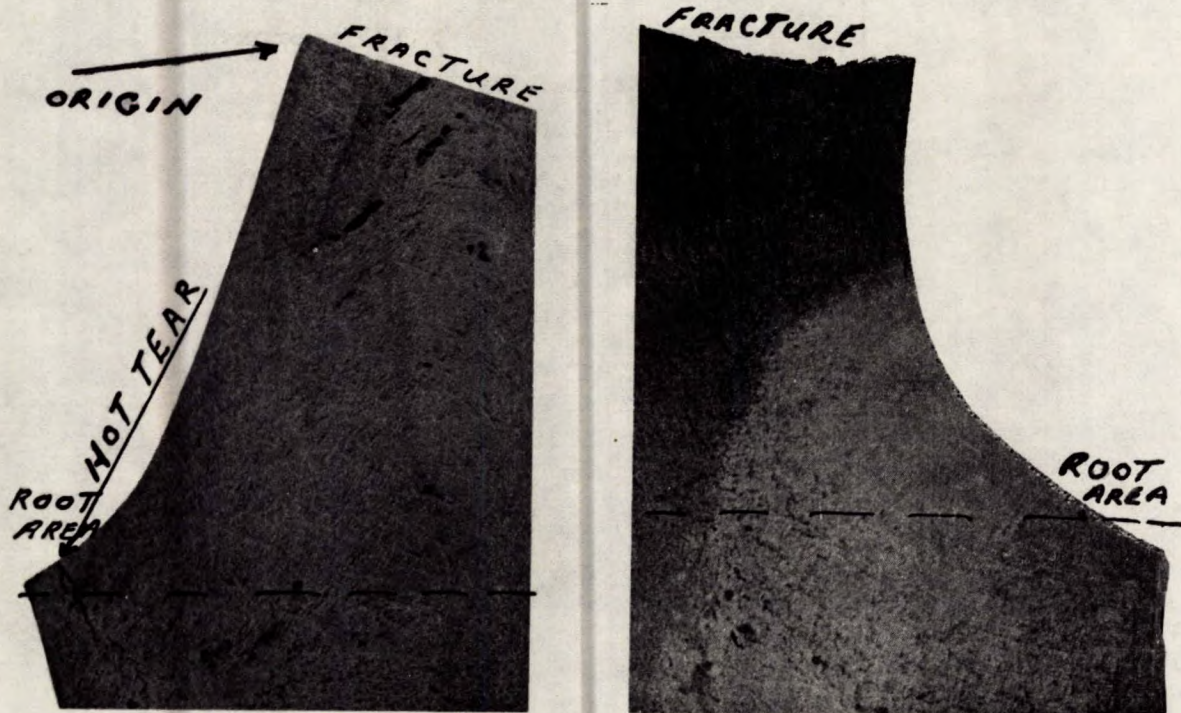
Figure 8 illustrates sulphur prints and deep-etches on a section normal to the fracture surface. (Note that sulphur print and deep-etch photograph prints are reversed during processing.)

Figure 8. Section Normal to Fracture at Origin. Sulphur print (a); same section deep-etched, HCl: water, (b). The fracture surface and origin side is marked. Also illustrated is a typical welded hot-tear in the root area which nevertheless did not contribute to the fracture.

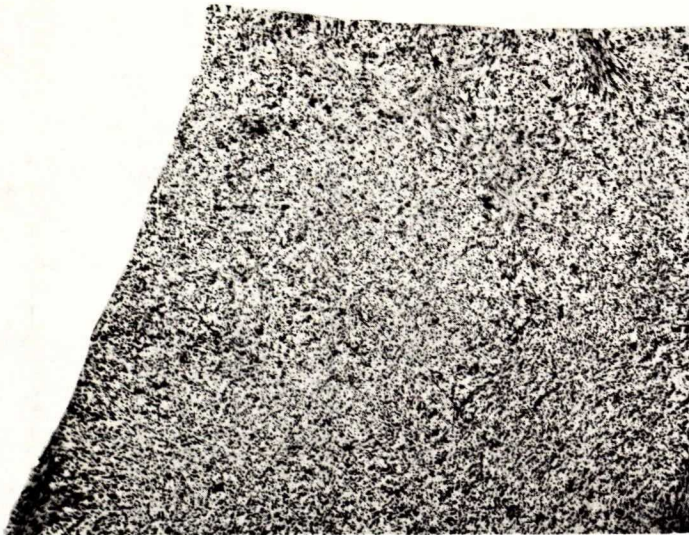
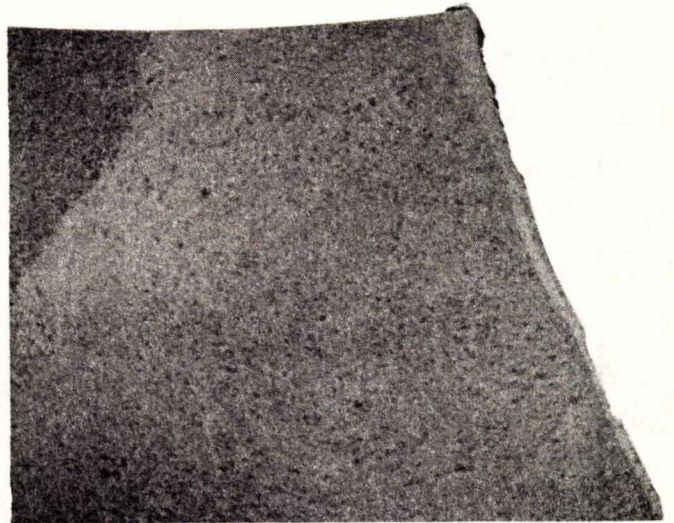
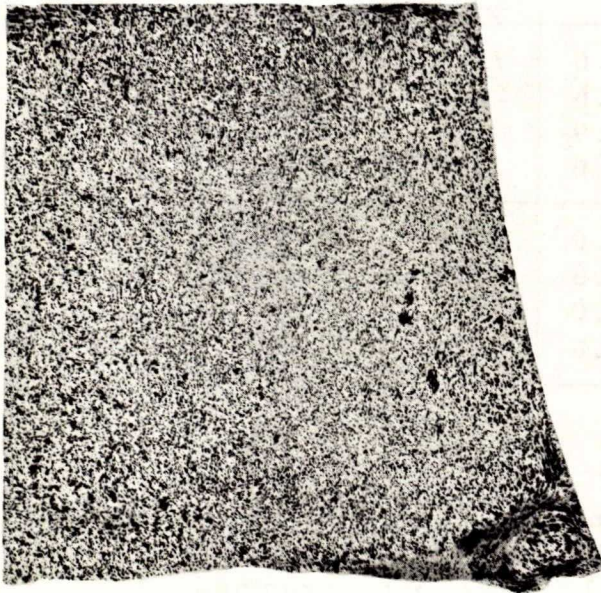
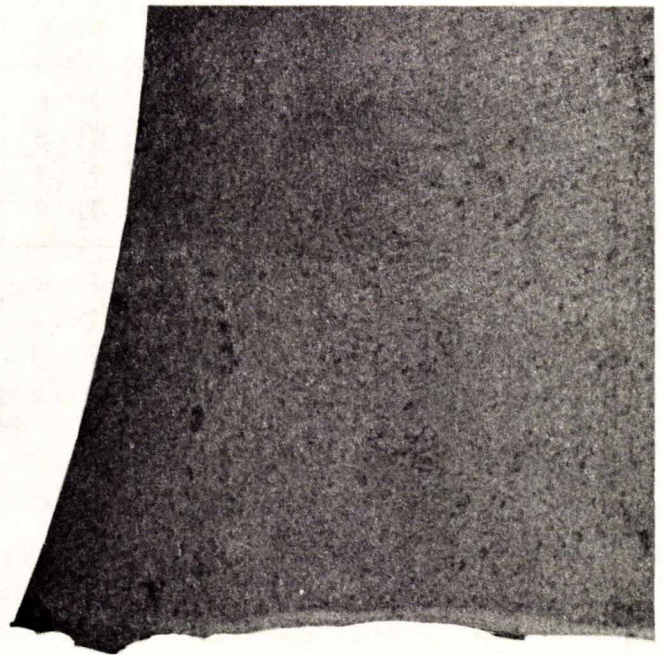
Figure 9 shows a section in the hub region matching the section illustrated in Figure 8. The casting appears sound and normal with respect to distribution of sulphides, macrostructure and absence of shrinkage.

Figure 9. Sections Illustrating Sulphide Inclusion Content and Macrostructure of Hub Region. Adjacent to sections shown in Figure 8 (i.e., this section is normal to the fracture surface).

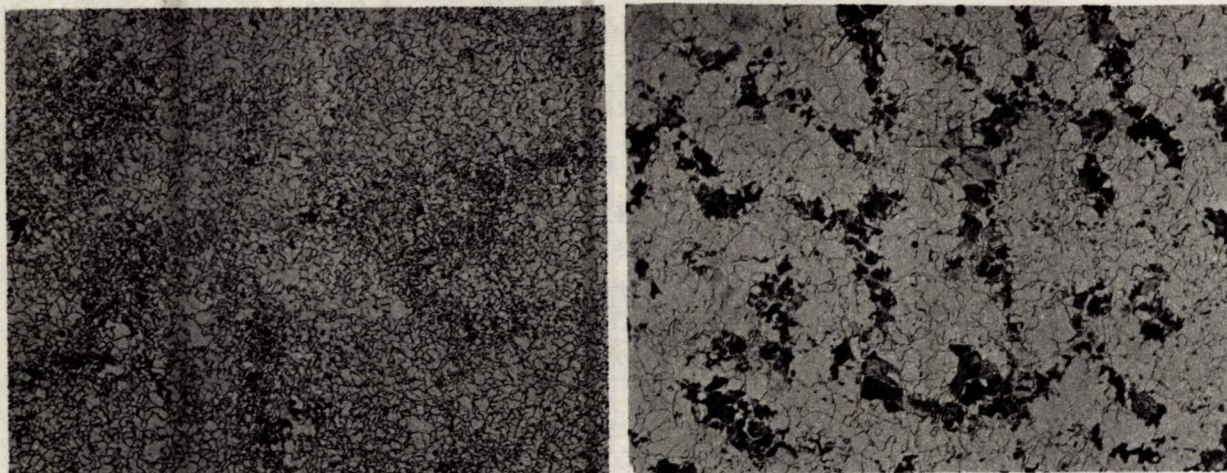
The microstructure of the hub of the broken blade is illustrated in Figure 10.

Figure 10. Surface (decarburized) (a); and General Microstructure (b), respectively of "Blade-Tip" Sample. Note that the general microstructure illustrated in Figure 10(b) resembles that of the "blade-stub" shown in Figure 11.

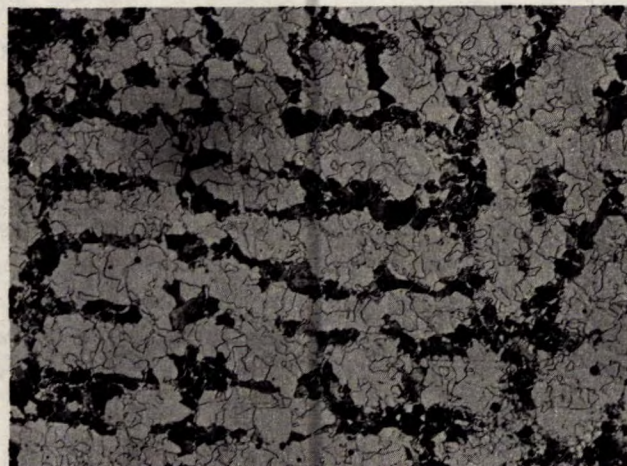
Figure 11 illustrates the microstructure observed at the trailing edge of the blade-stub taken at the fracture surface.

Figure 11. Dendritic Ferrite-Pearlite Microstructure at the Thin Section, Trailing Edge, Intersecting the Fracture of the "Blade-Stub" Sample. The general microstructure of this casting resembles that of the "blade-tip" sample.

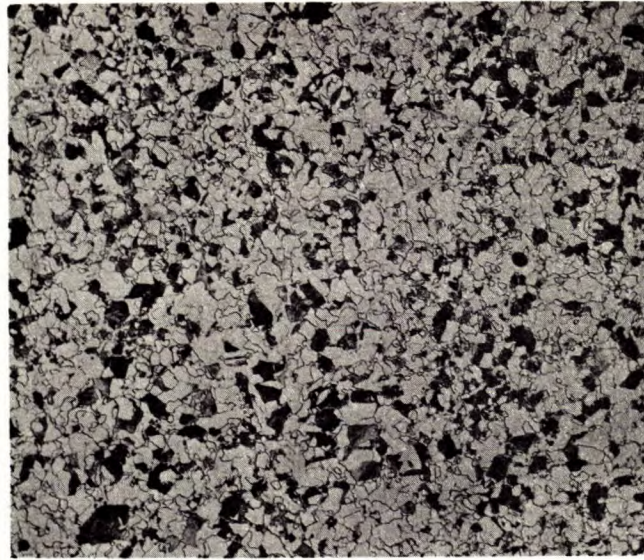
Figure 12 illustrates the microstructure at the thick section taken at the apparent origin as indicated by the chevron markings, visible on the fracture surface.

Figure 12. Ferrite-Pearlite Microstructure at the Fracture Origin, "Blade-Stub".

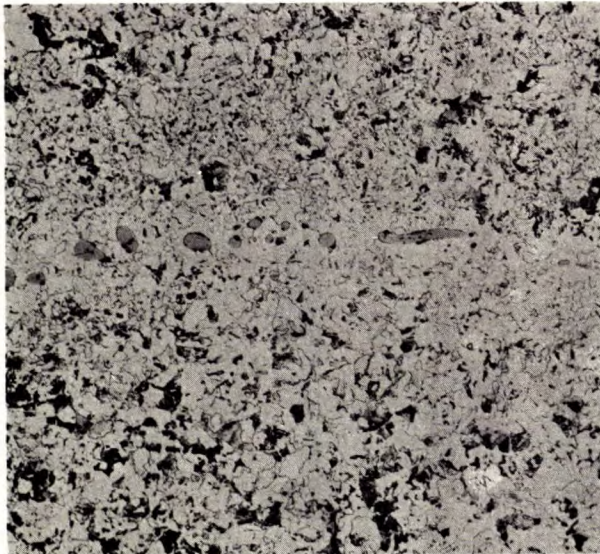
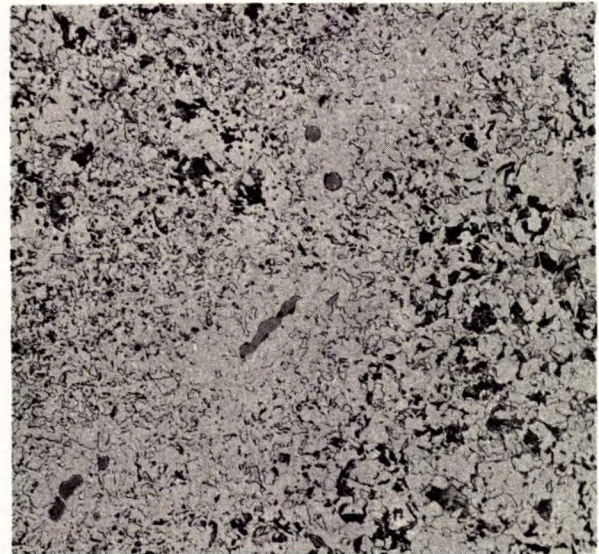
Figure 13 illustrates a grain boundary and sulphur segregation observed in the root area of the broken blade-stub.

Figure 13. Microstructure and Sulphide Distribution at "Blade-Stub" Grain Boundary in the Root Area are Illustrated.

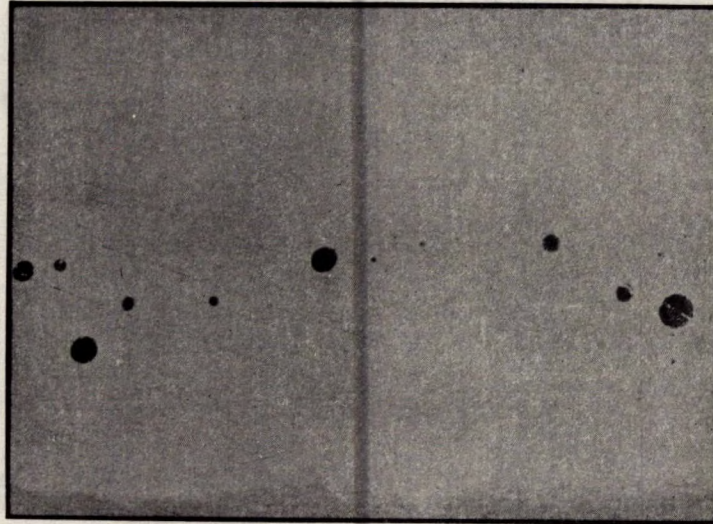
Figure 14 illustrates typical silicate (deoxidation) inclusions observed in the blade-stub casting. Figures 15(a) and (b) illustrate duplexed silicate inclusions and one MnS inclusion viewed in the as-polished condition under white light, Figure 15(a), and under polarized light, Figure 15(b).

Figure 14. Silicate (Deoxidation) Inclusions, Observed in "Blade-Stub" Casting.

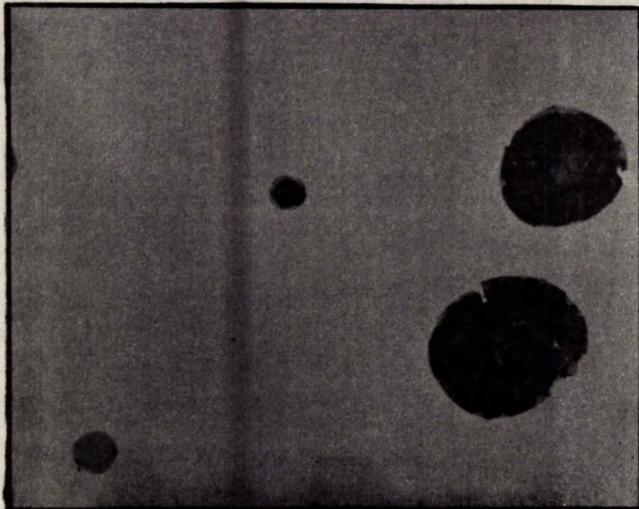
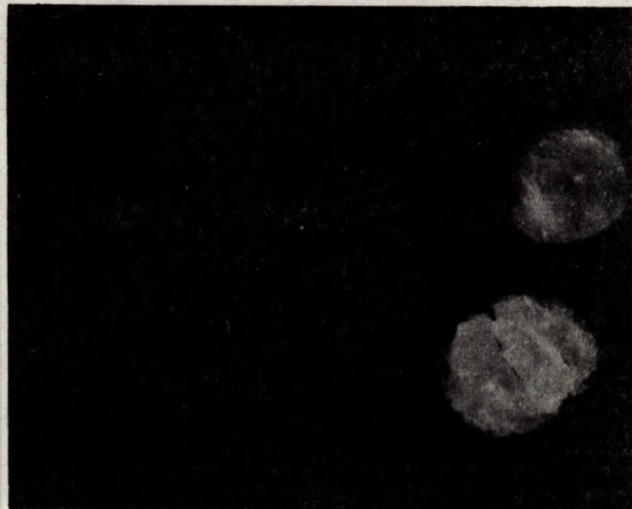
Figure 15. Illustrates Typical Spherical Silicate-type and One MnS type Inclusions, Observed in Propeller "Blade-Stub" Casting. The silicate inclusions are frequently duplexed with MnS at their outer surface.

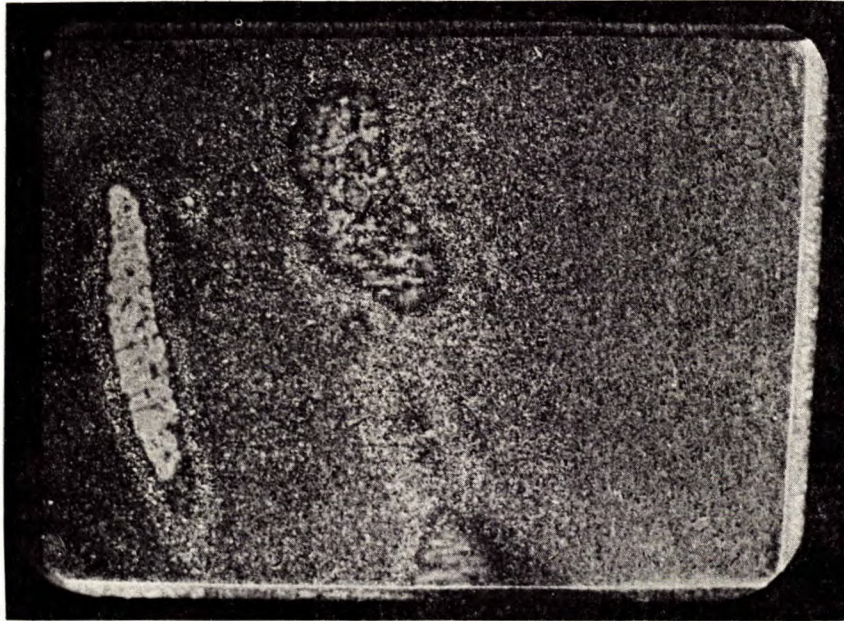
The appearance of the hot-tear on a polished section 1/2 in. beneath the fracture, 1/2 in. from the surface, and 2 in. from the apparent fracture origin, is illustrated in Figure 16 at low magnification.

Figure 16. Healed Hot-Tear Extending Inwards at 45 Degrees from Cast Surface, 2 in. from the Fracture Origin. Last-freezing metal from 2 in. inside the casting flowed into the tear filling it and leaving a 3/8 in. diameter shrinkage hole at the 2 in. position. Apparently the tear formed and healed itself after a 2 in. thick skin (skull) had formed on the surface of the casting and after effective feeding of metal from the riser had ceased.

The area illustrated in Figure 16 was enriched with respect to phosphorus, from 0.004% to 0.116% as shown by wet chemical analysis of drillings from the segregate. Microprobe analysis showed that the grain boundaries were filled with MnO. Microshrinkage and areas of phosphide eutectic were also observed and were consistent with the defect having been healed by inflow of segregated, last-freezing, metal. The defect was not a weld and there was no possibility of, or evidence of weld preparation; also, weld deposits were all typically low with respect to sulphur, whereas sulphur and phosphorus segregation was observed in this area both by wet analysis and by sulphur printing, as illustrated in Figure 7.

A welded hot-tear defect was observed about 2 in. from the apparent origin of the fracture, but did not appear to have been directly related to the fracture. (This defect was unusual and for this reason considerable attention was paid to it -- it appeared to be a self-healed hot-tear containing microshrinkage, phosphorus segregation as steadite, manganese segregation as oxide, and sulphur segregation.)

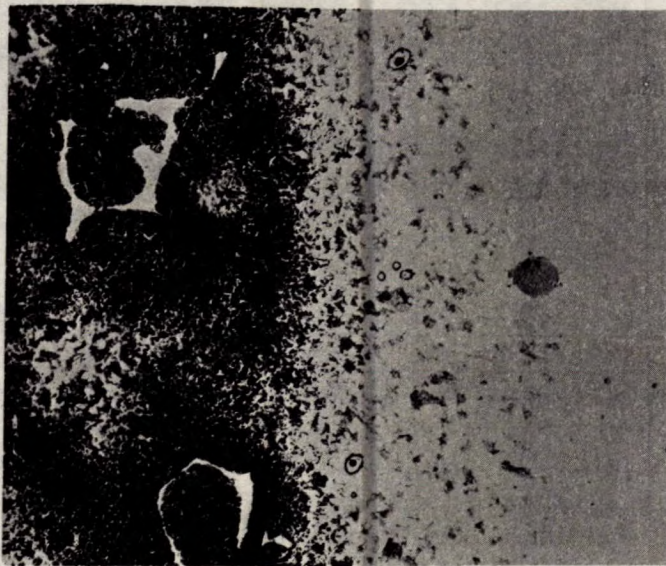
Figure 17. Illustrates Interface Between Matrix and Segregate.
Part of segregate area shown at the left of Figure 16.

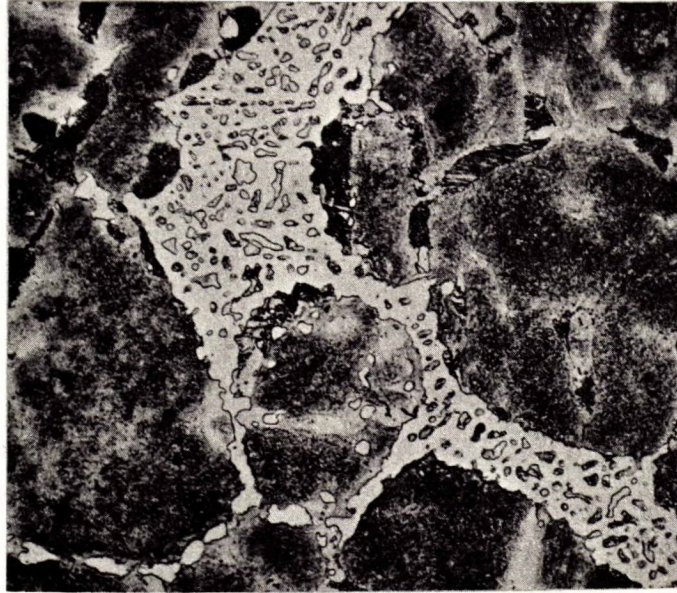
Metallographic and microprobe examination showed that in this area phosphorus was segregated sufficiently to form steadite, and manganese to form MnO films in grain boundaries. Sulphur and silicon were also segregated.

Figure 18. Illustrates Phosphorus Segregation in Hot-Tear Region. Phosphorus segregation has occurred to the extent that phosphide eutectic "Steadite" is visible in the microstructure.

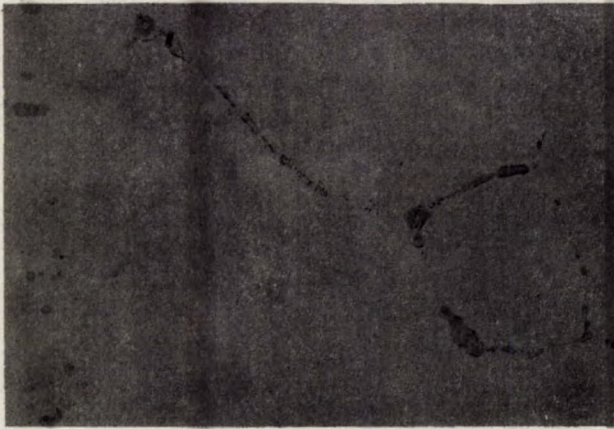
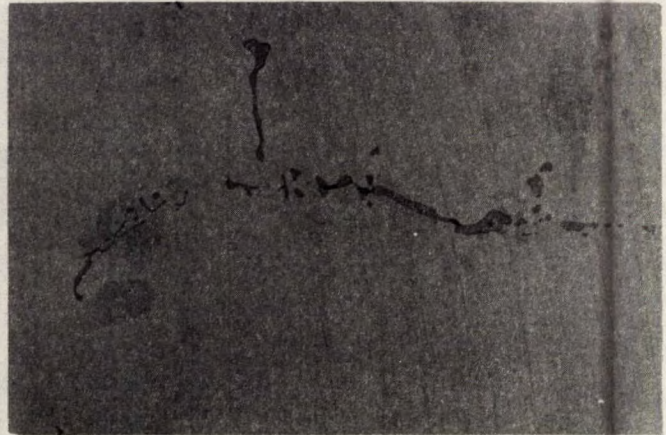
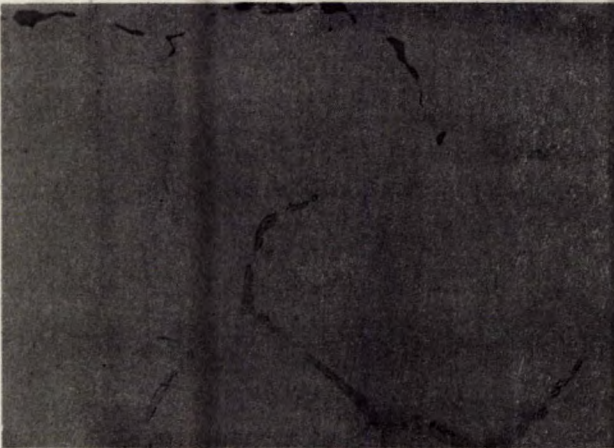
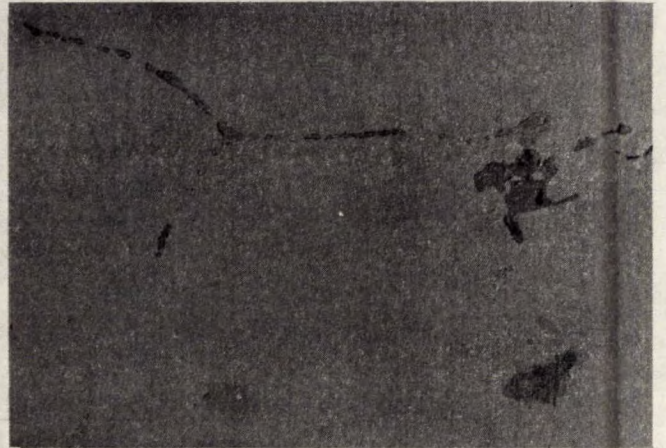
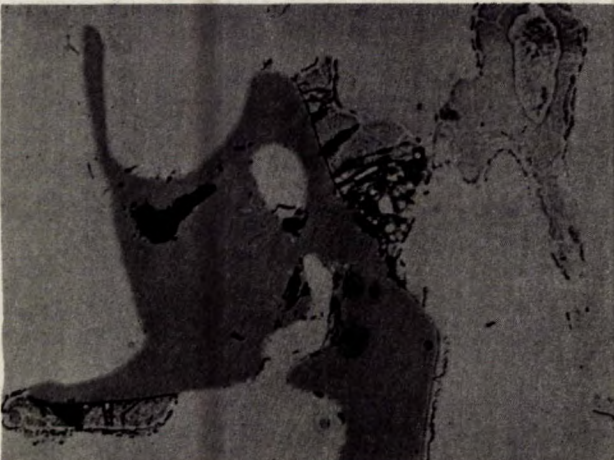
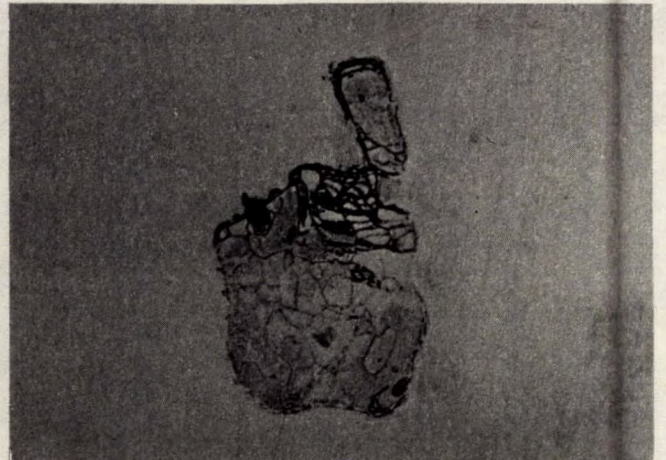
Figure 19 illustrates manganese segregation in the grain boundaries and inclusions in the hot-tear segregate area.

Figure 19. Mn Segregation at Grain Boundaries (a) to (d) Inclusive. Inclusions in segregate area are illustrated (c) and (f). Microshrinkage was also observed.

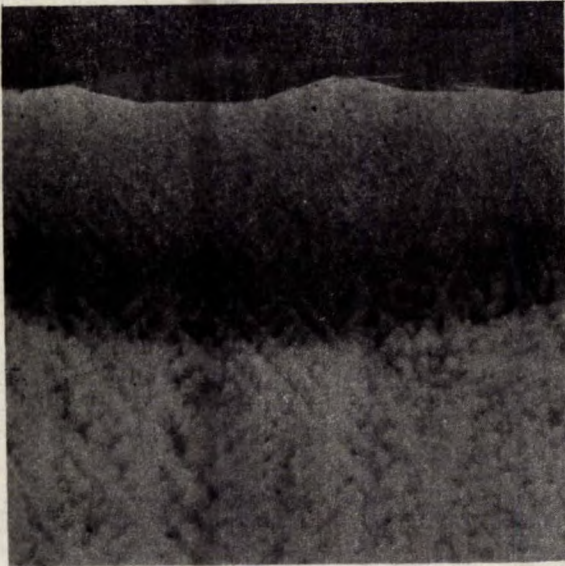
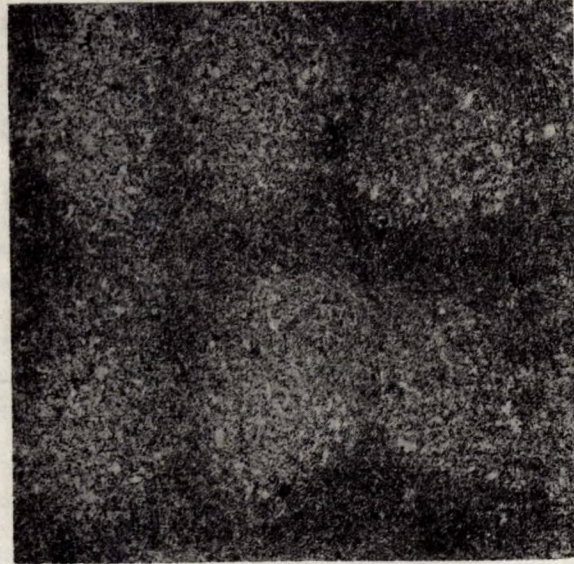
Figure 22. NDT Temperature -5°C ($+18^{\circ}\text{F}$), Melt 72-2. Vanadium, carbon, silicon at high side of specification. Figure 22(b) illustrates the fine-grained cored microstructure which gave cleavage-type fracture on Charpy V-notch test bars at ambient temperature.

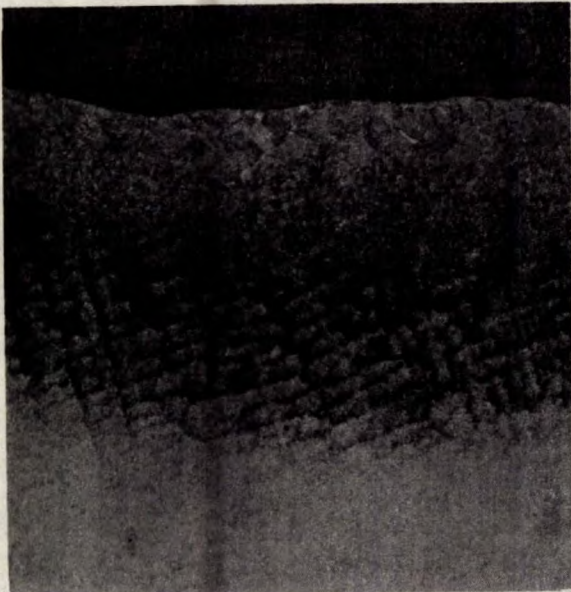
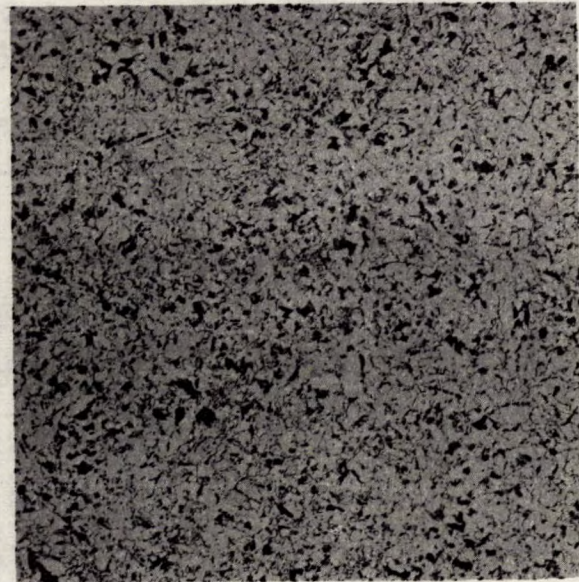
Figure 23. NDT Temperature -65°C (-75°F), Melt No. 12. No vanadium, carbon and silicon at low level. Figure 23(b) illustrates homogeneous, pearlite-ferrite microstructure which gave fibrous fracture in Charpy V-notch test bars at ambient temperature.
