MINES BRANCH INVESTIGATION REPORT IR 66-52

**EXAMINATION OF CRACKED AREA
OF A TYPE 416 SUCTION ROLL**

EXAMINATION OF CRACKED AREA OF A TYPE 416 SUCTION ROLL
E. B. EDDY JOB 87-5168

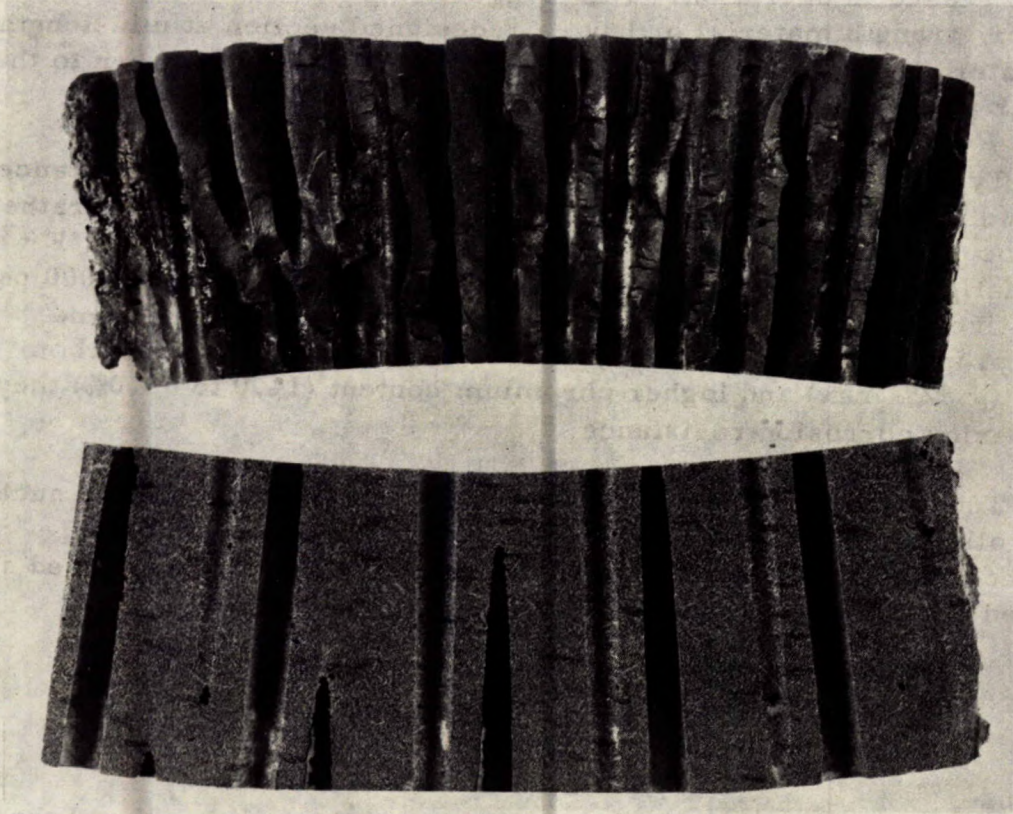
Figure 1 (actual size) shows the fracture surface and the macro-structure of the metal on a plane parallel to the mean fracture plane. The fracture was reported to have occurred transversely at about the mid-length of the roll.

The fracture surfaces were not bright and clear. However, the appearance of the fracture surfaces still indicated that fatigue fractures had initiated at multiple sites in the outer (measured radially) 1/2 inch of the suction holes. In this 1/2 inch length there were dense adherent deposits about 0.035 inches thick, and beneath these deposits the metal was pitted and generally so corroded that no machining marks could be detected. In the inner 1 1/4 inch of each hole the dense deposits were thinner or non-existent and few pits were observed. Over this inner 1 1/4 inch the tool marks of the drills were clearly visible. Indeed, over this inner length some of the holes were only slightly tarnished. Many of the holes were filled with loose fibrous deposits.

Most of the fracture surface was characteristic of abrupt brittle failure.

In Figure 1, the deep etched section parallel to the mean plane of fracture indicates that the failure occurred roughly transversely to the principal planes of hot working which were longitudinal and circumferential. It is not known for certain whether or not the roll was fabricated from plate or forged directly from an ingot. Observations indicate that it probably was forged directly from an ingot and, therefore, the principal planes of forging spiral along the length of the roll.

Figure 1. Portion of Failed Firth FCS-1 Stainless Steel Suction Roll - No. 8 Paper Machine - Second Press Section - E. B. Eddy
Job 87-5168 (actual size)
Upper: Fracture Surface (transverse fracture at mid-length of the roll)
Lower: Macro-etched section parallel to the fracture surface.

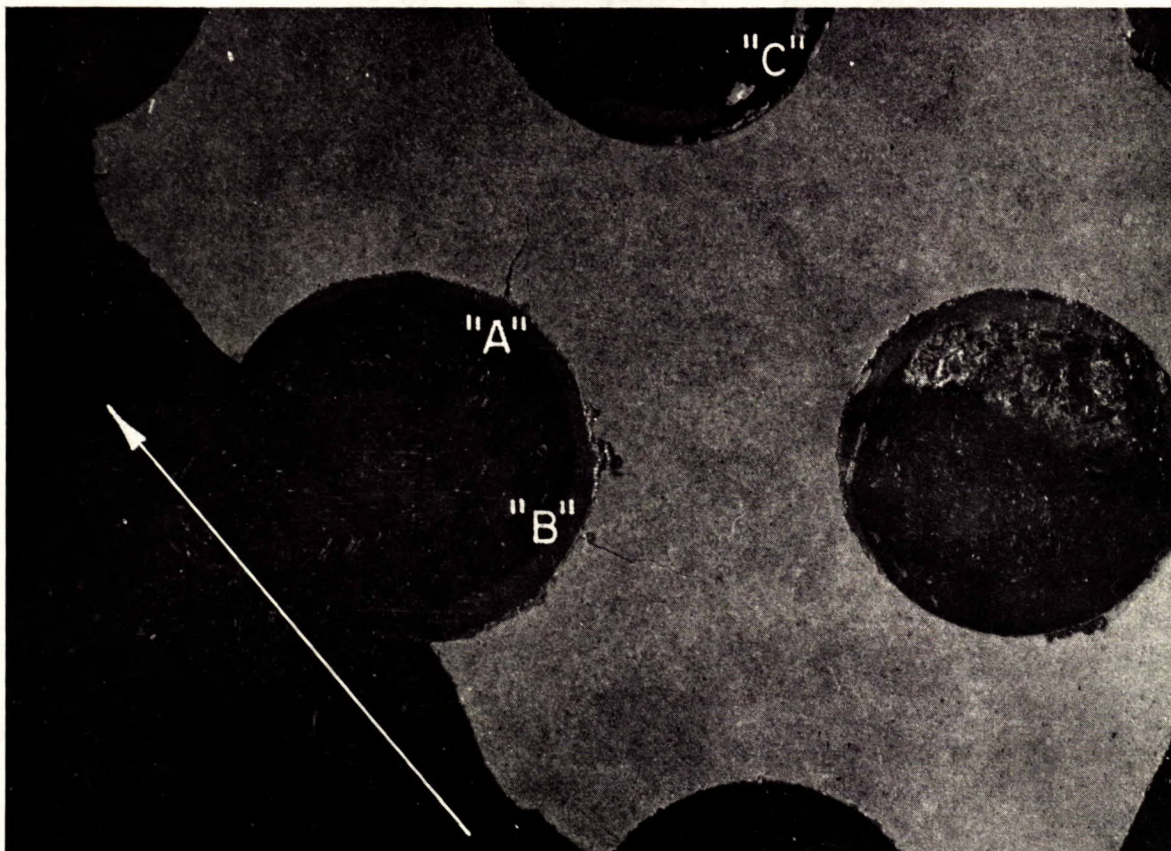
Figure 2 (X9) shows a cross-section of some of the drilled holes at and close to the fracture. This section was located about 3/8 inch below the outer surface of the roll. In this section the fracture intersects the longitudinal plane of forging, as indicated by the inclusion stringers, at an angle of about 45 degrees. Two cracks are readily visible intersecting the inclusion stringers at about 15 degrees ("A") and at 90 degrees ("B").

The fracture was stated to be transverse i.e., circumferential and at mid-length of the roll. The 5-inch length of fracture indicated that the path of fracture followed a regular zig-zag path along lines of closest approach of drilled holes. The holes had been drilled regularly, probably in a slight spiral pattern, so that paths of weakness were formed. These paths intersected one another at 60 degrees since the holes were spaced to form sets of equilateral triangles. Over the 5-inch length of fracture, which had a mean circumferential path, the actual path of the fracture passed, via the shortest path in each case, through three holes cutting across the mean transverse path to the left; it then veered 60 degrees to the right across the mean transverse path and passed through seven holes; it then veered 60 degrees to the left through four holes; and then veered 60 degrees to the right through four holes.

Figure 2. Macrograph showing corrosion pits and dense adherent deposits in the suction roll holes. The main fracture cuts across the lower left part of the field in the direction of the arrow. Small cracks are visible at locations "A", "B" and "C". Etched in Vilella's reagent. (X9)

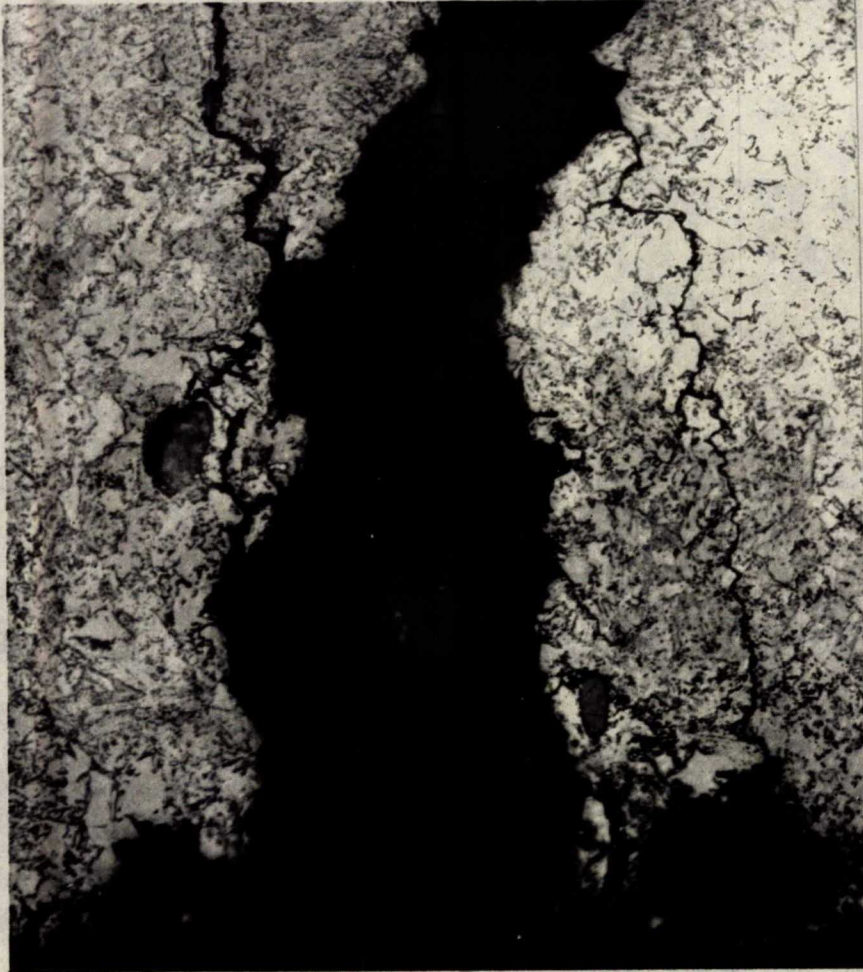
Figure 3 shows the starting region of crack "A". Figure 4 shows the starting region of crack "B". It is evident that the cracks initiated in the corroded and pitted surfaces of the drilled holes.

Figure 3. Crack radiating from corrosion pits at location "A" in Figure 2. This crack started in the direction of inclusion stringers and then turned 90 degrees to the left to parallel the main fracture. Etched in Vilella's reagent. (X500)

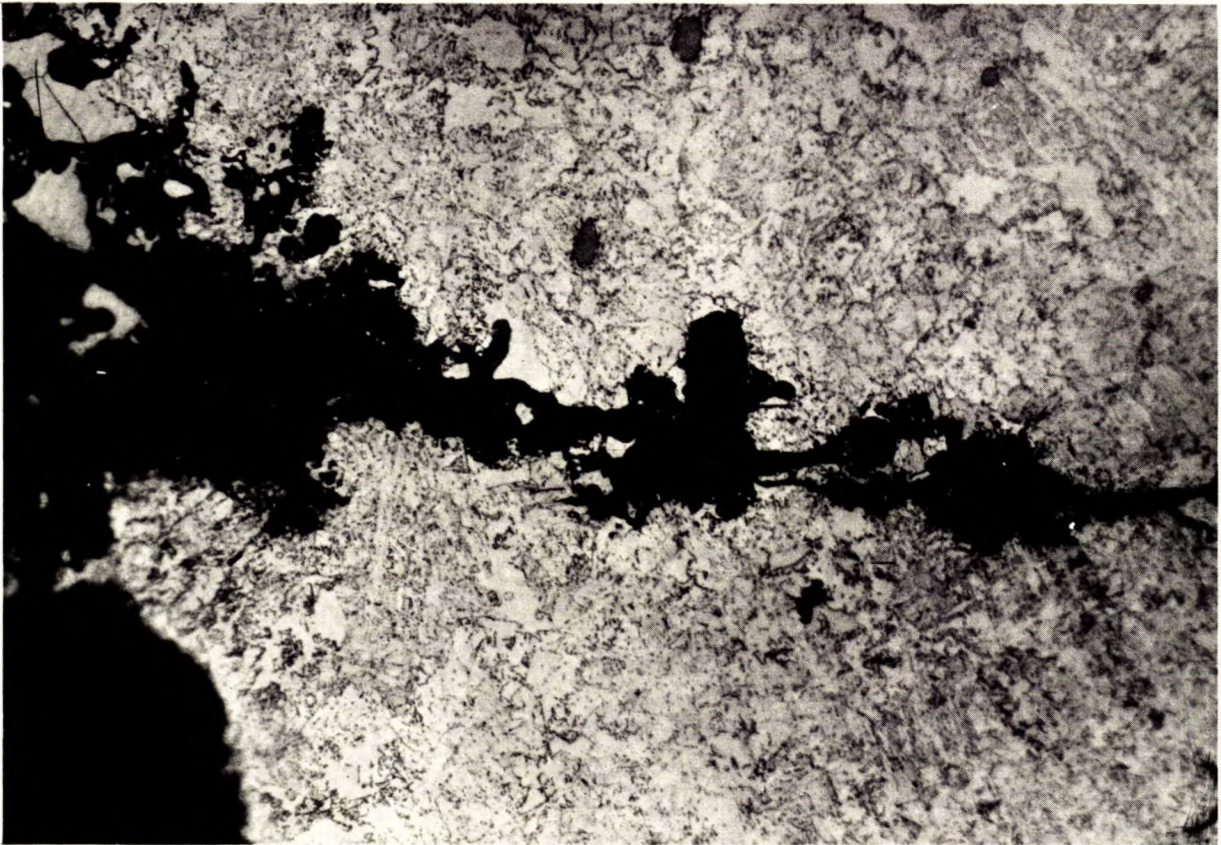
Figure 4. Crack radiating from corrosion pits at location "B" in Figure 2. The path of this crack is directly across the longitudinal forging direction. Pitting and general corrosion attack within the crack is evident. Etched in Vilella's reagent. (X500).

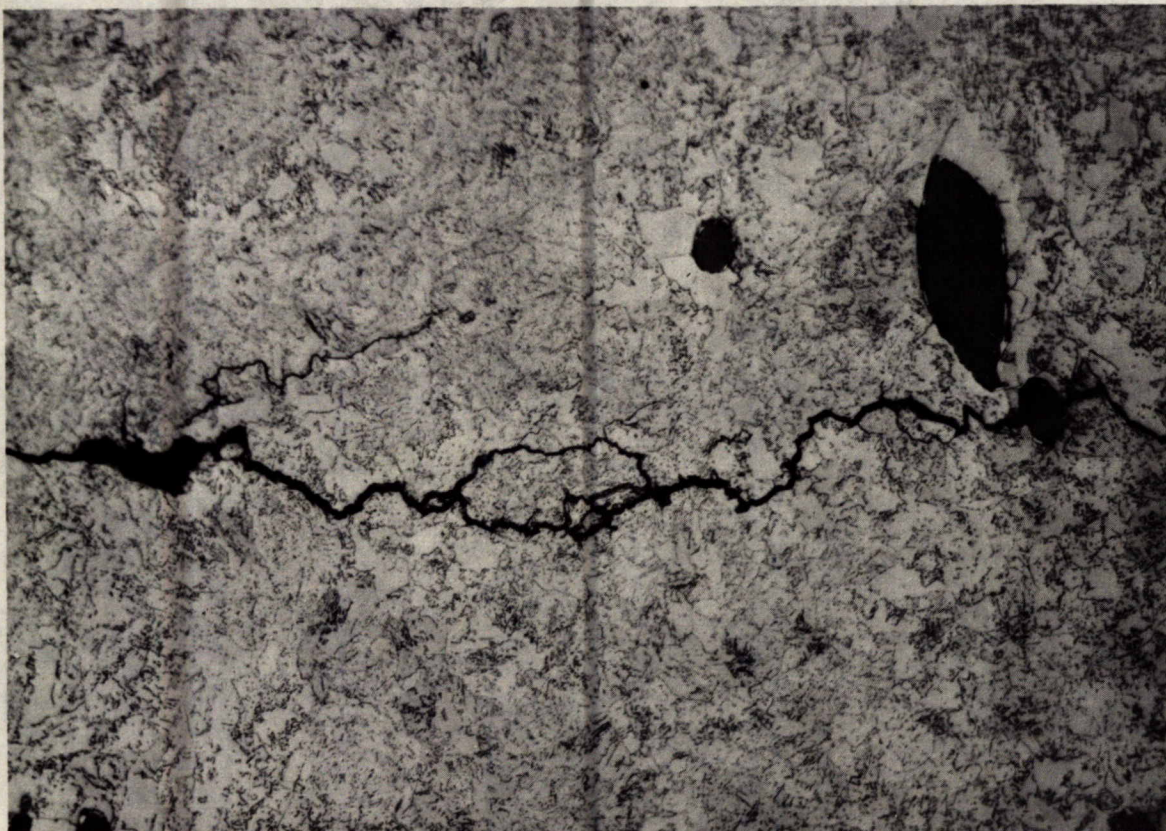
Figure 5, taken along crack "C", shows that the crack paths are mostly intercrystalline with little tendency to propagate along multiple paths.

Figure 5. Photomicrograph of cracked region "C". This is a representative field, where the path of the crack has not been obscured by corrosion, showing that the cracks progressed intergranularly without many secondary cracks. Etched in Vilella's reagent. (X500)
