MINES BRANCH INVESTIGATION REPORT IR 66-54

**CAUSE OF FAILURE IN KISKATINAW
RIVER PIPELINE**

A natural gas pipeline of API 5LX52 steel (26 in. diameter and 0.281 in. wall thickness) in the Alberta Mainline failed on December 12, 1965 at the Kiskatinaw River crossing, Peace River District, British Columbia, under normal service conditions with an internal pressure of approximately 260 psi.

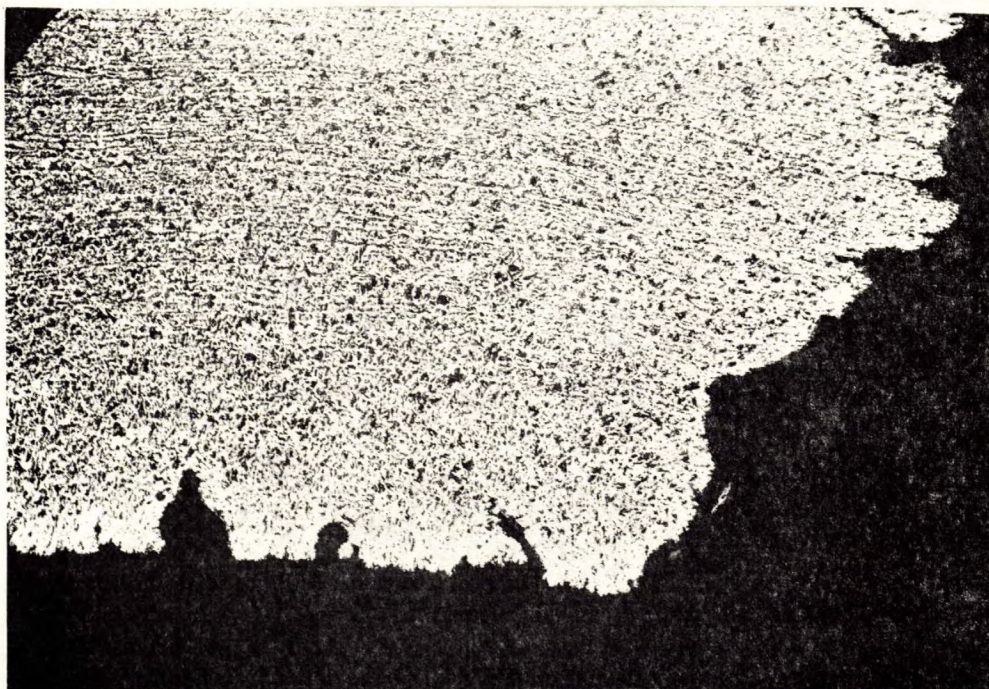
Figure 1 - Fissures adjacent to subsidiary fracture in
Sample No. 8 (inside surface). Fracture on
right-hand side.
Etched nital

The unusual subsidiary fracture in Sample No. 8, thought at first to be due to some corrosion defect, appeared on closer examination to have been caused by violent deformation. A large number of small cleavage cracks had appeared along ferrite paths on the pipe surface, and these had opened up in varying degrees on bending, giving rise to a woody-textured fracture. This phenomenon was associated with the structure in the metal near the surface, with pearlite lamellae somewhat randomly oriented, but tending to lie perpendicular to the plate surface (Figure 3).

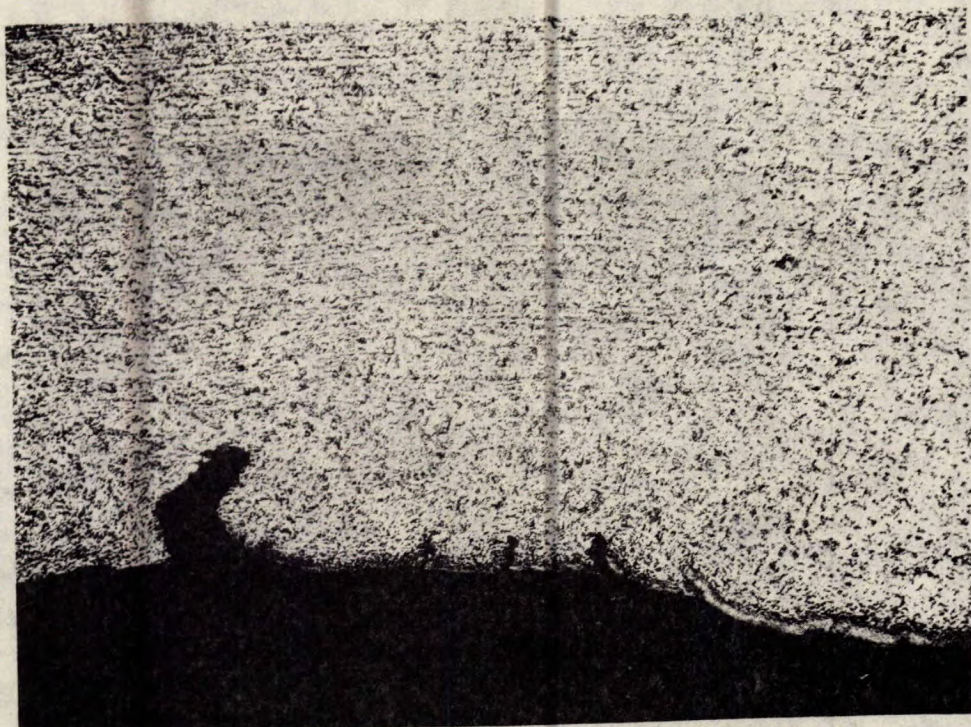
At some locations, some of the fissures could be seen to have opened up, while others remained quite narrow. Figure 2 shows these two types in close proximity.

Figure 2 - Examples of opened and unopened fissures in
Sample No. 8 (inside surface).

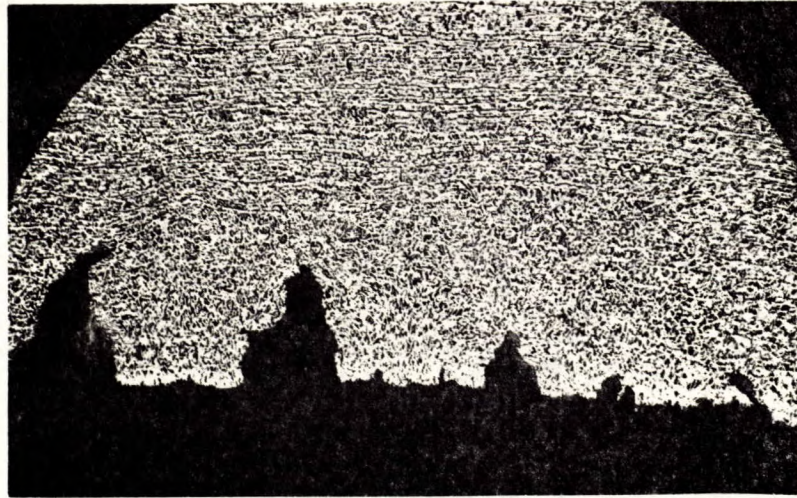
The fissures shown in Figure 1 are seen in the somewhat more general view in Figure 3. The slight banding indicated by the pearlite formation does not extend to the edges where the fissures occur. At the edges, the pearlite lamellae, though somewhat randomly oriented, tend to lie perpendicular to the plate surface. In addition, there is evidence of distortion in the pearlite formation around the fissures.

Figure 3 - Fissures and pearlite formation in Sample No. 8
(inside surface).
Etched nital

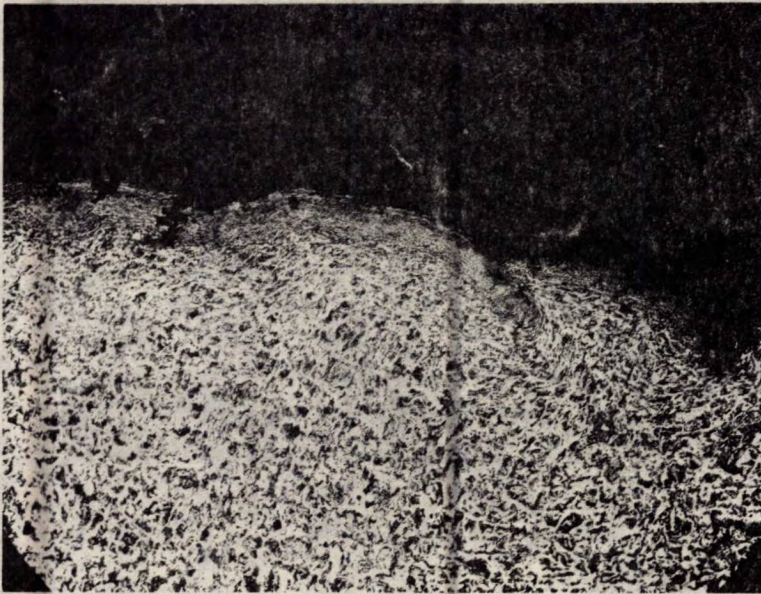
On the same sample (No. 8), a mechanical gouge mark, which appeared to be superficial, was visible on the outer surface of the pipe wall, and for part of its length ran alongside the fracture, i. e. about $1\frac{1}{2}$ in. A specimen was cut for microscopical examination. The gouge mark showed its effect in a layer of highly compressed metal which had transformed to martensite. The sudden heating caused by friction raises the steel to a temperature above the critical point, and because the heating is so localized, the mass of metal has a quenching action, resulting in a transformation to martensite. Figure 4 illustrates the formation of the martensite layer. Some fine cracks can be seen in the latter.

Figure 4 - Martensitic compressed layer caused by mechanical gouge (outside surface).

On the same sample (No. 8), which was badly twisted and deformed, a mechanical gouge mark, apparently somewhat superficial, ran for part of its length alongside the fracture, i. e. about $1\frac{1}{2}$ in. The gouge showed its effect on the structure by a layer of compressed metal which had transformed to martensite. Under slightly different circumstances, this could be a serious weakness in the pipe, but in the present instance the defect does not seem to have played a major role. It is not possible to exclude the possibility that a similar gouge mark was located near the weld at the failure origin, visible only on the other side of the fracture in the pipe which was not recovered.

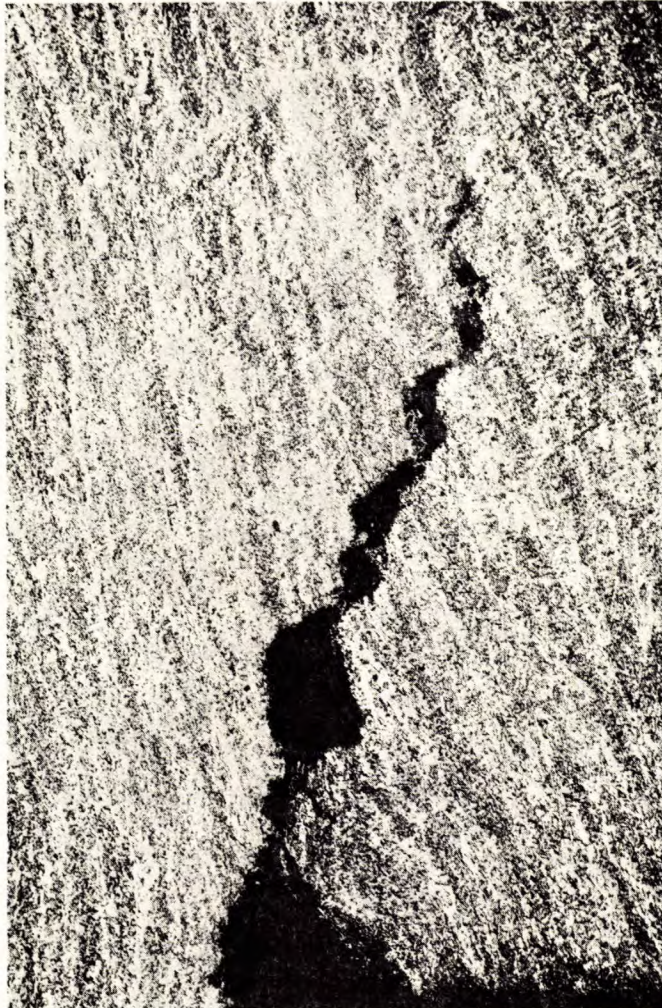
A small unmarked sample containing part of the submerged-arc weld showed some pits on the outer surface. Microscopical examination showed that cracking had penetrated part way through the wall at these locations as shown in Figure 5. There were several small pits grouped together and located about $1\frac{1}{2}$ in. from the intersection of the weld with the fracture.

Figure 5 - Cracking from pits in weld metal (inside surface).

Based on the evidence of the fracture appearance, it is thought that the fracture started near the longitudinal submerged-arc weld, although no defects were found in the weld at this location. About $1\frac{1}{2}$ in. from the intersection of the fracture with the submerged-arc weld, some cracking was found emanating from pits on the inside surface (Figure 5). This may

have been due to slag traps near the weld surface from which cracks extended when the pipe was being distorted under high stresses at the time of failure. The shallow pits found in the weld metal on the outside surface close to the fracture (Figure 6) are probably corrosion pits. These pits may have occurred in the deformed metal subsequent to fracture before the pipe was retrieved from the river bed.

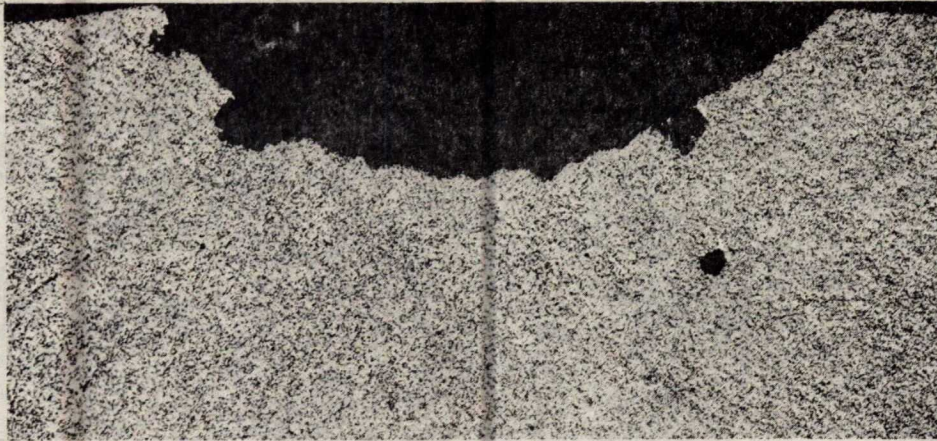
A section for microscopical examination had been cut through the weld at the fracture, during the investigation by Dr. Hanson. In order to discover whether similar pits were present closer to the fracture, the micro-sample was broken from its bakelite mount. A few shallow pits were discovered on the inside surface, as shown in Figure 6, but no associated cracking was found.

Figure 6 - Shallow pits in weld metal (outside surface)
close to fracture.
