MINES BRANCH INVESTIGATION REPORT IR 66-55

**EXAMINATION OF CAST STAINLESS (Mn-Cr)
STEEL PROPELLER - C.C.G.S. 'NARWHAL'**

D. E. PARSONS AND D. A. MUNRO

PHYSICAL METALLURGY DIVISION

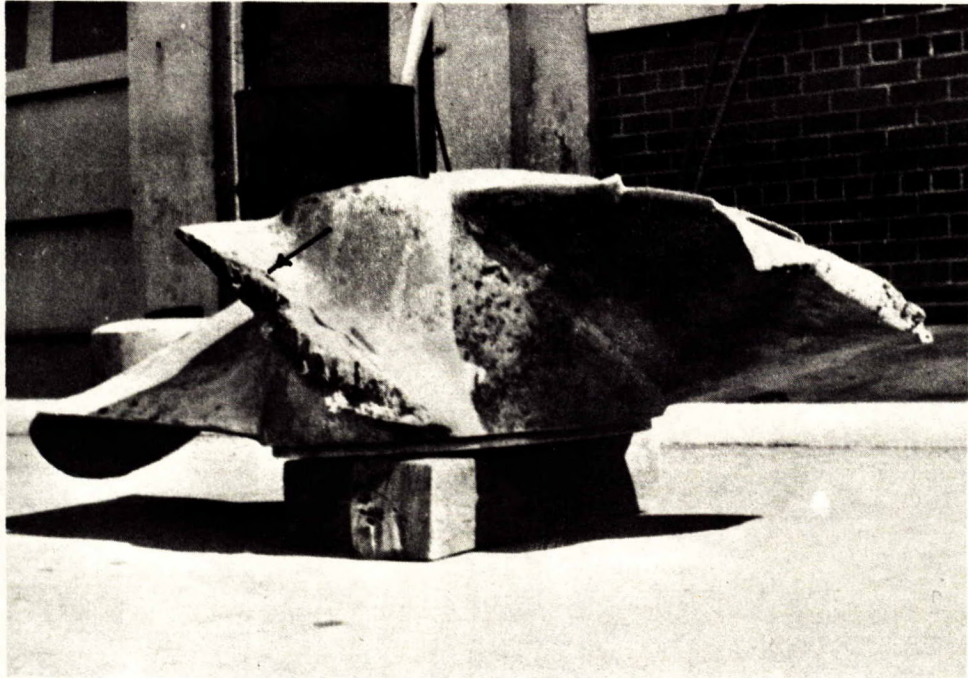
The appearance of the broken propeller blade is shown in Figures 1, 2, 3 and 4. Figure 2 illustrates the columnar fracture visible at the stub of the missing blade. The tips of the other blades were severely deformed, one blade tip, having bent through more than 45 degrees. Severe deformation of the blades caused the formation of numerous secondary cracks, where the metal was stressed to rupture.

Figure 1. Stainless Steel Propeller C.C.G.S. Narwhal Showing Fracture and Stub of Missing Blade. Foreign pieces of steel were found wedged in a crack in the position marked by the arrow-adjacent to the main fracture.

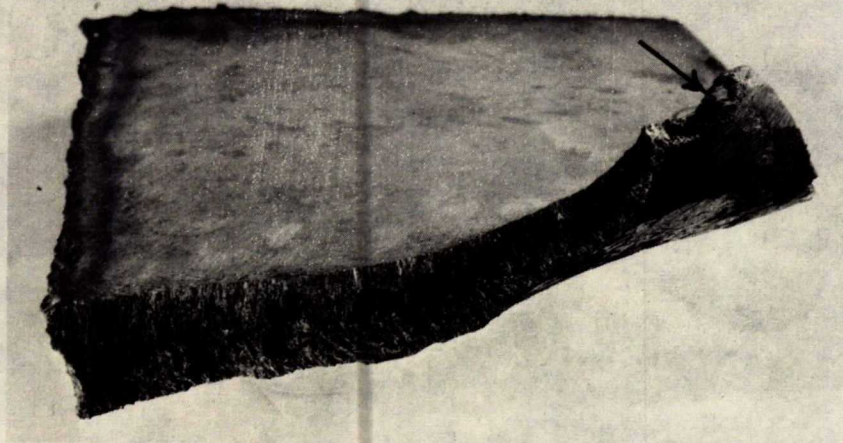
Figure 2. Typical Columnar Fracture Surface (Chill-cast)
and Embedded wood (arrow) is illustrated wedged
in a crack near the blade-tip.

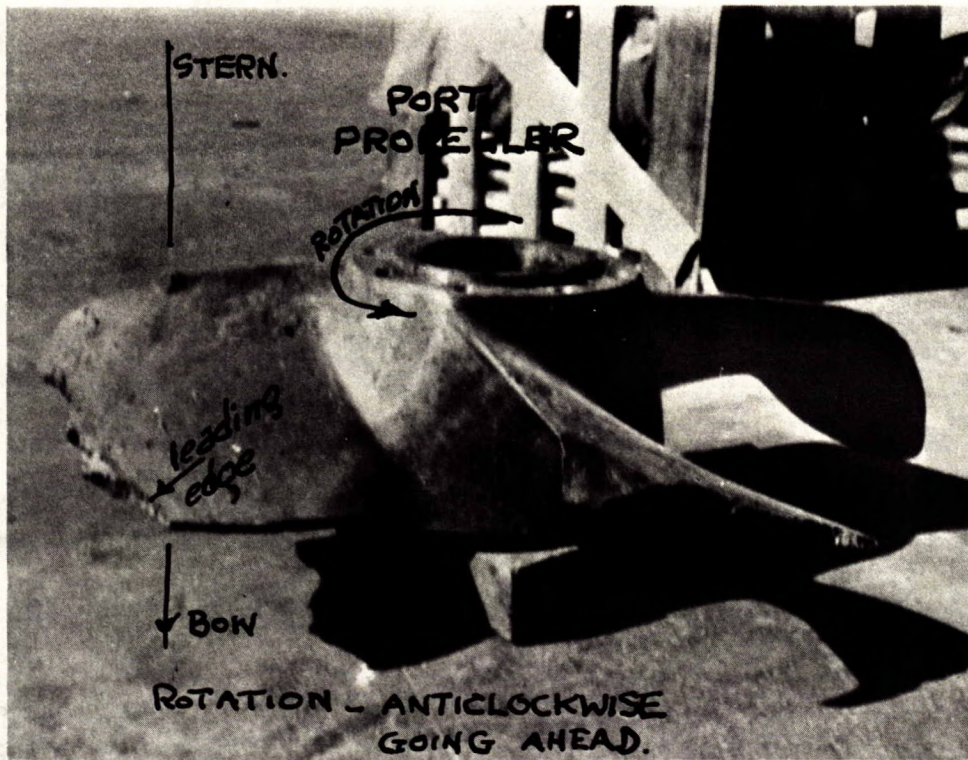
Figure 3. Illustrates Severe Deformation of Blade Tips. This view rotated 180° from that shown in Figure 1. The missing blade and stub are not visible in this photograph.

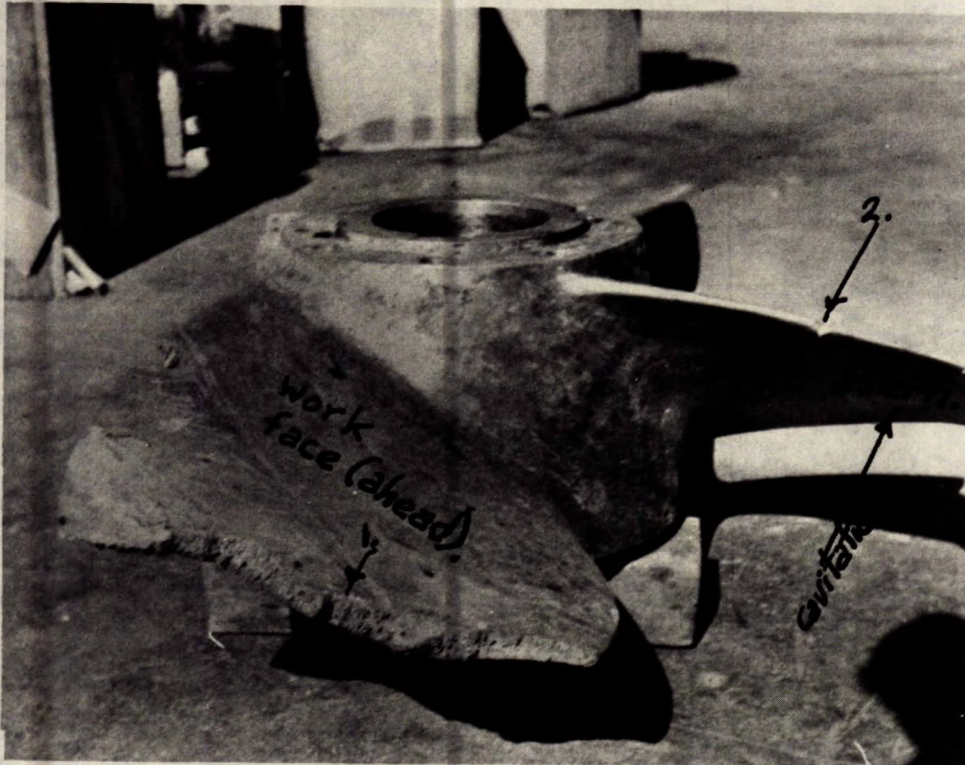
Figure 4. Broken Blade Tip Showing Columnar Fracture (arrow 1) and Nick (arrow 2). Same as figure 3 but rotated 90°. Some cavitation corrosion was observed near the blade-tip on the astern surface.

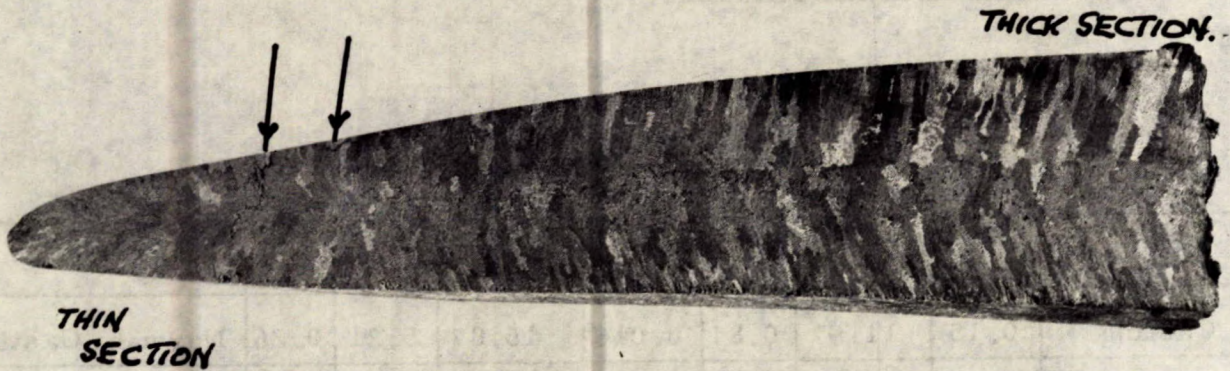
Figure 5. The Columnar (chill-cast) Macrostructure present in the casting is illustrated. The intergranular cracks (fracture) illustrated (arrows) are secondary and occurred at the same time as the main fracture.

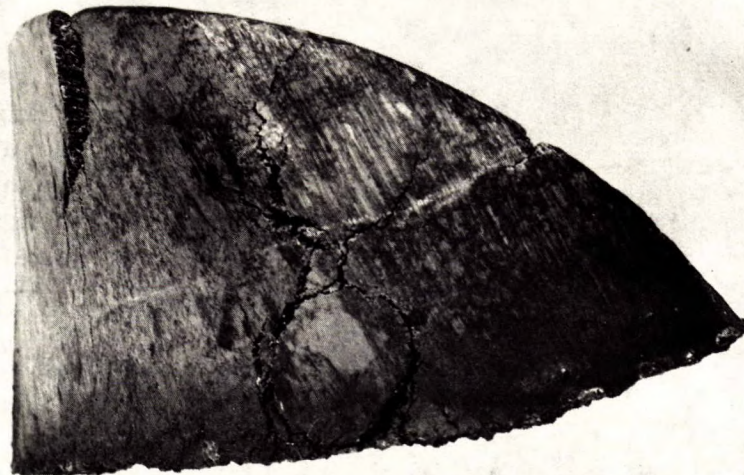
Figure 6. Tip of Bent Blade (Flame cut) Showing Secondary Cracks and Rupture Caused by Impact of Blade. This blade had bent about 45° without separation. When fracture did occur it followed an interdendritic path.

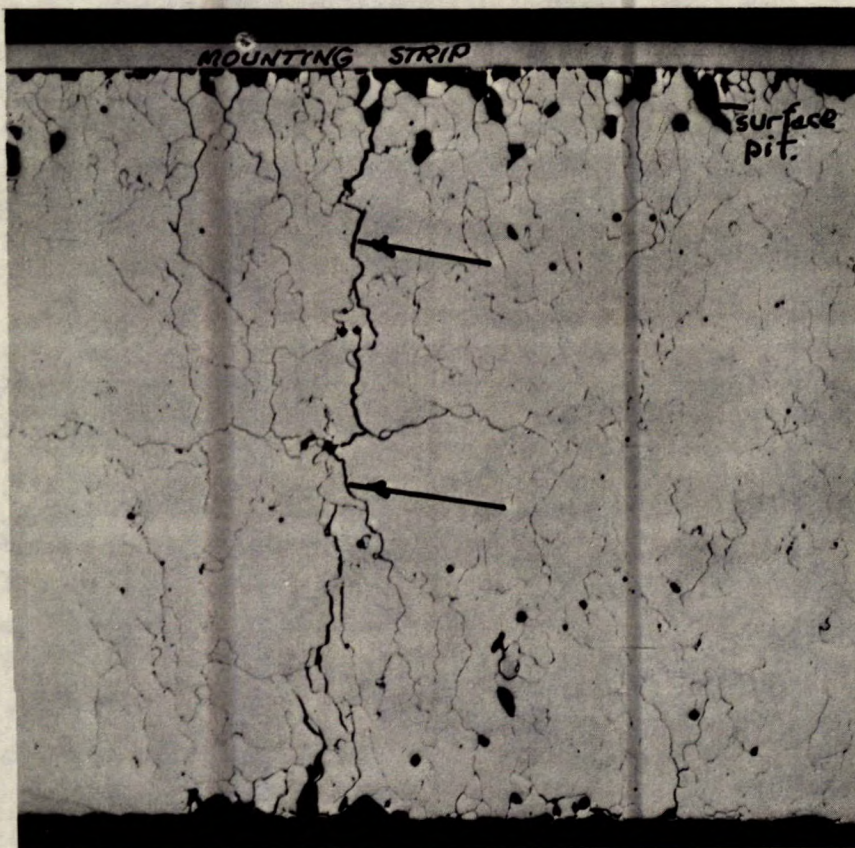
↓ "cavitation"
pitting and
intergranular oxidation
↑ (0.03 in.)

Figure 7. Section in Region Marked, "Thin Section", Figure 5. The path of a crack formed by impact is illustrated (arrows). The extent of corrosion pitting and intergranular oxidation (cavitation + corrosion) in this area after 4 years' service is illustrated.

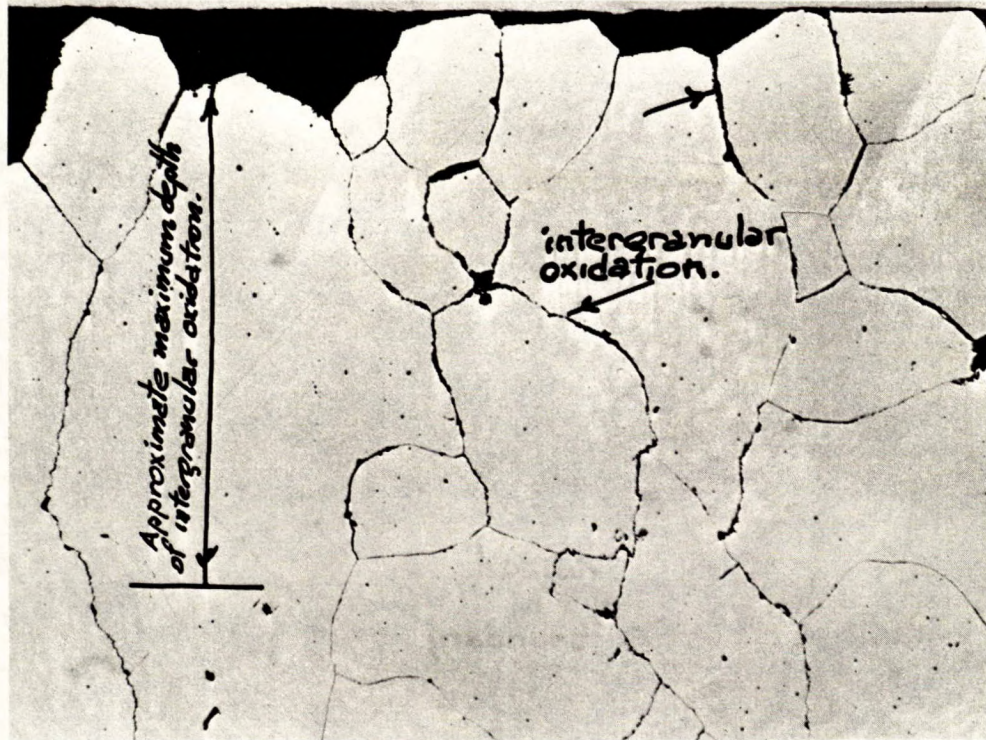
Figure 8. Surface Adjacent to Mounting Strip as in Figure 7, but at Higher Magnification - "Thin Section" (Figure 5). The depth of intergranular oxidation (grain boundary corrosion attack) is approximately 0.03 in. This area illustrated contains the most severe corrosion observed i. e., corrosion has possibly been accelerated on this surface by cavitation close to the tip of the blade.

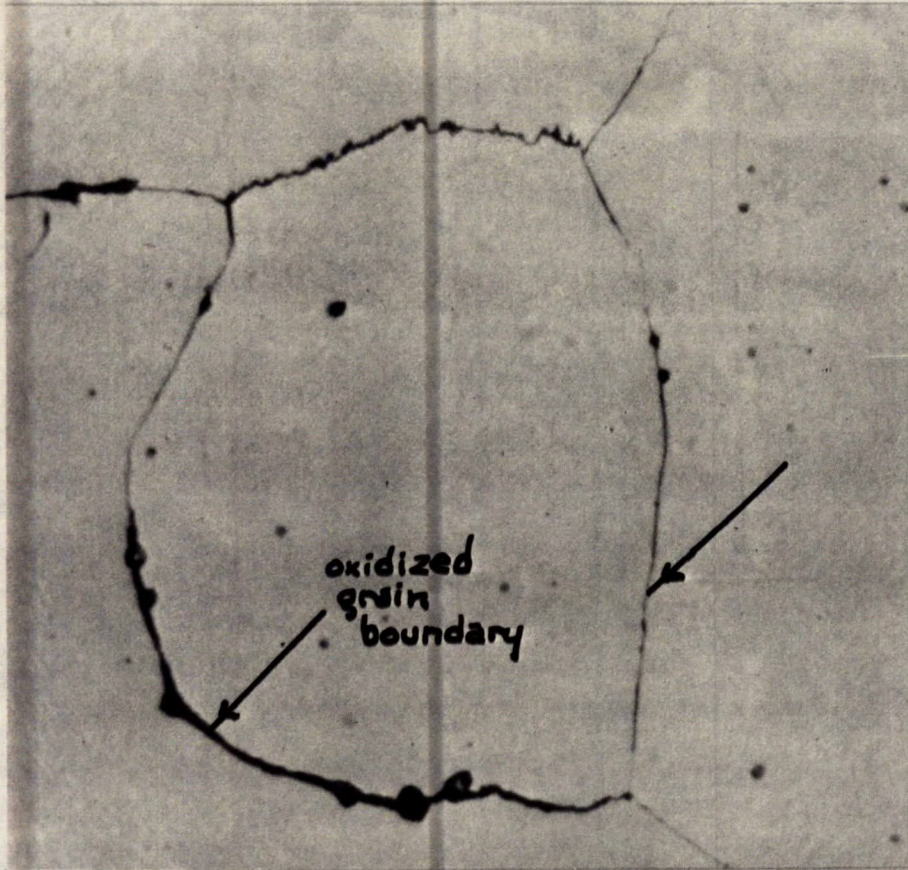
Figure 9. "Thin Section" Area Intergranular Oxidation Observed in Area of Cavitation and Corrosion for a depth of 0.03 in.

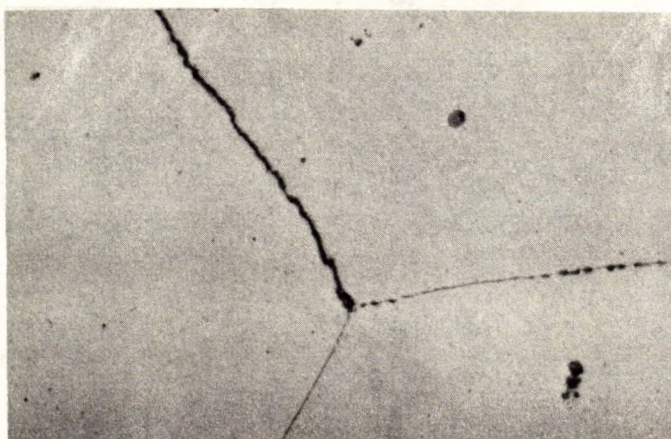
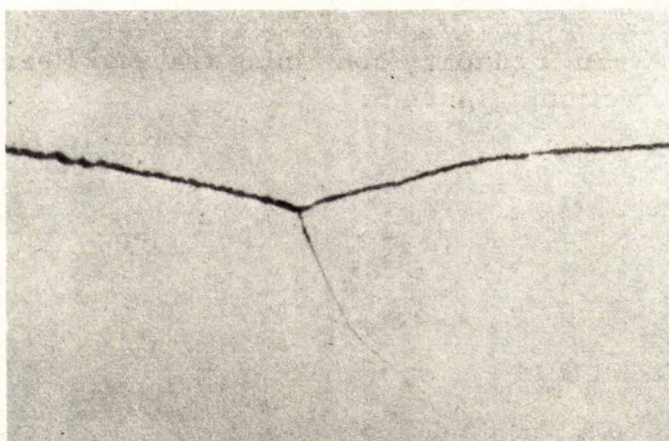
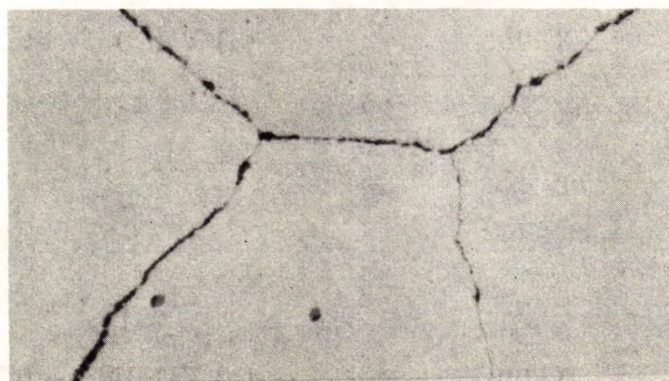
Figure 10 (a, b and c). Intergranular Oxidation, Thin Section, 0.02 in. from Surface. Photomicrographs illustrate the limit of penetration of intergranular oxidation - (cavitation-corrosion).

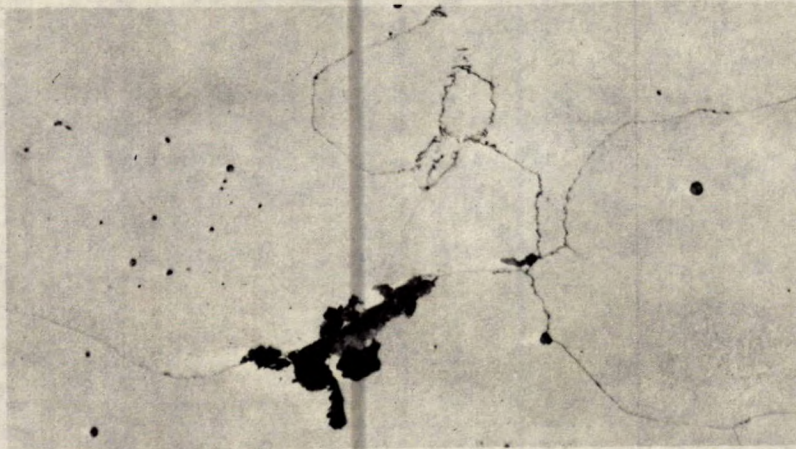
Figure 11. Grain Boundary containing trace of Pearlite Thick Section, Figure 5.

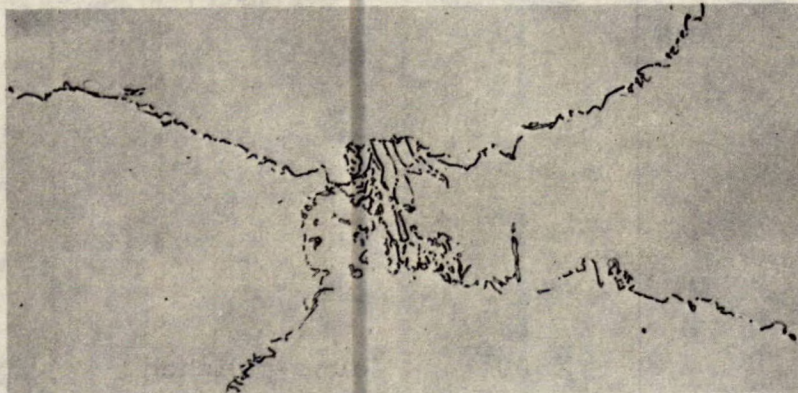
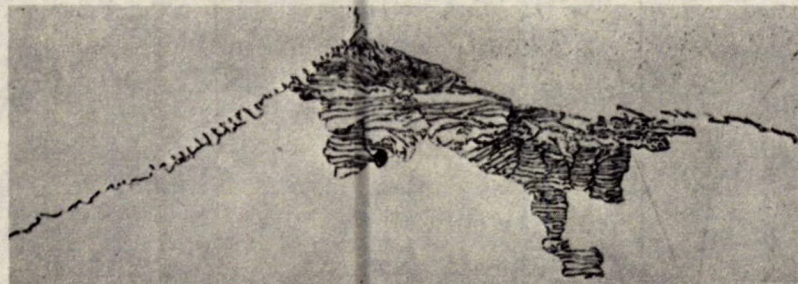
Figure 12 (a and b). Grain Boundary Thick Section. Traces of pearlite were observed in the thick section region but were not seen in the "thin section" and hub samples.

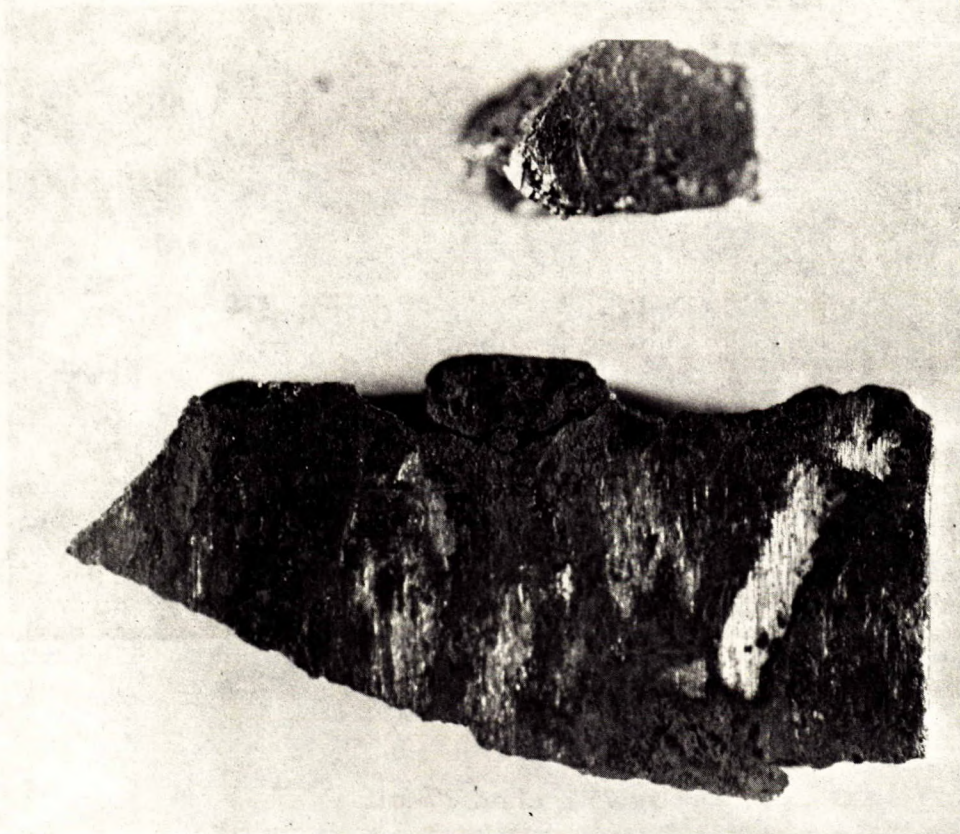
Two pieces of foreign (ferritic) steel were observed to be wedged in a crack adjacent to the main fracture (arrow figure 1). The appearance of the two ferritic steel fragments are shown in Figure 13.

Figure 13. Fragments of Foreign Ferritic Steel which were Wedged in a Crack Adjacent to the Broken Stub. (see Figure 1). This metal was foreign to the propeller casting showing that the object struck by the propeller contained both wood and ferritic steel.

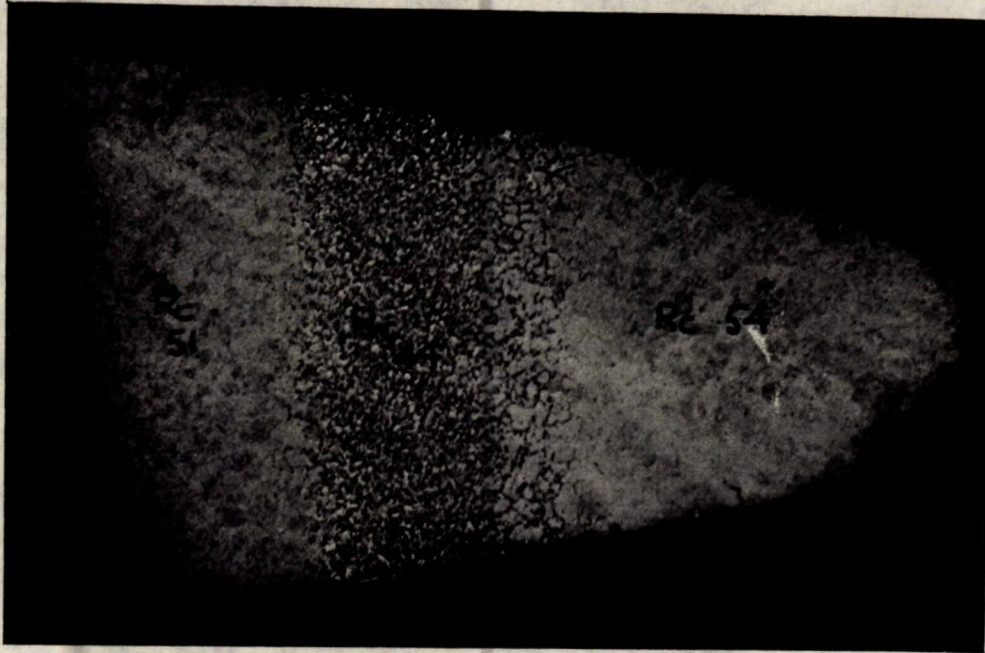
Figure 14. Foreign Steel Fragment Removed From Crack (Rockwell C as shown). The metal is ferritic and magnetic whereas the casting is austenitic and non magnetic. This fragment of steel has been hardened and has a carbon content and microstructure resembling that present in a hardened steel wedge or axe-head.

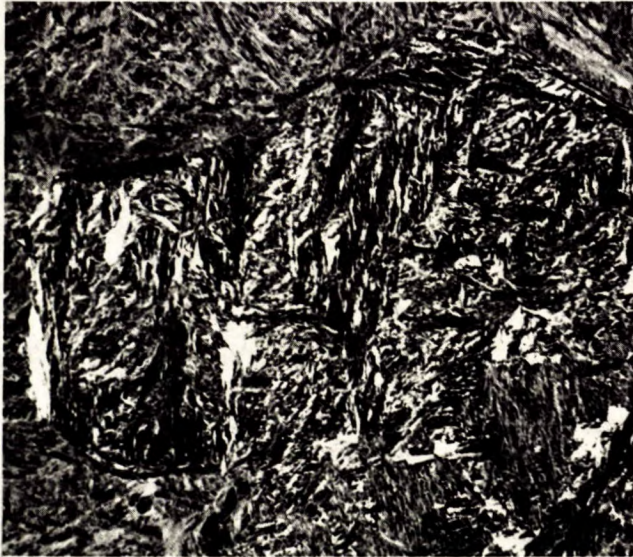
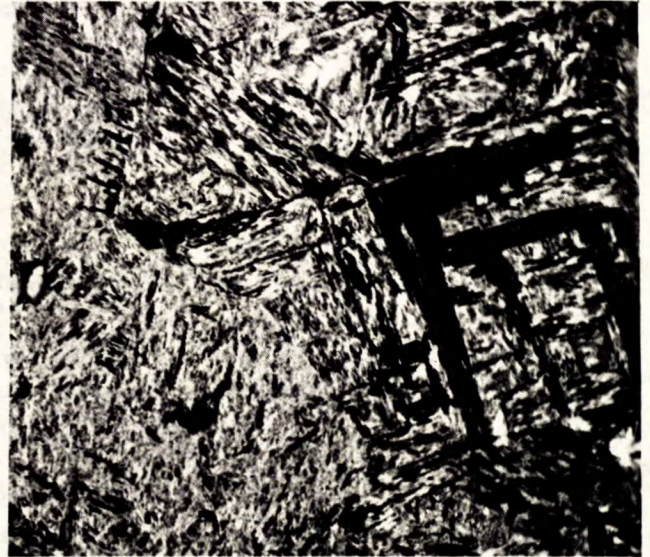
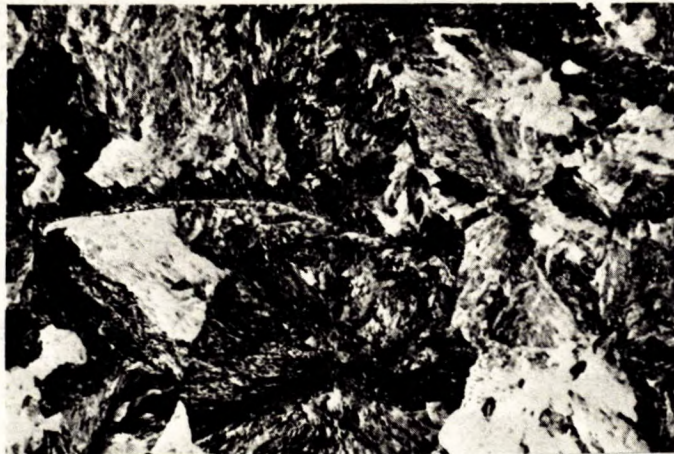
Figure 15 (a, b and c). Hardened Steel Fragment (Figure 14).
The hardened areas are illustrated (a)
and (b). An area of fine pearlite (R_c 44)
is illustrated (c).
