MINES BRANCH INVESTIGATION REPORT IR 66-57

FAILURE OF FLAT STEEL SPRINGS USED IN VIBRATING TABLES

Mines Branch Investigation Report IR 66-57

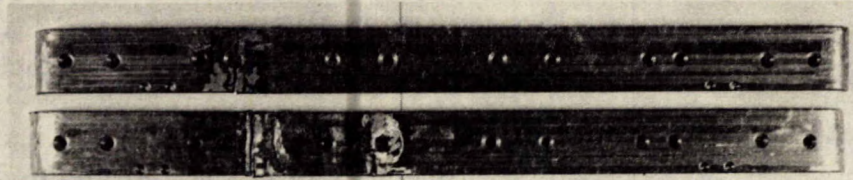
The first two springs (Nos. 1 and 2), which had been welded after initial failure and had subsequently failed, are shown in Figure 1. Their general appearance is that of plate 4 in. wide x 3/8 in. thick x 51 in. long with the ends bent under and a series of holes drilled for attachment. Failure in each case had initially occurred through a hole, although in the case of No. 1 plate, the first fracture had stood up after welding and the second fracture occurred through the whole section. Note that both fractures in each plate occurred in the same region, i. e., where cross-member was attached. The surface finish of the drill holes was poor and in some cases the holes had been counter-sunk right through the thickness of the plate resulting in a sharp edge at the bottom. Holes in such condition should be avoided for service in a fatigue environment.

Figure 1. Photograph showing two flat steel springs (Nos. 1 and 2) received after failure subsequent to welding.

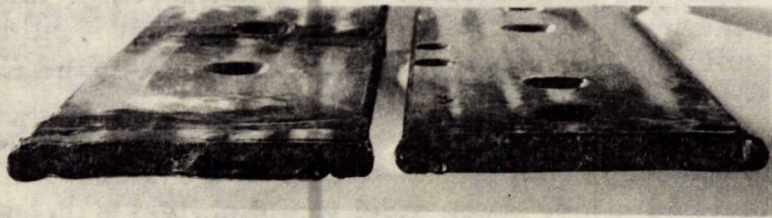
The fractures of these welded joints are shown in Figure 2. The appearance indicated that incomplete welding had occurred and the smooth-surfaced areas suggested that the two fracture faces had been rubbing together. As stated earlier, a true assessment of the nature of original failure could not be obtained from these samples because of the welding. The third sample, however, was untouched after failure and the fracture surface, shown in Figure 3, clearly indicated a fatigue failure which had started at the bottom of the bolt hole. At this point, where the bolt would bear against the plate spring, the surface was deformed and highly polished on the side near the centre of the plate, i. e., where the eccentric shaft acted. This showed that the pieces had been rubbing together for some time after fatigue failure and also indicated that considerable movement by the flexing of the spring occurred at that side of the bolt.

Figure 2. Photographs of fracture surfaces of the above flat steel springs.

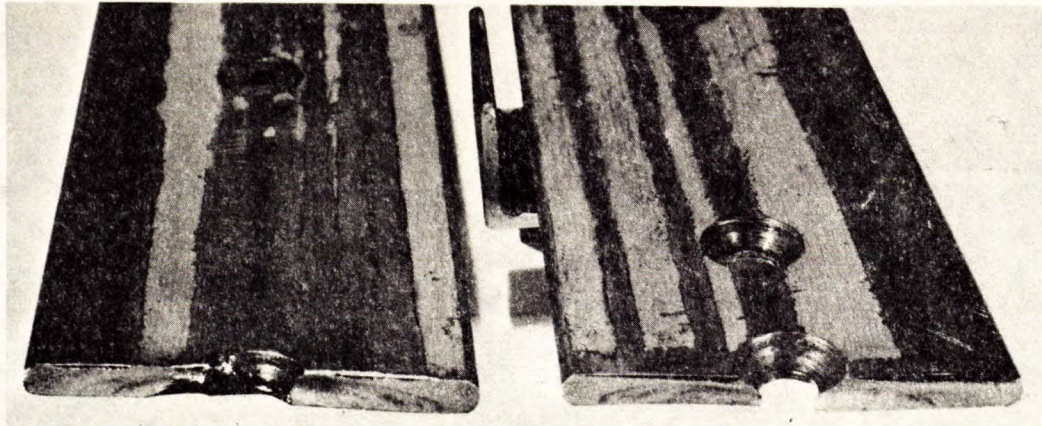
Failure occurred by fatigue and was probably aided by a stress-concentration at the cross-member bolt hole.

Figure 3. Photograph of fracture surfaces of an original failure (No. 3). Note typical fatigue markings and areas which have been polished as a result of surfaces rubbing together.

- (1) Efforts should be made to ensure that no sharp edges exist at the drilled holes and the final surface finish of the holes is ground smooth.
- (2) The strength of the present material may be increased by reheat-treatment i. e., water quench from 1500°F and temper to the desired strength. This steel, however, is susceptible to cracking on severe quenching and the presence of the holes in the plate makes matters worse; therefore, care would have to be taken to prevent this. An oil quench would probably be safer although it may not allow complete hardening through the section. Because of the length of the plates, heat treatment should be done vertically to avoid distortion. A suitable hardness would be in the range 390/450 Brinell.

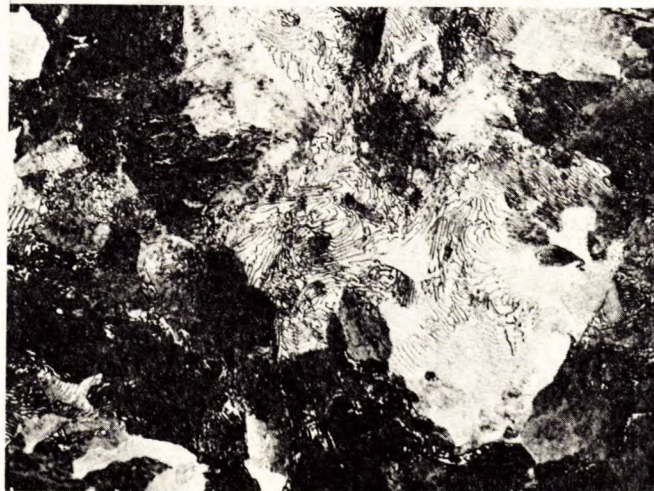
A sample, cut from the No. 2 plate, was polished and etched and examined under the microscope. The microstructure (Figure 4), consisted of lamellar pearlite, thus indicating that the steel had not been hardened. Some surface decarburization of about 0.003/0.007 in. was present. In accordance with the sulphur content of 0.036%, many long, elongated, sulphide inclusions were observed.

Figure 4. Photomicrograph of microstructure in No. 2 spring showing lamellar pearlite.
