MINES BRANCH INVESTIGATION REPORT IR 66-65

**FAILURE OF FUEL TANK, M113A1
ARMoured PERSONNEL CARRIER**

AUGUST 8, 1966

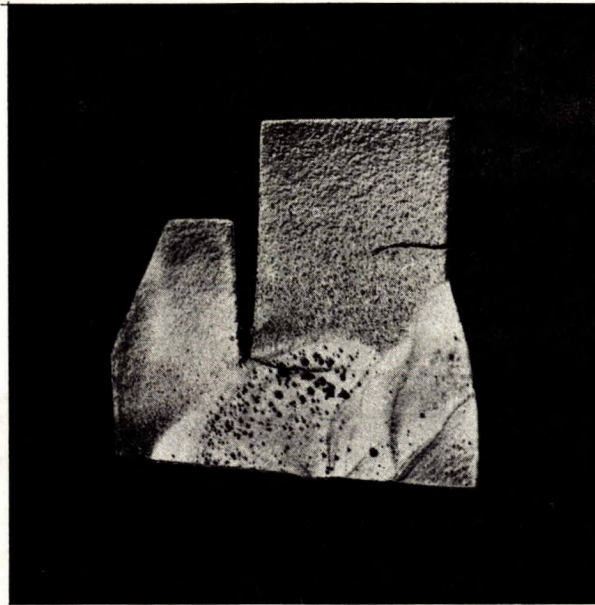
A section was taken from the end of the crack to confirm that cracking had progressed from the outer surface inward. This is shown in Figure 1. It will be noted that the crack has started on the outer surface and had not yet progressed through the plate thickness. The location of the crack in this figure is not characteristic of its normal location with relation to the weld. The crack had turned slightly away from the weld at this point and appears not to be related to the junction of the weld reinforcement with the plate.

Figure 1 - Crack progressing inward from outer surface. Note also root crack in weld.

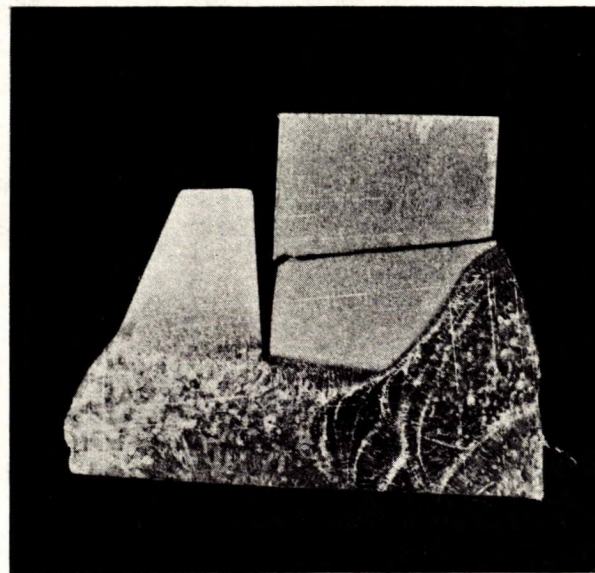
A more typical illustration of the crack is shown in Figure 2. The origin of the crack is shown at the sharp increase in section caused by the weld reinforcement. It proceeds inward through the parent metal to final failure. A sudden increase in section such as this acts to concentrate stress rather than to distribute the loading equally through the unit. This is a cause of fatigue failure.

Figure 2 - Typical cross-section of failure.

Better service life would be obtained from a separate, suitably baffled tank attached in a manner that will dampen hull vibrations, or from the use of a self-damping bladder-type container.

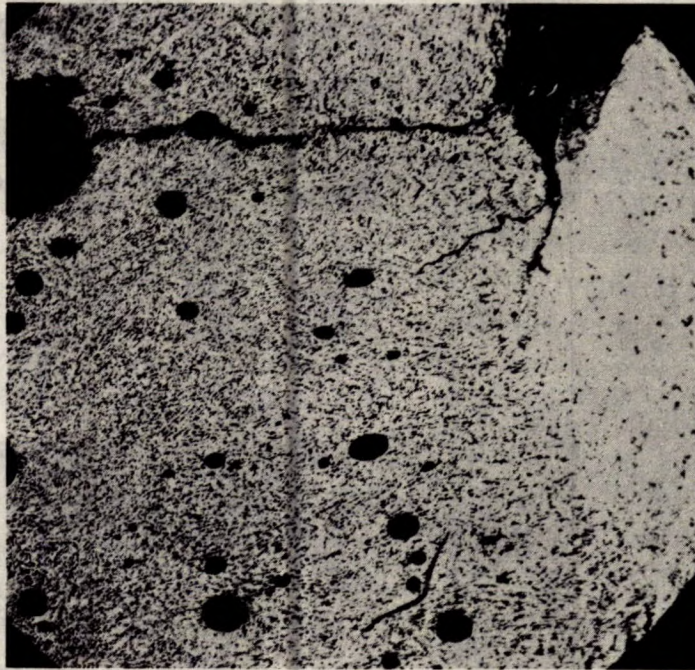
Microscopical examination revealed additional cracking in the root of the weld where the end plate and backing strip meet (Figure 3). These extended for varying distances into the weld and appeared to be caused by fatigue.

Figure 3 - Cracks starting in the root of the weld.
Note: Globular dark areas are porosity
in weld metal.
