MINES BRANCH INVESTIGATION REPORT IR 66-69

**EDGE CHIPPING OF ROTARY
SLICER STEEL KNIVES**

W. M. CRAWFORD AND D. A. MUNRO

AUGUST 17, 1966

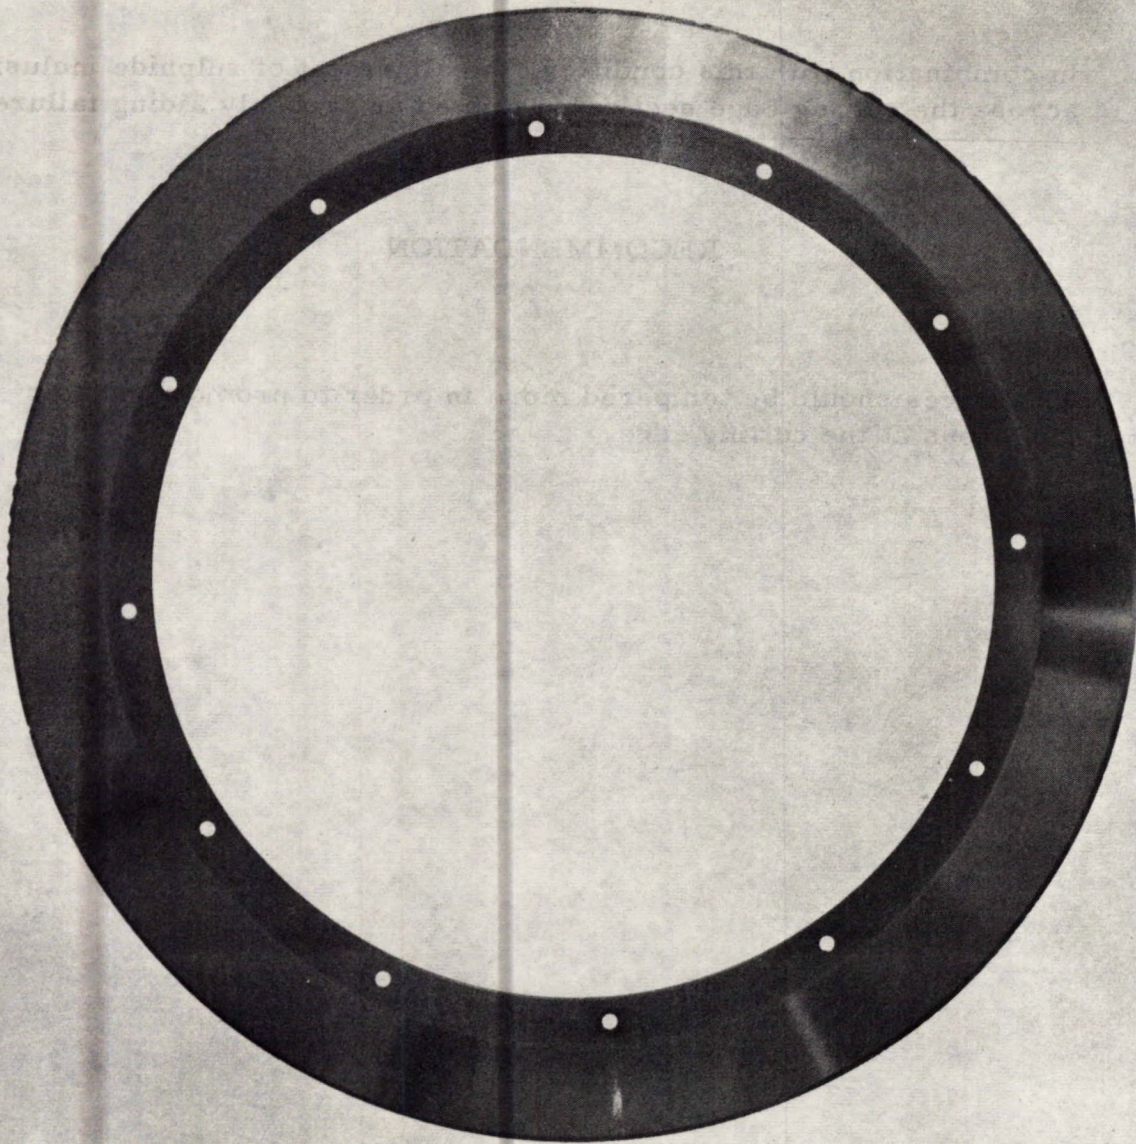
The blade, as shown in Figure 1, measured approximately 1-1/2 in. wide, x 11-1/2 in. diameter, with an angled ground edge of about 1/8 in. The bright surface appearance suggested that the steel had been plated. The cutting edge had been ground very sharp, and was clean enough such that it did not show any obvious signs of corrosive attack. Chipping of the edge had occurred randomly around the blade, and examination under the stereomicroscope revealed the fracture surfaces to be very brittle in appearance.

Figure 1. Photograph of rotary slicer knife showing chipping at the edge of the blade.

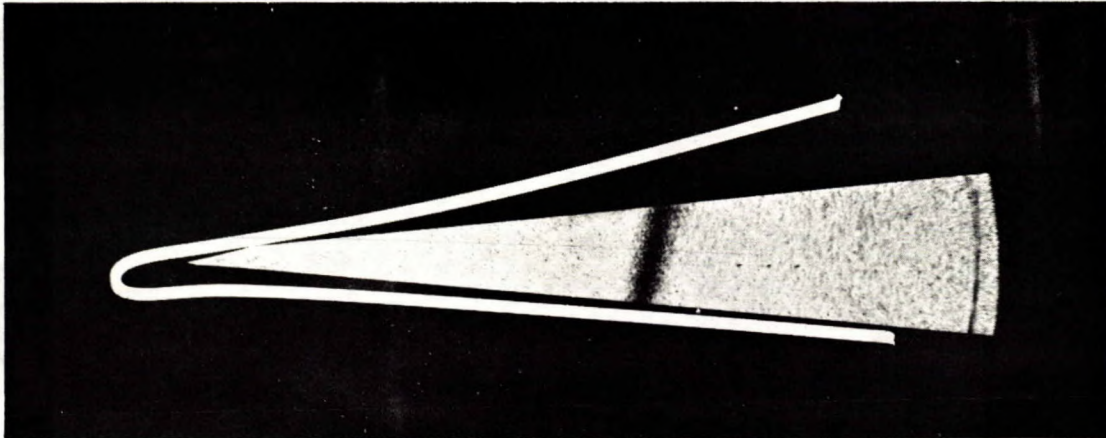
A section for micro-examination was cut through the blade at a point where the edge was still sound. After polishing and etching, examination under the microscope revealed three zones of different microstructure consistent with an edge-hardening heat treatment having been carried out on the knife after machining, i. e., the hardened zone at the cutting edge, the original soft-structured area of the body of the knife unaffected by the hardening treatment, and a zone of transitional microstructure separating the two. This is seen in the low magnification photomicrograph of Figure 2. The dark-etching band of transitional microstructure indicates the depth to which the blade was hardened; this depth was noted at approximately 1/2 in.

Figure 2. Photomacrograph of a cross-section of the blade, through the cutting edge, showing the depth of hardening as delineated by the dark-etching band of transitional microstructure. (The white band is a metal strip used to protect the edge of the specimen during polishing.)

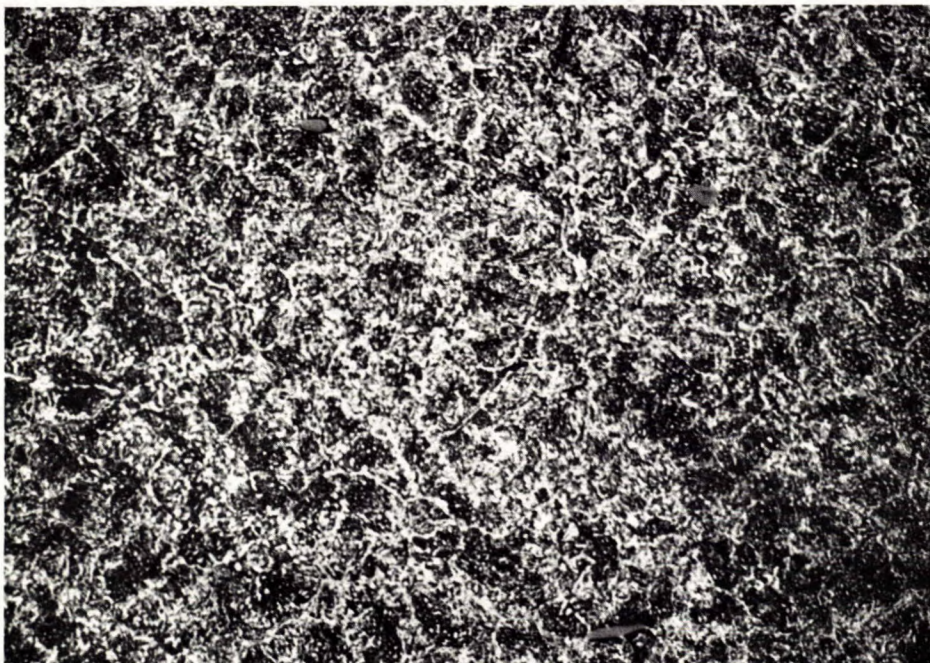
The microstructure of the hardened zone, shown in Figure 3, consisted of carbides set in a matrix of martensite, and a Tukon micro-hardness survey, carried out along the length of the zone, gave consistent readings of Rockwell 62C. This is very hard, and suggested that the martensite had been tempered only slightly. Concomitant with the sulphur content of 0.045%, many elongated sulphide inclusions were present, as shown in Figure 4. It was noted that these inclusions were aligned at right angles to the vertical axis of the knife, i. e., across the width of section, and, in the very thin sections of the extreme outer edge, a considerable proportion of the width would sometimes be made up of the length of an inclusion.

Metallographic examination of the cutting edge identified martensite in the microstructure, and the hardness value of Rockwell 62C suggested that only a light tempering treatment had been carried out on the knife or perhaps it had even been left in the as-quenched condition. Data available on this steel shows that the ideal as-quenched hardness is in the region of Rockwell 65/67 C, and a drop in hardness to 62C would be obtained with a tempering temperature around 350/400° F, which is rather low. Ideal as-quenched hardness, however, is not always achieved in production practice; it is possible that the blade could have been put into use in the completely untempered state, losing the few hardness points down to Rockwell 62C as a result of treatment received in service, and during processing of the metallographic sample, on which this hardness was registered. In any event, the hardness indicated that the martensite was in a relatively untempered condition and hence lacked toughness. The most obvious reason for the chipping, therefore, would appear to be that the cutting edge, being so thin in section, and composed of hard, brittle material, was unable to stand up to impact loading during service. The presence of the many sulphide inclusions, and the manner in which they were aligned across the thin cutting edge, probably aided failure. With the knife in a tougher condition, however, the detrimental effect of the inclusions would decrease and it is probable that, for the type of service involved, the present sulphur content would not cause trouble.

The most likely explanation for the chipping, however, as indicated by the results of the examination, appears to be the lack of toughness in the thin cutting edge section, due to insufficient tempering. The remedy lies in tempering at a temperature high enough to give the desired level of toughness. This would reduce the hardness of the cutting edge, and it probably would not retain its sharpness for as long, but this may be acceptable since each slicing machine has a device which allows the knife to be sharpened at any time. The appropriate tempering temperature then, depends on how much hardness can be sacrificed for a gain in toughness. In order to determine the relationship between hardness and tempering temperature, three specimens were cut from the knife and each was tempered for 1 hour at 500°F, 750°F, and 1000°F respectively. The resulting hardness of these specimens is given in Table 1.

Figure 3. Photomicrograph showing the microstructure of the hardened zone of the blade. This consisted of carbides in a matrix of martensite - Rockwell Hardness 62C. The white edge is the chromium plating.

1. The knives should be tempered more in order to promote greater toughness at the cutting edge.

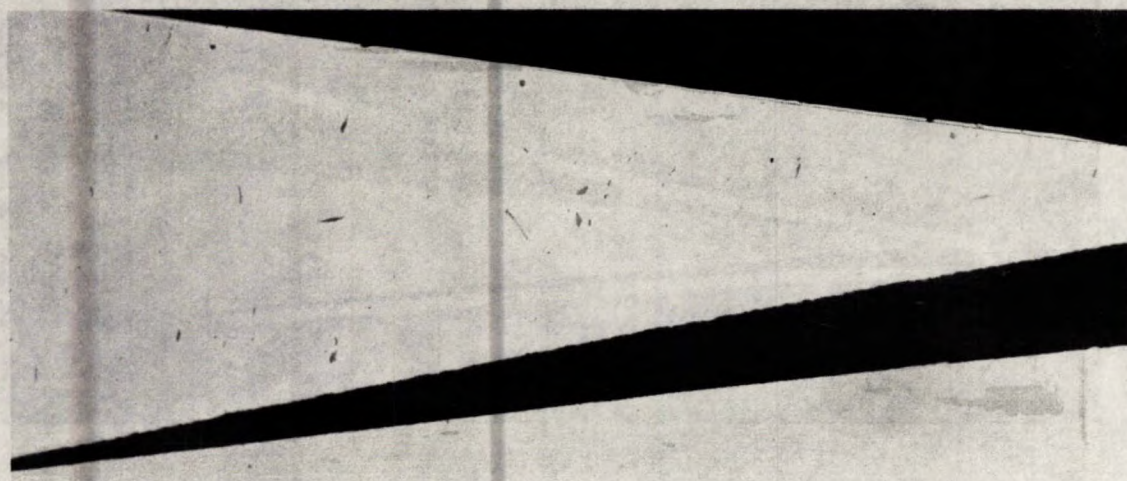
2. In combination with this condition, the alignment of sulphide inclusions across the cutting edge section was noted as probably aiding failure.

Figure 4. Photomicrograph of a section through the cutting edge of the blade, showing sulphide inclusions.

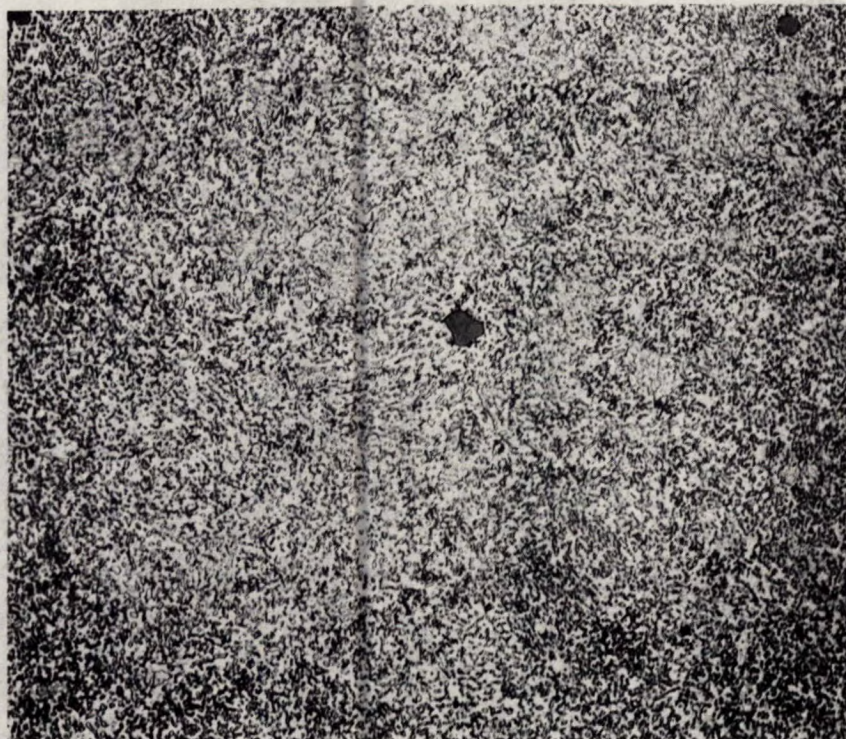
The microstructure of the body of the knife was typical of the spheroidized annealed condition that renders high-carbon steel soft enough for machining. This is also the best condition for a successful hardening treatment that will produce a long-lasting edge. As shown in Figure 5, this machinable structure consisted of spheroidized carbides set in a matrix of ferrite. A hardness of Rockwell 96B was obtained.

Figure 5. Photomicrograph showing the microstructure of spheroidized carbides and ferrite in the unhardened body of the blade - Rockwell Hardness 96B.
