DEPARTMENT OF MINES AND TECHNICAL SURVEYS

MINES BRANCH INVESTIGATION REPORT IR 66-21

EXAMINATION OF CRUST BREAKING TOOLS

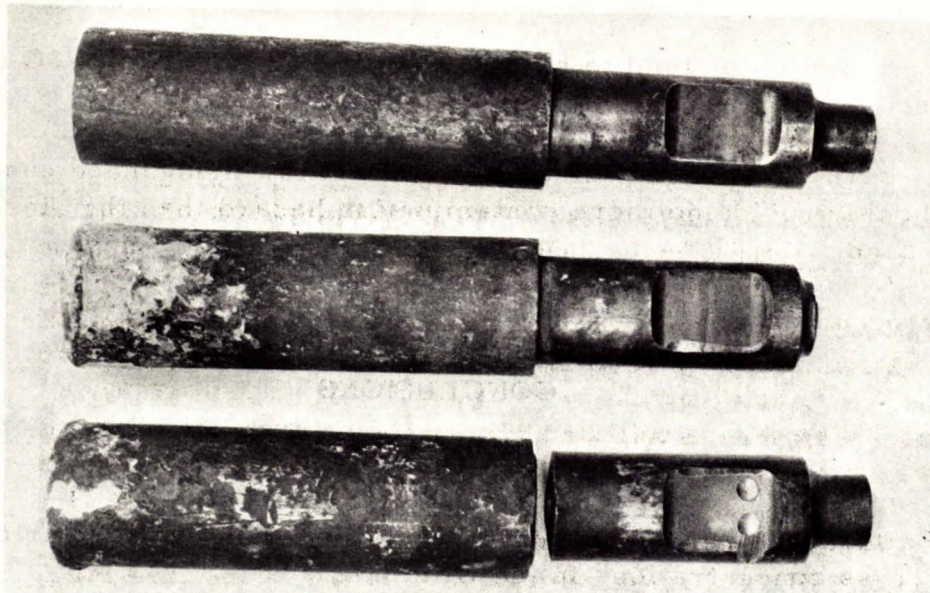
The three crust breaking tools are shown in Figure 1.

1. Failure was caused by fatigue resulting from cyclic overload due to stress concentrations in the fillets.
2. The tools had been made of a machinery steel of a grade of steel similar to AISI 5046 that had not been strengthened by a heat treatment.
3. Failures will almost certainly recur frequently unless the fillets can be removed or enlarged, and/or a strengthening heat treatment used.

Figure 1. Crust breaking tools showing two broken at fillets and one unused fillet. As Received, X1/4.

1. Improve the design by either enlarging or removing the fillets if possible.
2. Strengthen the tools by quenching and tempering, or by using material procured in the strengthened condition.
3. Combine recommendation (1) and (2).
4. Use an alternative material such as the air hardening, shock resisting or hot work steels suggested within the text of this report.

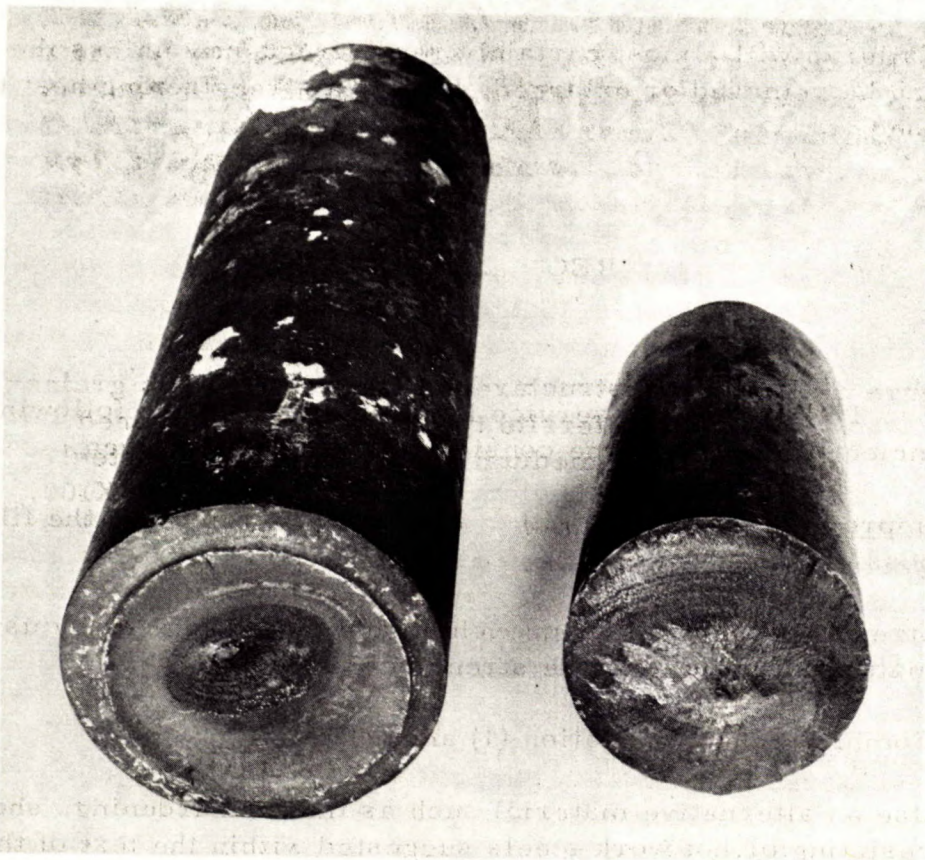
The fractured surfaces of the tools show the typical markings of fatigue failure due to cyclic bending stresses. This is shown in Figure 2. Considerable heating had occurred at the hammer end of the large section. Also, severe upsetting or deformation had occurred in service.

The failure was due to fatigue, which resulted from cyclic stressing in the fillet regions. Overstressing at localized points in fillets can occur due to abrupt cross-sectional changes in dimension. Any reduction in the abruptness of these changes by redesign would lessen the degree of overstressing in the fillet region and should give longer life for these tools. This could be accomplished by cutting larger fillet radii or, if possible, tapering the fillet out completely. However, it is doubtful if this type of failure can be completely eliminated when using this material with a fillet and without a strengthening heat treatment. Equivalent grades should be obtainable in the heat treated condition, at machinable hardness within the range 35 to 40 Rc, from commercial outlets.

Figure 2. Fractured surface of a broken crust breaking tool. As Received, X2/3.

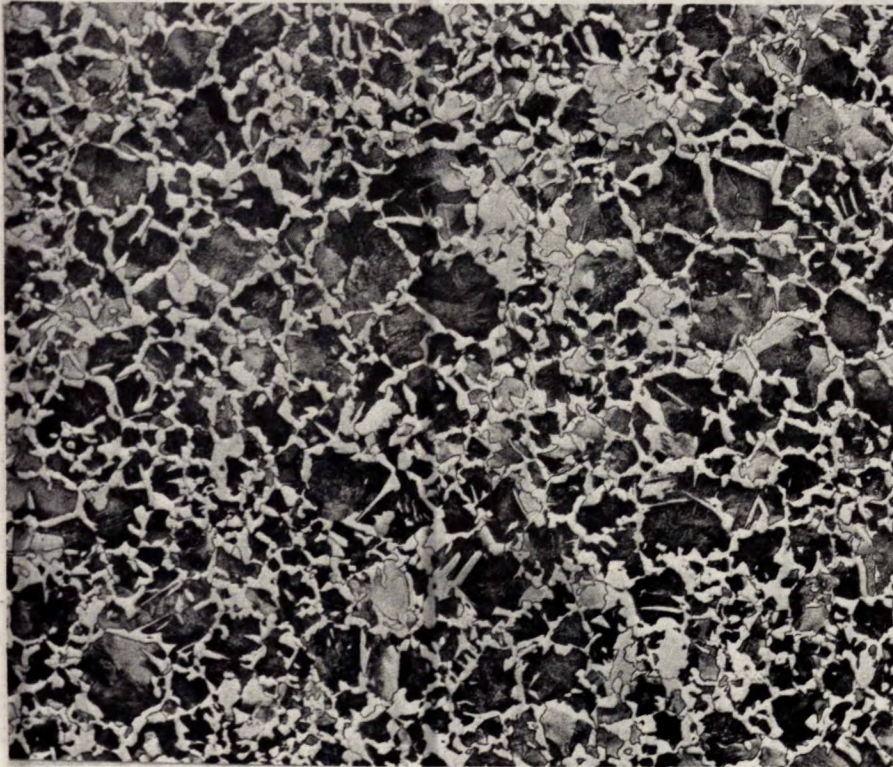
The microstructure of the crust breaking tool consisted of pearlitic grains outlined by ferrite similar to a coarse-grained normalized medium carbon steel. The microstructure is shown in Figure 3.

The microstructure indicated that the material had been normalized. This condition was consistent with its hardness.

Figure 3. The microstructure consists of pearlitic grains outlined by ferrite typical of coarse-grained normalized medium carbon or low alloy steel. Etched in 2% nital, X100.

To strengthen the regions where failure tends to occur, the tools could be quenched and tempered.
