REVIEW OF ROCKBURST INCIDENTS AT THE MACASSA MINE, KIRKLAND LAKE

B. ARJANG AND G. NEMCSOK

DECEMBER 1986

MINING RESEARCH LABORATORIES
DIVISION REPORT MRL 87-21 (TR)

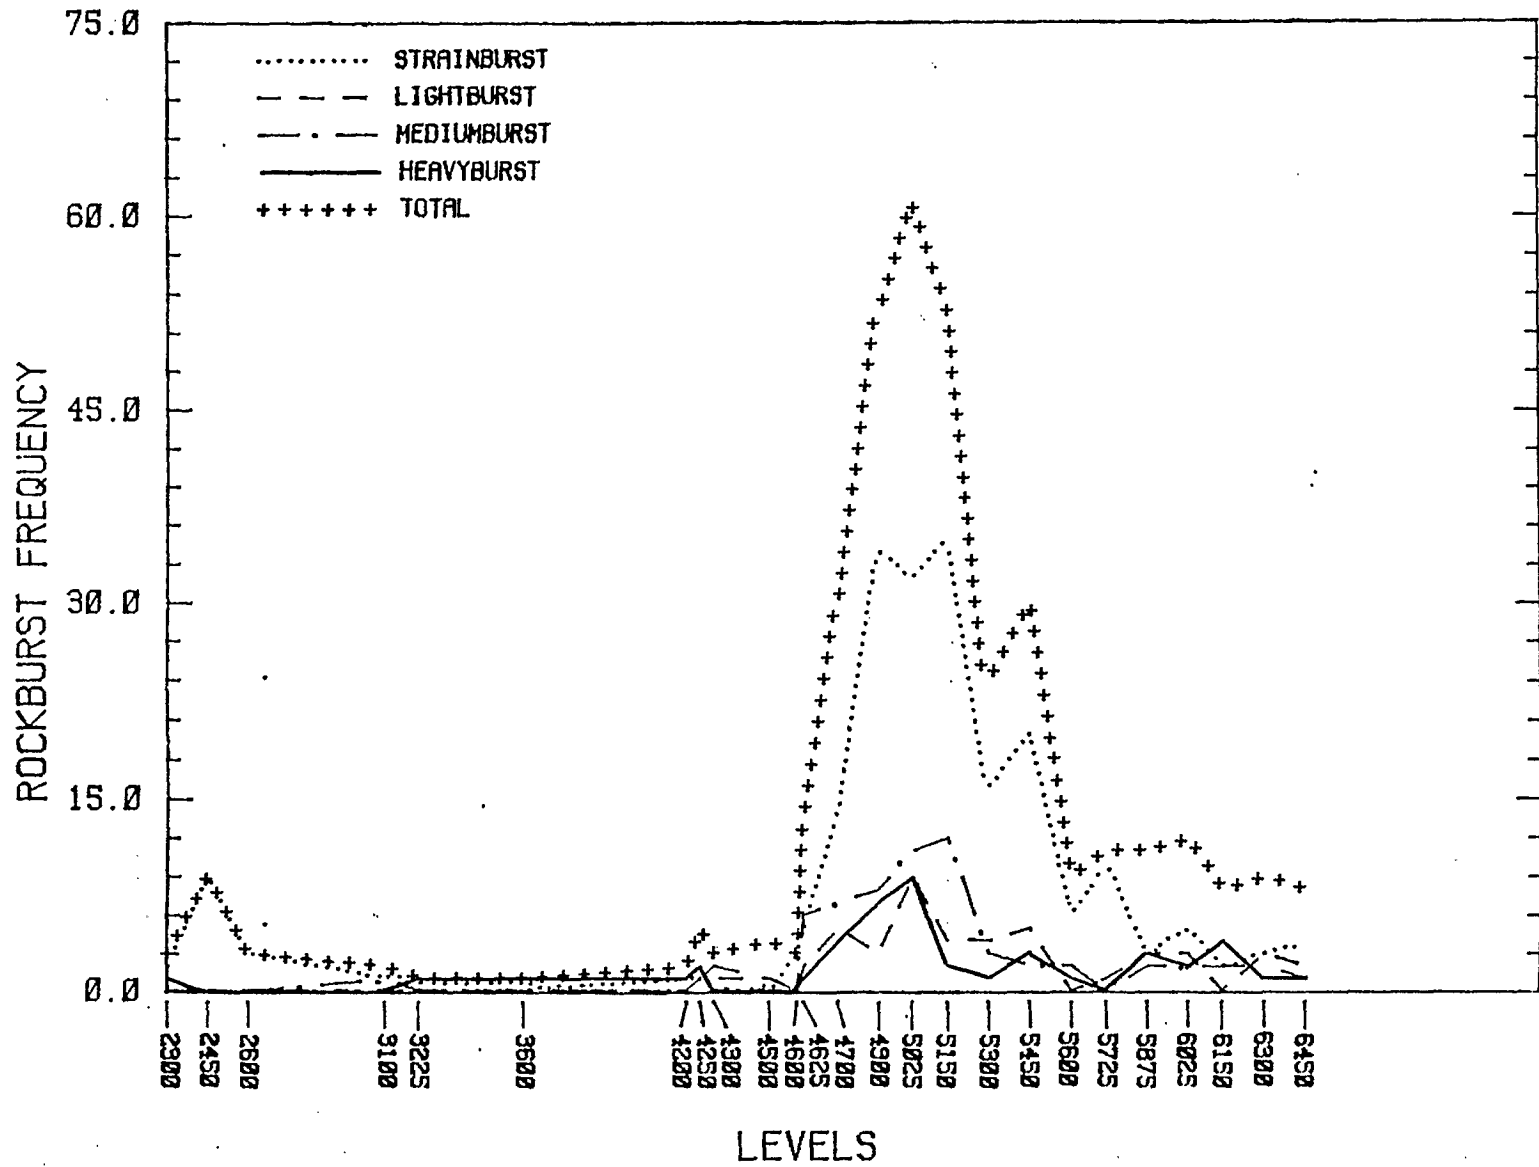
Rockburst events were reported from a depth of 670 to 1935 m below surface with a preponderance between 1400 to 1650 m reflecting where most mining was taking place. Figure 1 shows the rockburst frequency by working levels. The highest frequency was concentrated in the proximity of the 1500 m level.

Fig. 1 - Distribution of rockbursts by working levels, Macassa Mine.

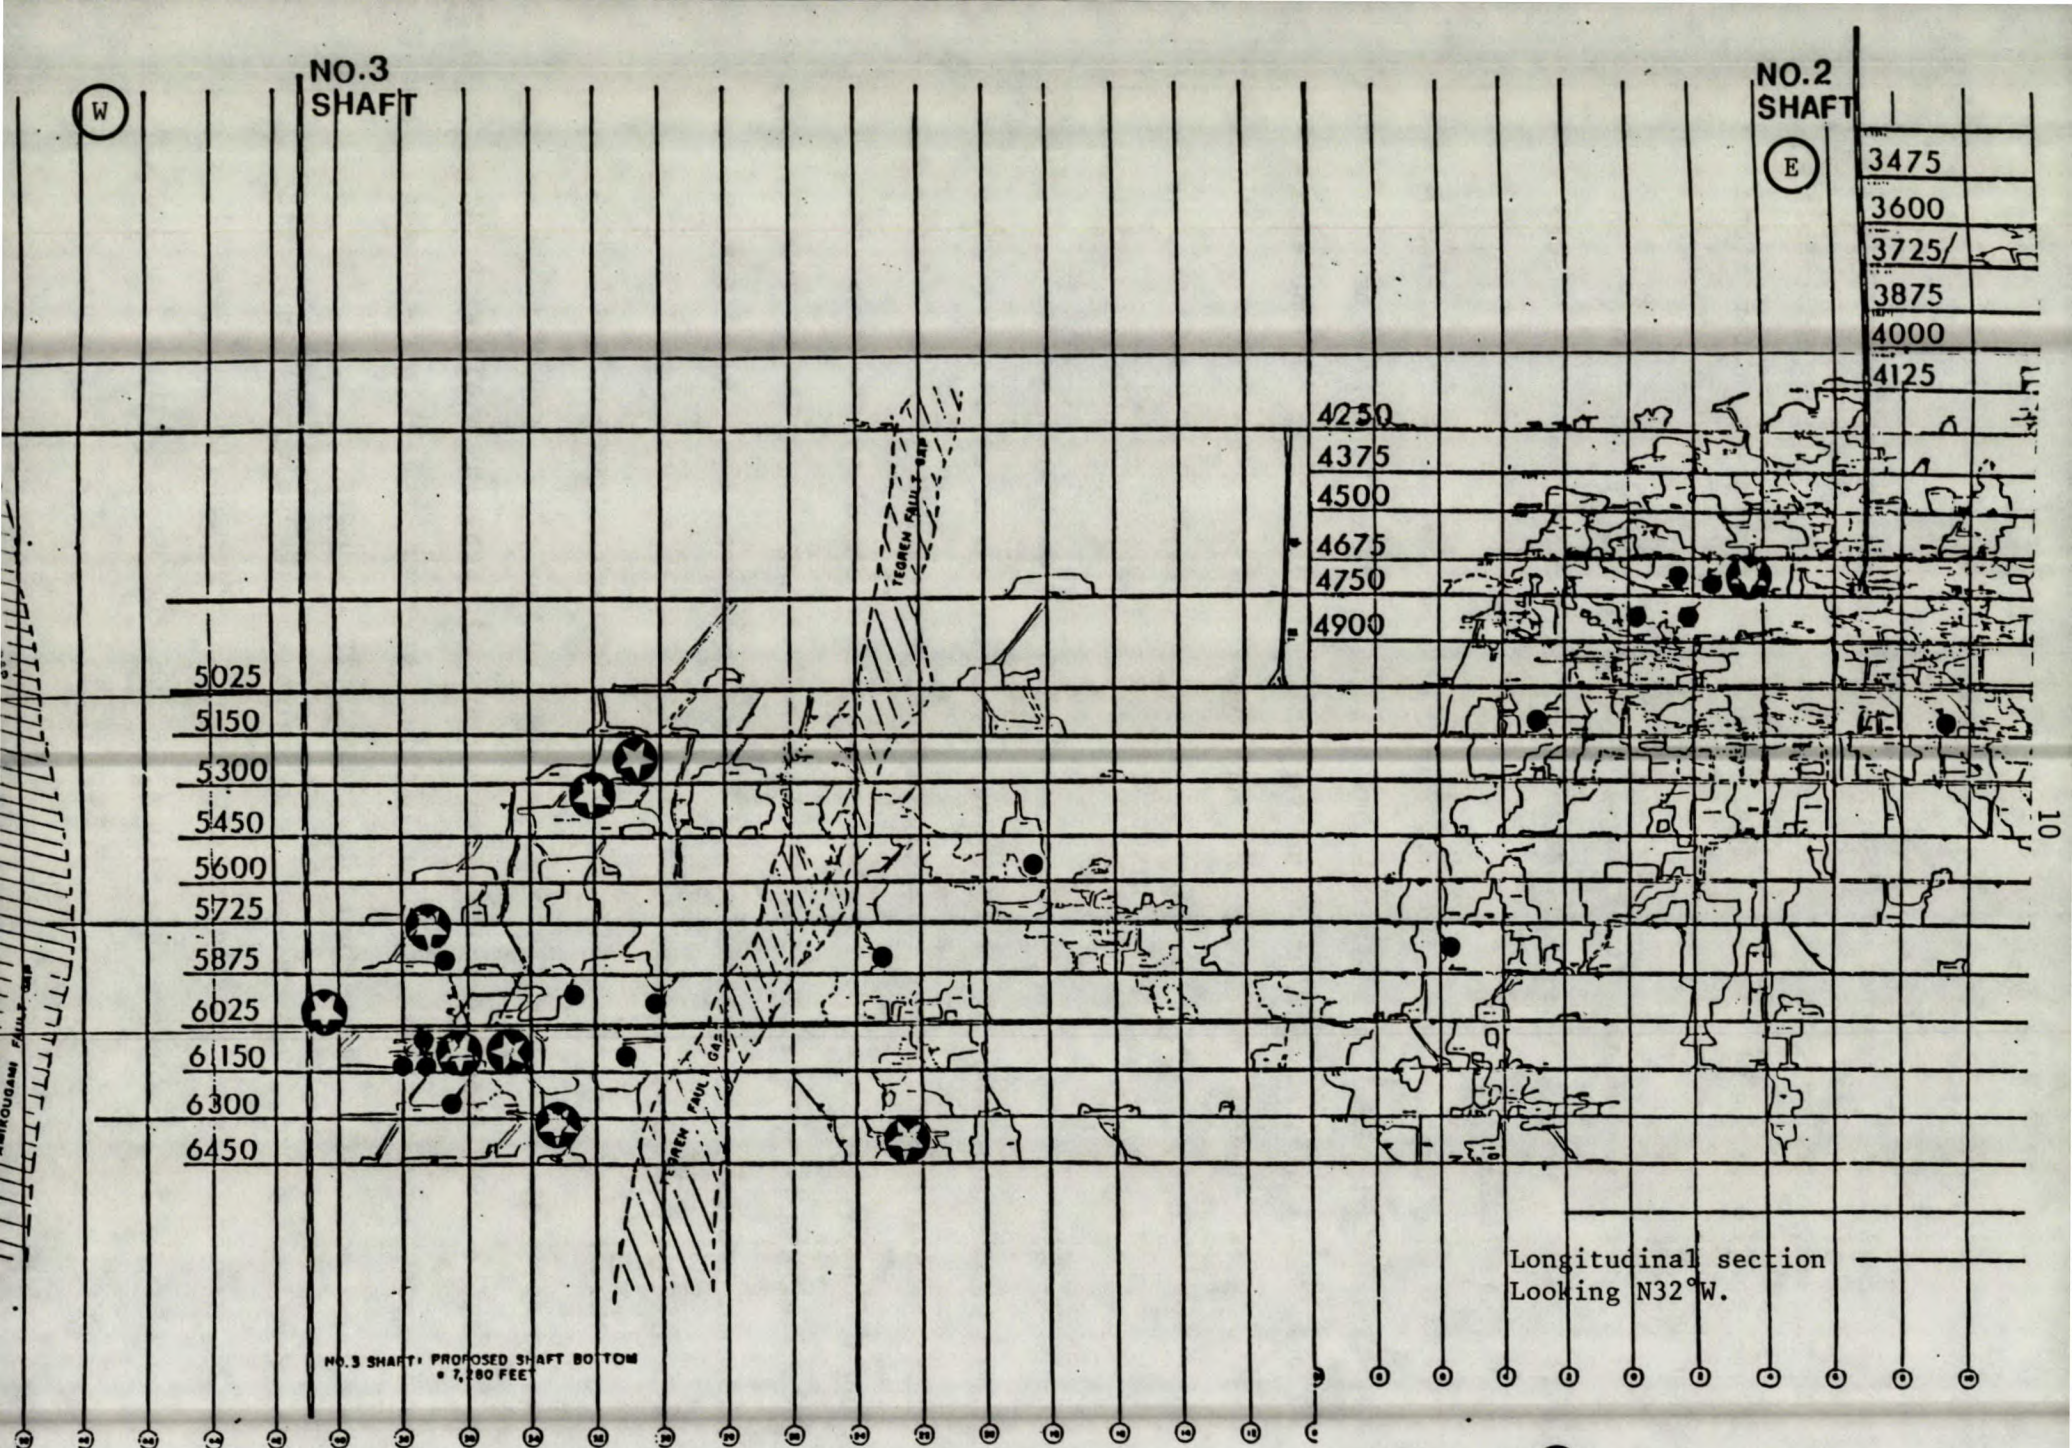
From 1984 to 1986, a number of significant rockbursts occurred at the Macassa Mine. These were recorded on the Eastern Canada seismic network. The events, which were concentrated mainly in the west end of mining developments, had magnitudes ranging from 2.2 to 3.1 M_N . Most of the damage was observed in the levels and sub-levels within the orebody. Generally, all events followed the previous rockburst activities observed in these areas. The most extensive rockburst, with a magnitude of 3.1 M_N , occurred in the pillars on the 6150 level, in the area between 61-38 and 63-38 stopes. After the event, about 130 m of the drift (61-04 Dr.) below the affected stoping area was closed. The estimated rock displacement was over 1000 tons. Some minor damage was observed in the cross-cuts and drifts around the rockburst area.

Figure 2 shows the location of rockburst events recorded on the Eastern Canada seismic network, and the distribution of "heavy rockbursts" from visual observations.

Fig. 2 - Location of rockbursts on the west and central area at the Macassa Mine. (★) Recorded rockbursts, magnitude 2.2 to 3.1 MN. (●) observed "heavy rockbursts", rock displacement >50 tons.
