BURNING TRIAL ON SCHEDULE IV CONTAINER

E. Contestabile, R. Vandebeek and R. Augsten

July 1987

MINING RESEARCH LABORATORIES  
DIVISIONAL REPORT MRL 87-72 (TR)

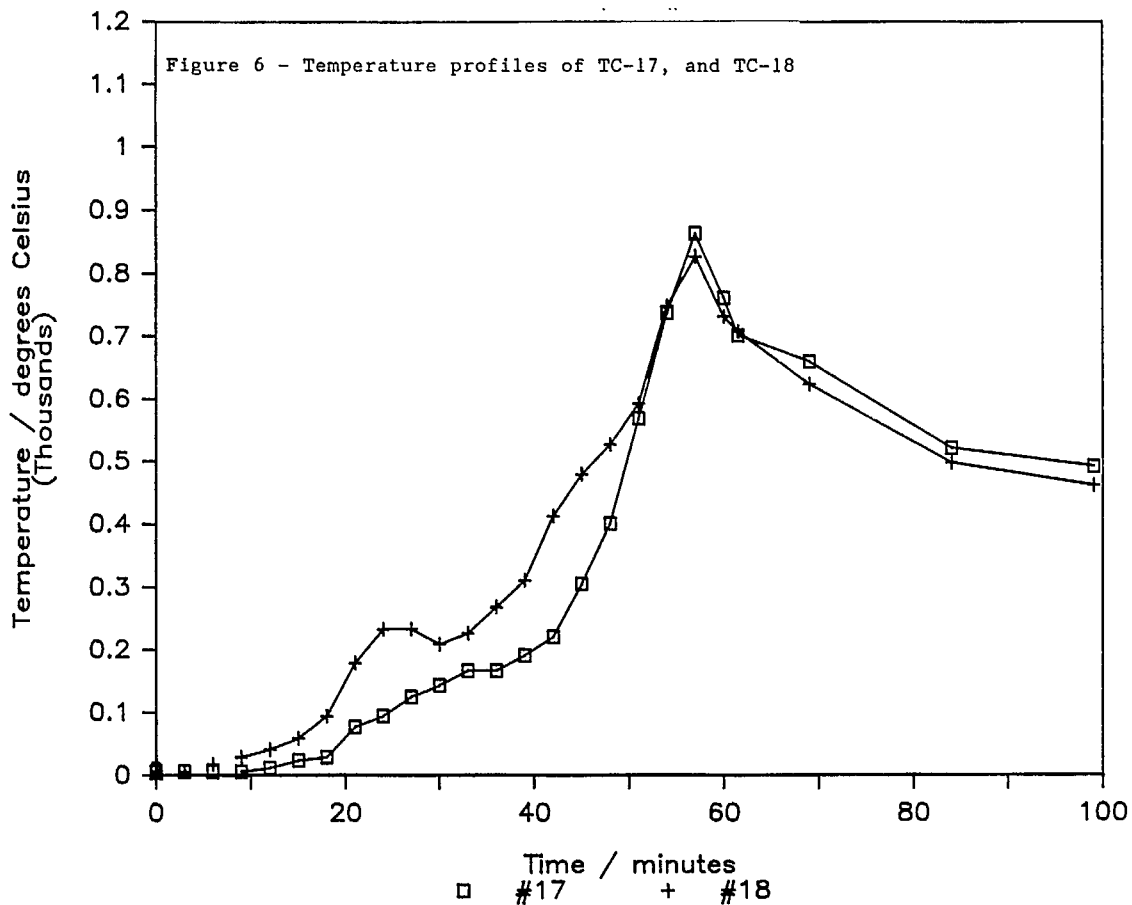
- (a) The burning of the fuel in the pails that caused the tall flames at the back side of the container, coupled with the high thermal conductivity of the metal screw, resulted in TC-18 to register a quick rise in temperature. As comparison, note the difference between the TC-17 and TC-18 traces shown in Fig. 6. TC-18 detected much higher temperatures than the other thermocouples until the detonators began to fire at  $t = 25.5$  minutes. The sensed temperature then dropped and followed the trend of most of the other thermocouples.
- (b) As seen from Fig. 7, most of the thermocouples, especially TC-3, TC-4, and TC-5, showed a fast rise and sudden fall or decrease in the rate of temperature rise at  $t = 20$  min. It is believed that the thermocouples were responding to a temperature rise due to water being evaporated. The steam was

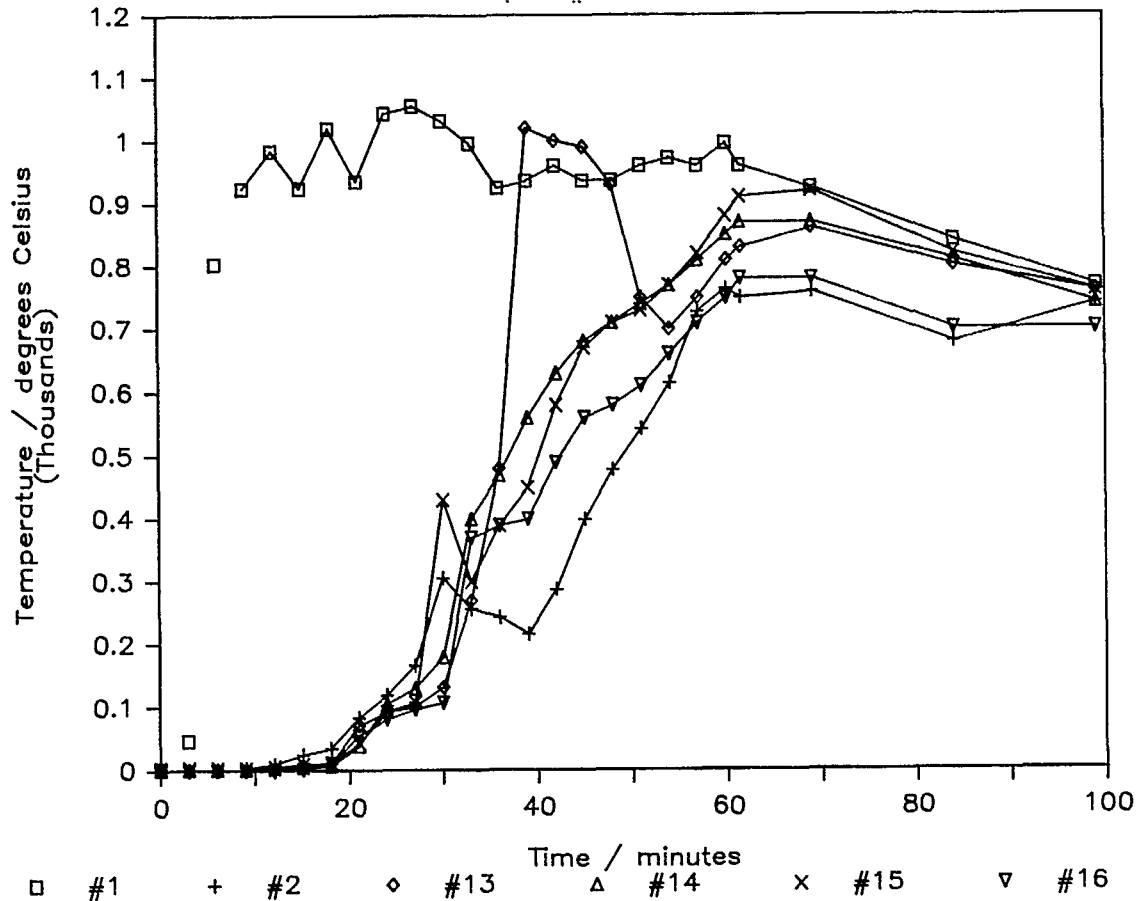
Figure 8 - Temperature profiles of TC-1, TC-2, TC-13, TC-14, TC-15, and TC-16

- (c) All the thermocouples on the bottom panel (TC-2, TC-13, TC-14, TC-15, and TC-16), began registering much higher temperatures than the rest when the detonators started firing ( $t = 25.5$  min). These results are shown in Fig. 8. As expected, the perimeter thermocouples registered the highest rates the detonators destroying the inside wooden liner and insulation as they fired. The temperature profile of TC-13 indicates that the bottom, front, left corner sustained the most damage. TC-13 quickly rose to the fire temperature and remained there for at least ten minutes. It then decreased, ( $t=50$  min)

probably, due to the insulating effect of the ashes and insulation falling from the top panel. The remaining thermocouples kept measuring temperatures that would eventually approach that of the fire.

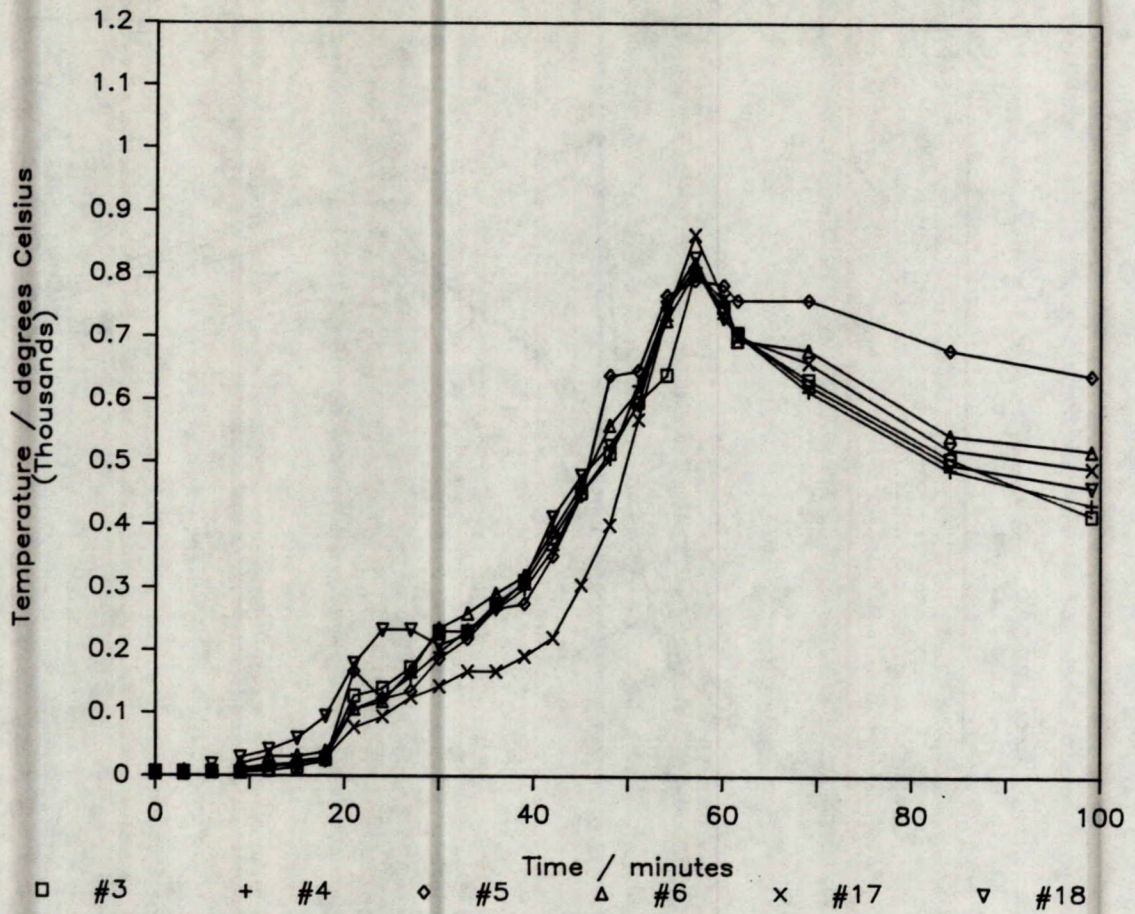
Figure 9 - Temperature profiles of TC-3, TC-4, TC-5, TC-6, TC-17 and TC-18

- (d) The other thermocouples (TC-3, TC-4, TC-5, TC-6, TC-17 and TC-18) began indicating sharp rises in temperature when flames were seen emanating from the perimeter of the door at  $t=26$  min. (Refer to Fig. 9.) This trend continued to about 58 min when maximum temperatures were recorded. After this time, the registered temperatures kept falling.

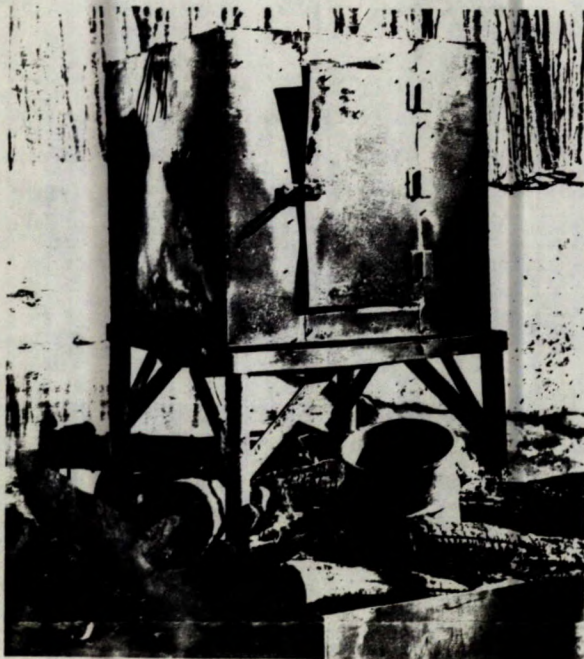
Observations after the burn indicated that the metal container had maintained its integrity as indicated by Fig. 10. The door, as seen from Fig. 11, was warped on the clasp side,

Figure 10 - Container after burn

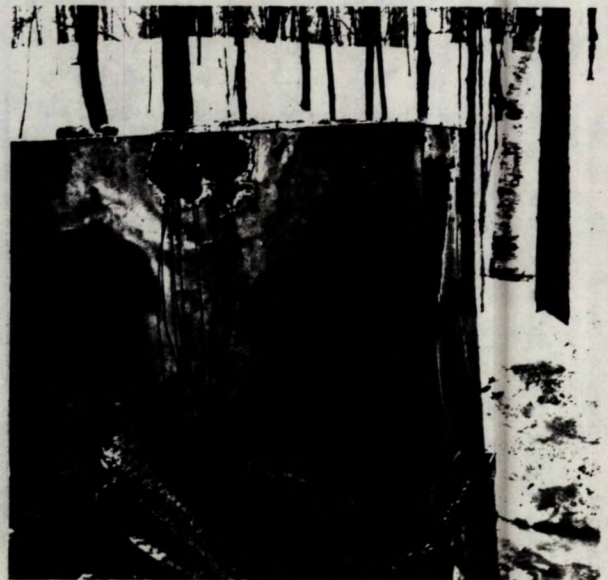
but otherwise held. Figure 12 shows the right hand side.

Figure 11 - Heat caused door to warp

A weakness in most containers is usually the door and opening. Structurally the existing

closure can be improved by forming a lip on the perimeter of the door and opening and by providing two clasps for the locking mechanism. The insulating value around this opening can then simply be improved by incorporating an insulating tape similar in material to those mentioned above.

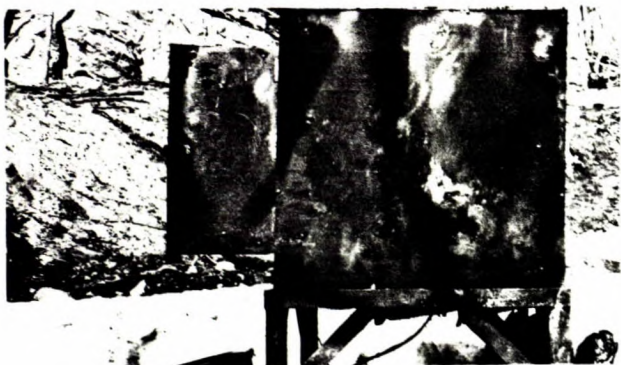
Figure 12 - Right side of container after burn

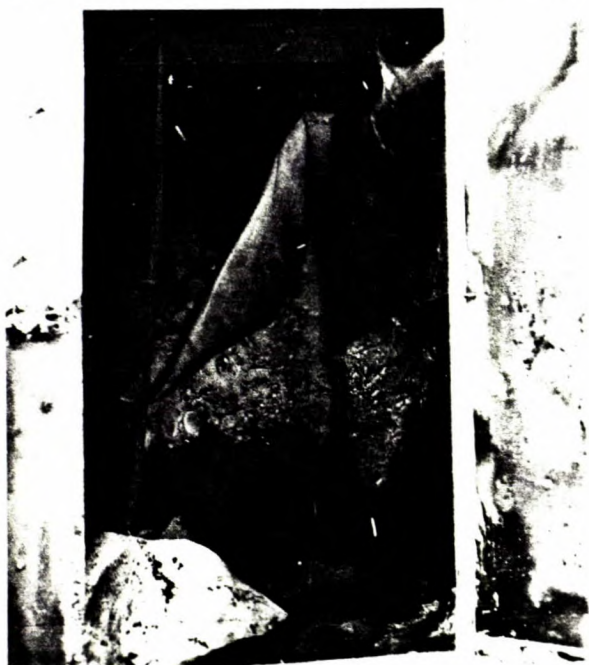
Close inspection revealed a 3 cm crack on the bottom, front, left corner. The bottom panel had many bulges and several perforations. Figures 13 and 14 indicate the condition of the insulation.

Figure 13 - Substantial deterioration of insulation

This type of container can be greatly improved at little cost by using insulation rated for higher temperatures. The AF 545 insulation presently used has a binder and glass fibre that melt at about  $150^{\circ}\text{C}$  to  $1000^{\circ}\text{C}$  respectively. It is possible to use mineral fibre or alumina/silica insulation that is rated from  $1300^{\circ}\text{C}$  to  $1600^{\circ}\text{C}$  (1).

Improving insulation should increase the time to the first detonator firing. However, since the presently-used inner wooden liner and insulation are easily damaged as the detonators fire, as indicated by the extensive damage to the bottom panel, a substitute liner material should be considered. A material such as steel, in the existing design, would reduce the insulating value, however, if it were coupled with the higher rated insulation, this would not occur. Steel would protect the insulation and result in an increase in the time required to function all the detonators.

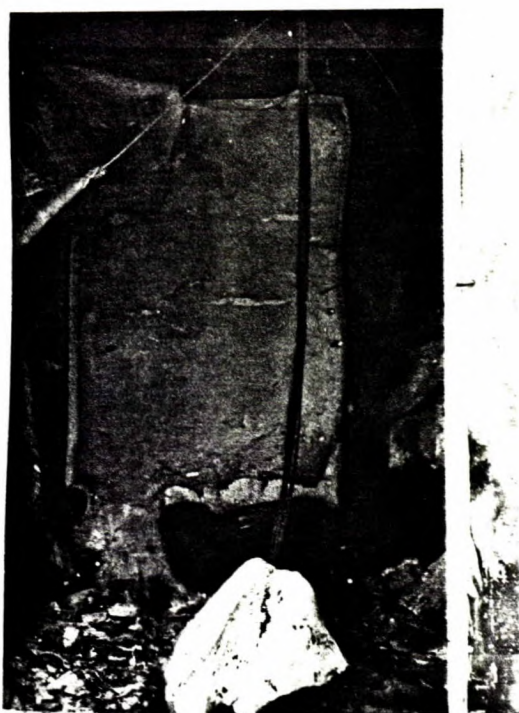
Figure 14 - Deterioration of insulation  
(back, left corner)
