VIDEO PROBE INSPECTION OF ROOFBOLT HOLES
AT KIDD CREEK MINE

G. Herget and B. Arjang

FEBRUARY 1989

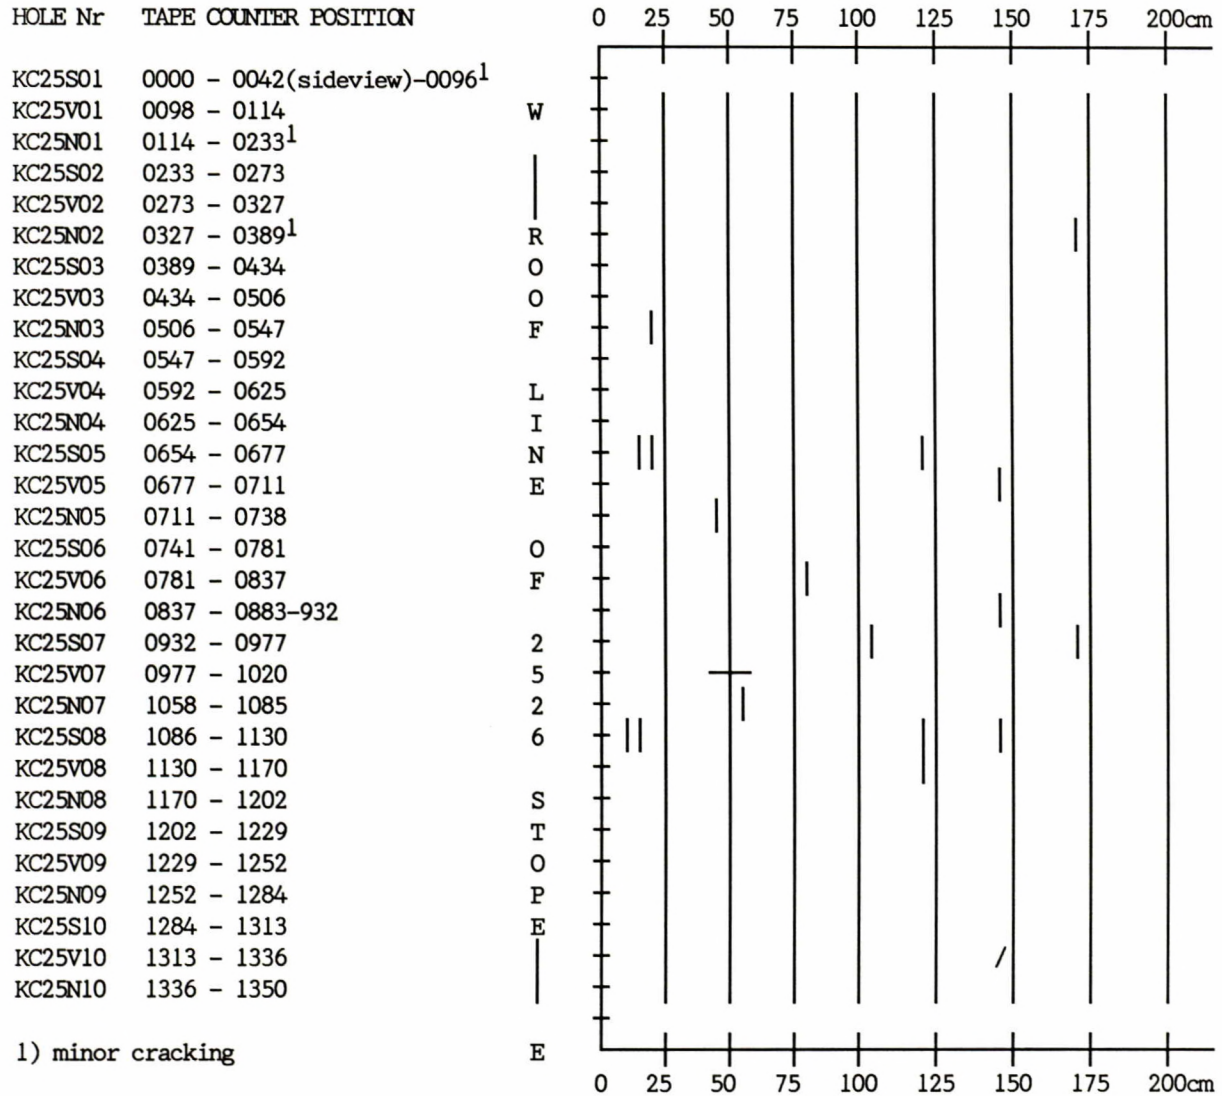
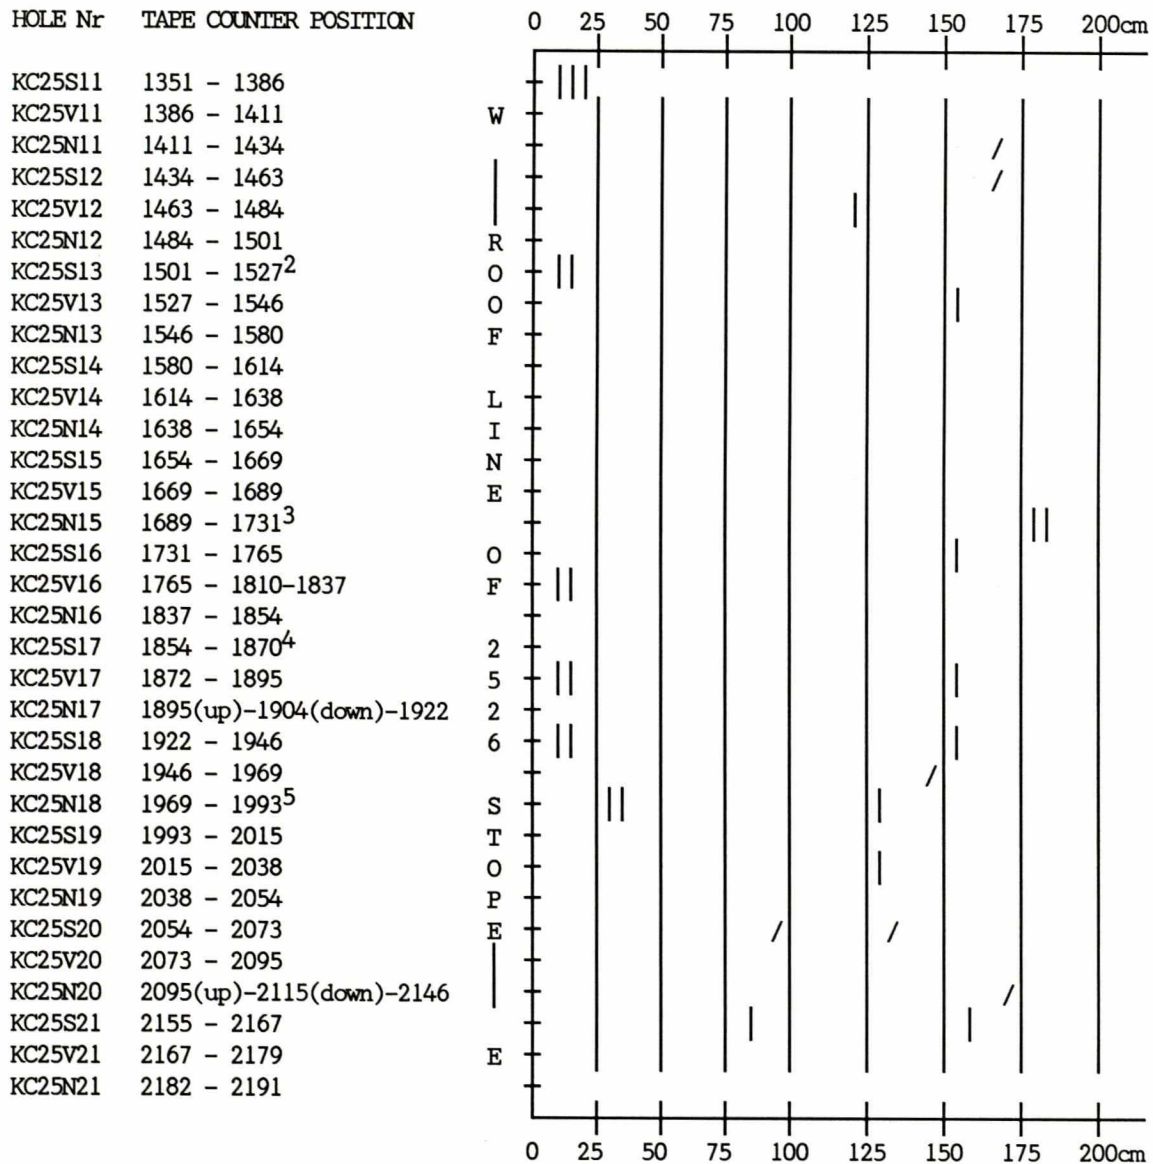
TABLE 1 - Swellex Borehole Inspection Summary for Kidd Creek
Mine 2526 Stope U/C (Video tape Nr. 1)

Figure 5 shows the geology of the site provided by Kidd Creek mine. Nearly all the holes were located in massive sulfides consisting of yellow pyrite (FeS_2) and brown stringers or areas of sphalerite (ZnS). Only occasionally the holes showed quartz veins. All holes were slightly fractured at the collar from blasting. In a number of places the roof required scaling. In total the rock mass is very competent and only occasionally do the borehole walls show small breakouts from micro cracking or some subhorizontal jointing. Only seven holes showed vertical fractures (Table 1).

- 2) rough wall of collar
 3) (2 runs), back of hole cracked (1724)
 4) breakouts
 5) rough wall
