SEISMOLOGICAL SERIES

Operation and Maintenance
of the
Yellowknife Seismological
Array,
1966-68

E. B. Manchee and
W. D. Cooper

Seismological Service
of Canada

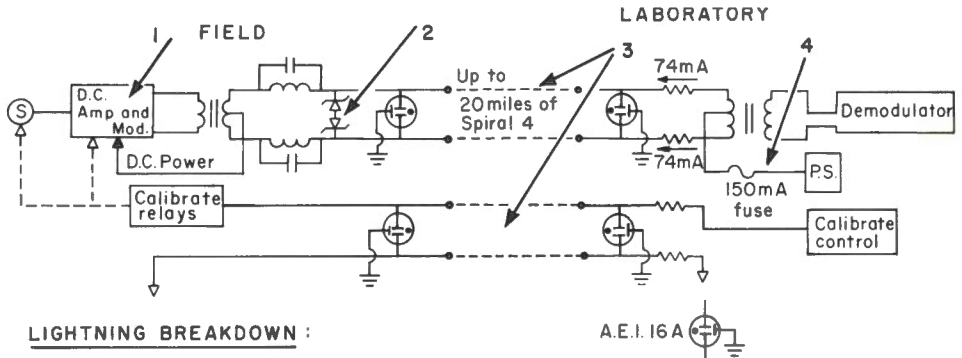
LIGHTNING BREAKDOWN :

1. Any transistor in the D.C. amplifier or modulator.
2. Zener diodes across signal pair.
3. Cable and junctions.
4. Fuse in D.C. power supply - 148 mA normal supply current - 150 mA fuses.
Any damage demanding > 150 mA total blows fuse.

Figure 2. Areas of lightning damage in the Yellowknife array cables and electronics.

Perhaps the most extensive (and expensive in terms of recording time) type of breakdown that has occurred has been that caused by lightning strikes. Whereas direct lightning strikes on the cables may damage the conductors or Scotchcasts as well as the electronics, even a near strike may cause induced currents in the lines which can damage the electronics. In each vault there are two AEI-16A three-electrode sparkgaps, placed across the signal and calibration lines as shown in Figure 2. The breakdown voltage of the AEI-16A is 150 V. No damage from lightning strikes has occurred in the calibration circuitry since the lines are connected only to fairly rugged relays. However, the signal lines are connected directly to the output transformer of the vault electronics package and, to provide additional protection for these electronics, back-to-back Zener diodes are placed across the signal lines. In spite of these measures, the protection circuitry has often failed to perform adequately.

Lightning surges may destroy the Zener diodes and may also be transmitted through the output transformer to the vault electronics, destroying the matched transistors or, in some cases, all the transistors in the preamplifier. In either case, a trip to the vault in question is necessary, usually with a replacement electronics package.

At the laboratory end, a pair of AEI-16A's is connected across the Spiral-4 conductors as in the vaults to protect the laboratory equipment from lightning damage. During severe thunderstorms, these sparkgaps sometimes fail to protect the signal circuitry, but the most common fault is then a blown fuse in the dc supply feeding the vault electronics via the signal lines. Here again the AEI-16A has provided adequate protection to the calibration circuitry as there have been no breakdowns.

During June, July and August of 1966, a grounded skywire was erected over the cable bundle on the Blue line south of the Mackenzie Highway, i. e., from B1 to midway between B3 and B4. At the same time, wooden insulators were inserted into the guywires that have been used on the tripods in various areas (such as rounding a corner). It was hoped that these measures would enable us to assess the feasibility of protecting the entire array while providing a measure of protection to the south end of the Blue line. The technicians are of the opinion that damage has been definitely decreased over this portion of the array; however, due to lack of detail in reporting, it has not been possible to separate the statistics on lightning damage for this part of the array from the statistics for the array as a whole. Also, a lightning strike on an unprotected part of the array could cause damage in a protected part. At any rate, the guywire insulators and skywire have not adversely affected this part of the array in any noticeable way.

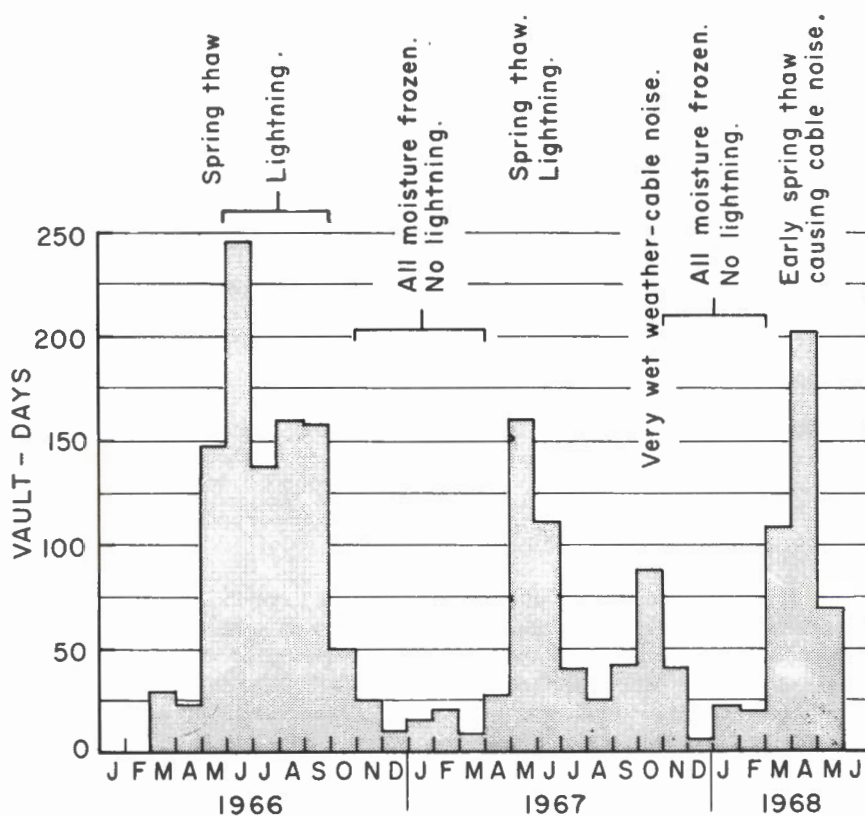
Figure 3. Noisy operating and calibrating conditions at the Yellowknife array, March 1966 to May 1968.

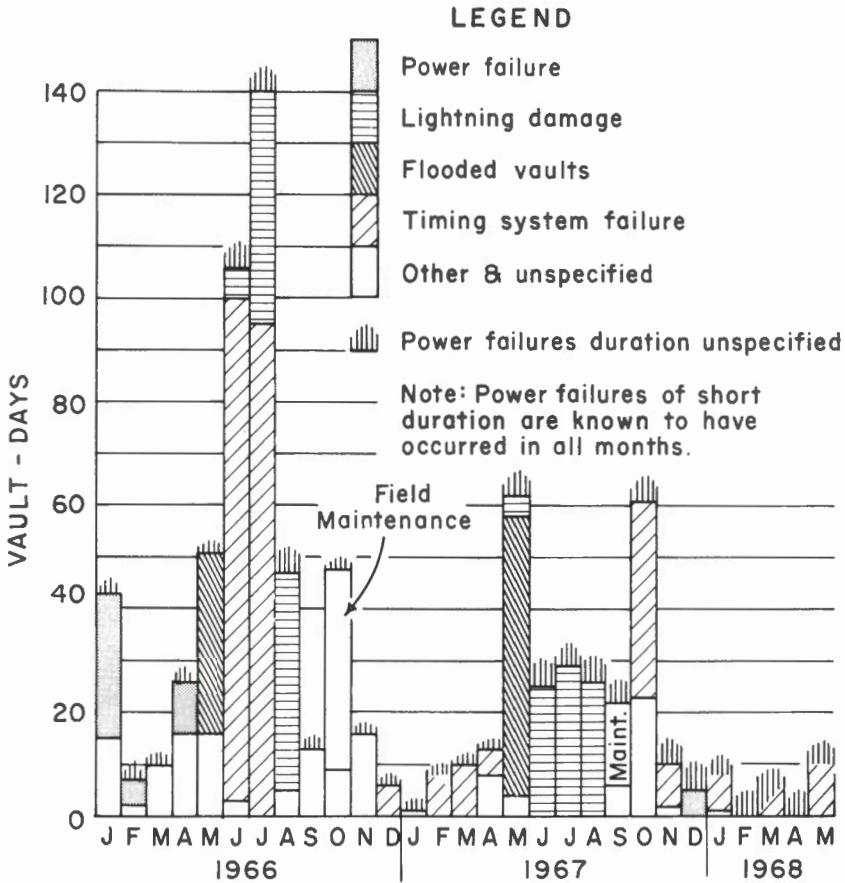
Figure 4. Loss of data at the Yellowknife array in vault-days, January 1966 to May 1968.

It is obvious from Figure 4 that no number can be presented to cover total data loss resulting from power failures. However, a reasonable estimate may be made, based partly on incomplete written reports and partly on current experience.
