**Final Inspection Report for Lalor Lake 3D
Field Inspection Conducted June 3, 4 and 5th 2013**

A final field Inspection has been completed on the Lalor Lake 3D project that was conducted for Natural Resources of Canada during February and March of 2013.

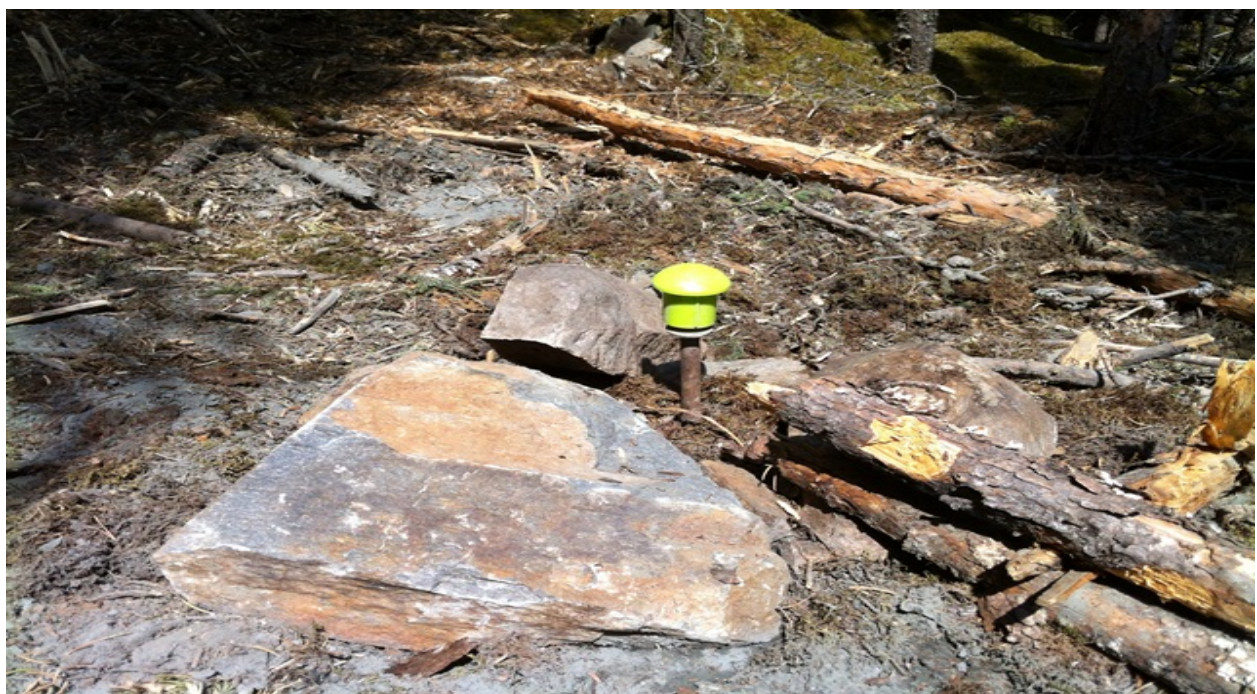
Shot Point 118175

Shot Point 118175: Jeff Mackie and Tim Daigle walked into this location as the lines are inaccessible in summer with UTV's. The shot point was located and the location confirmed with GPS coordinates. The hole was dug down to about 30 cm to exposed rock. The leads were then cut down and exposed. A Galvanometer indicated a dead cap. Three unsuccessful attempts were made with a portable blasting box to detonate this charge.

The explosive product used in both of these holes is ½ kg. Vibrogel paper NG with a No. 12 Electric Seismic blasting cap. The moisture present in both of these shot points locations will make the Sodium Nitrate go into solution which will take the oxygen component away thus eliminating the possibility of detonation. This process will be accelerated with the presence of moisture down both holes and it is anticipated that these charges will be inert within 24 months.

4 liters of water were poured down the hole to help accelerate the decay of the charge. 1 bag of cement was mixed and poured down the hole. A steel pin monument with a green fluorescent cap was placed in the concrete in the hole as well as a tin tag placed on a tree beside the hole indicating the location and shot hole number.

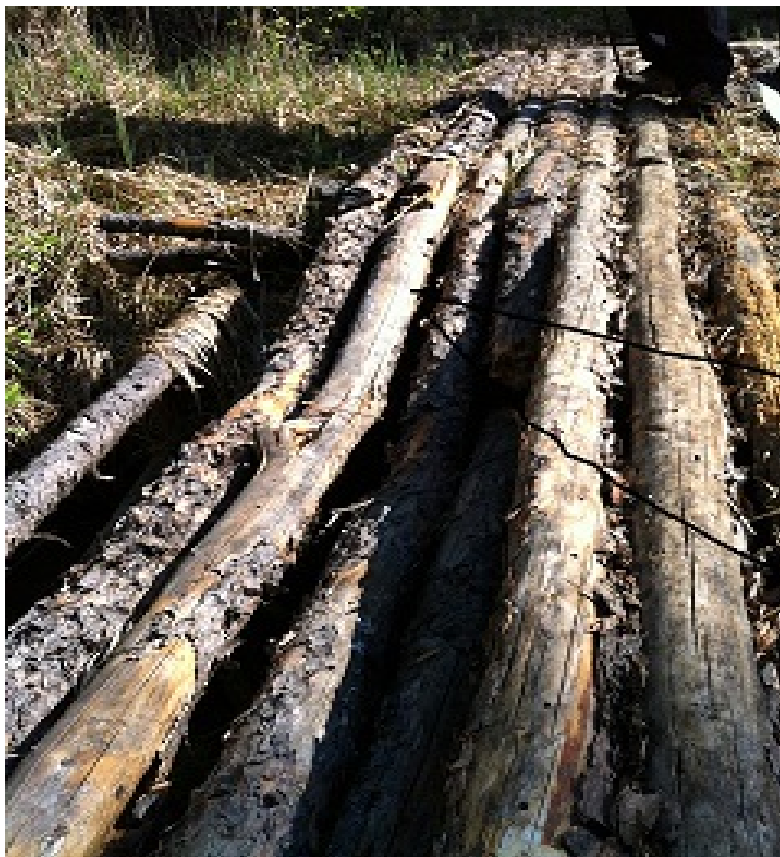
Here is a Picture of the bridge as we found it in June. The breaks are discolored and appeared to be older than a couple of months.

We decided that we had used this bridge so we should participate in its repair. We had two of our workers spend an afternoon replacing some broken decking and added a couple of supports below the structure

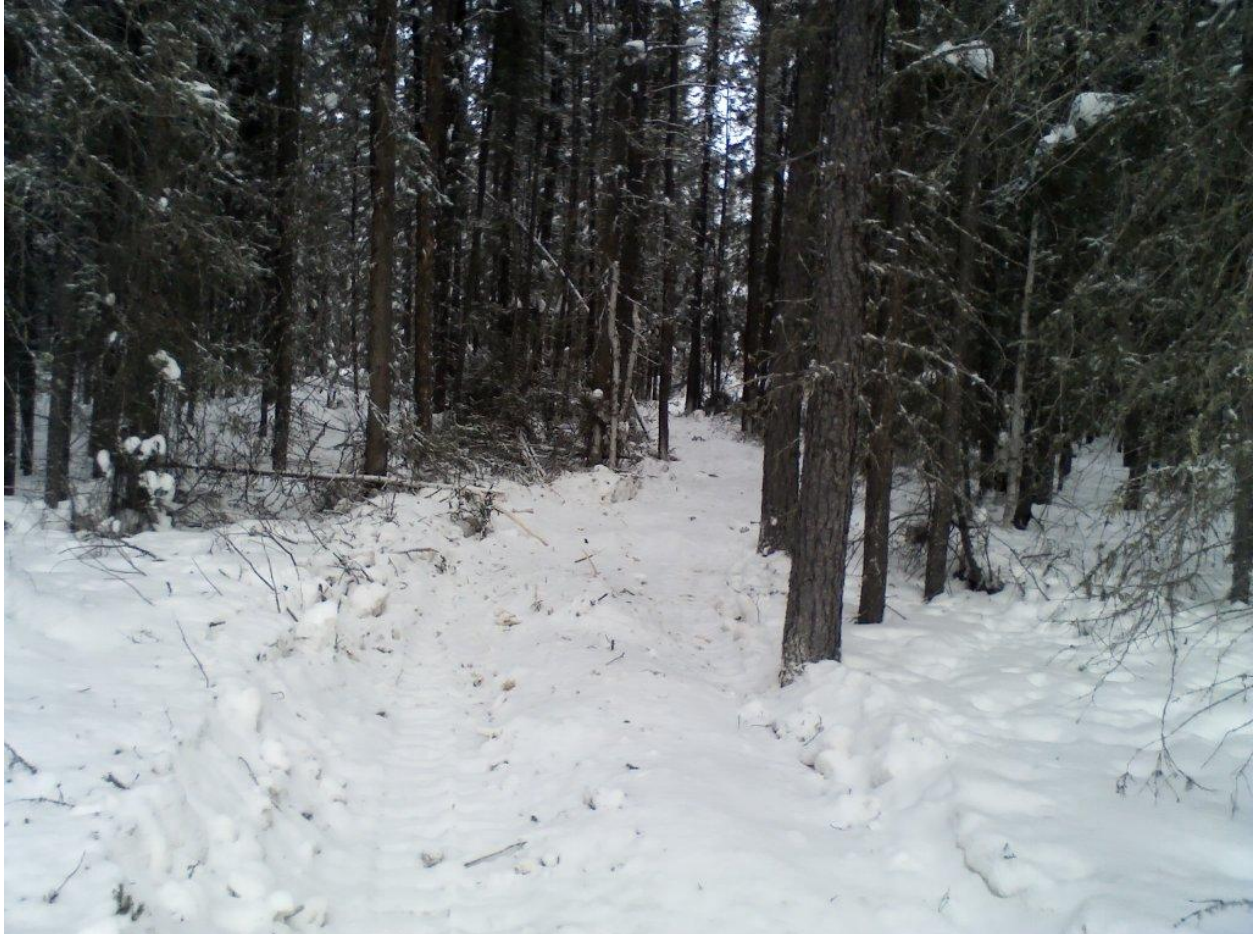
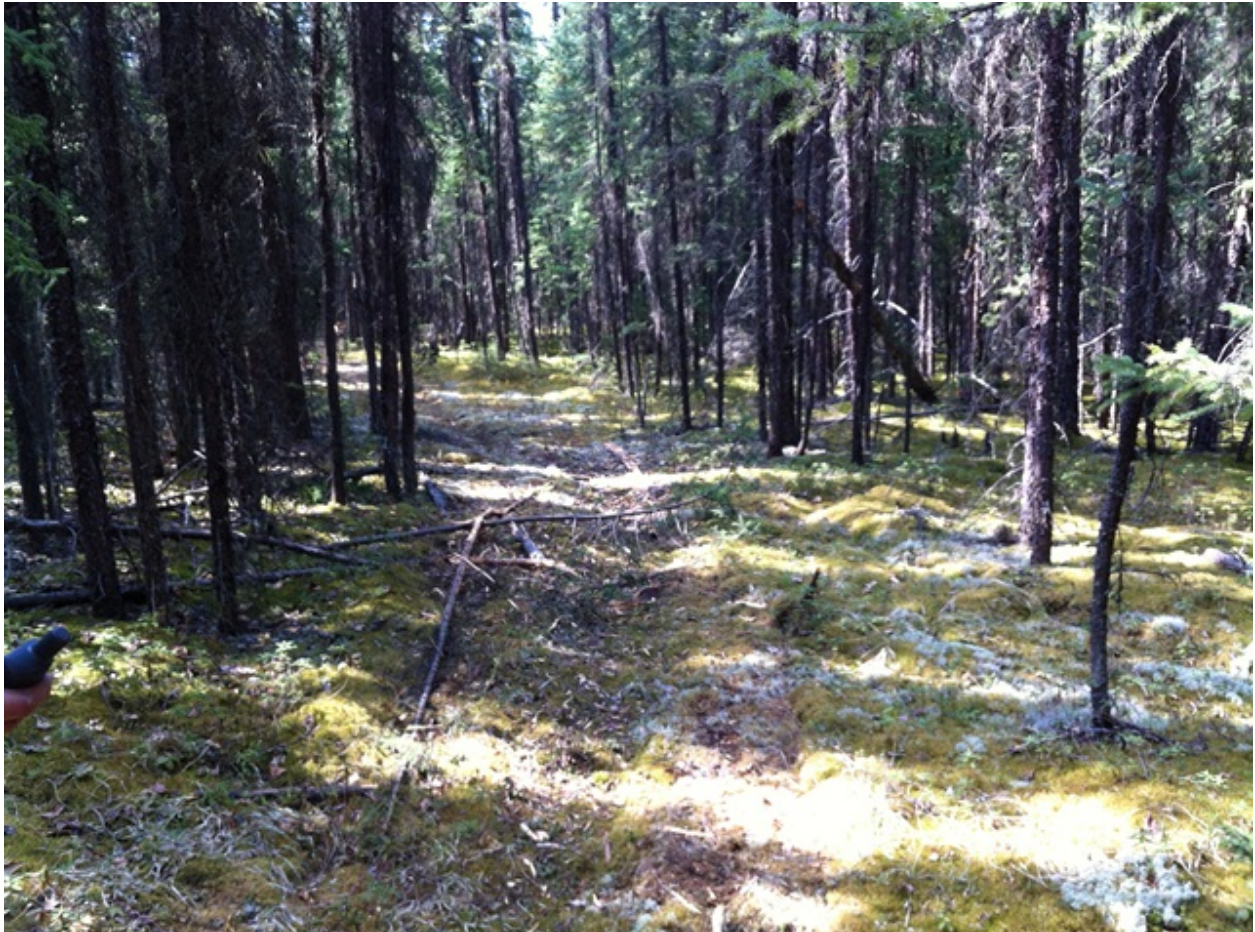
Upon inspection by ground, all the cutting that was observed appeared to meet the expectation of avoidance of bigger timber, minimize a straight line of site and have minimal ground cover disturbance.

Inspection from the air (helicopter) also proved that the mulching achieved very little visible disturbance as the lines were hard to see and follow, even at low level and slow speed flight.

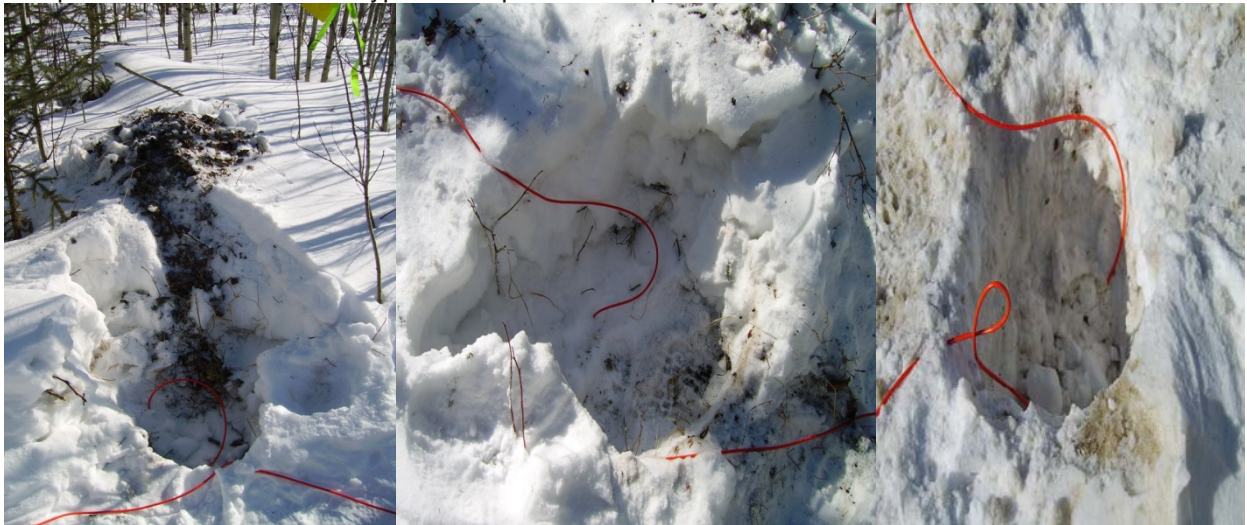
The pictures below shows the typical final product of a planted sensor on the Lalor Lake 3D.

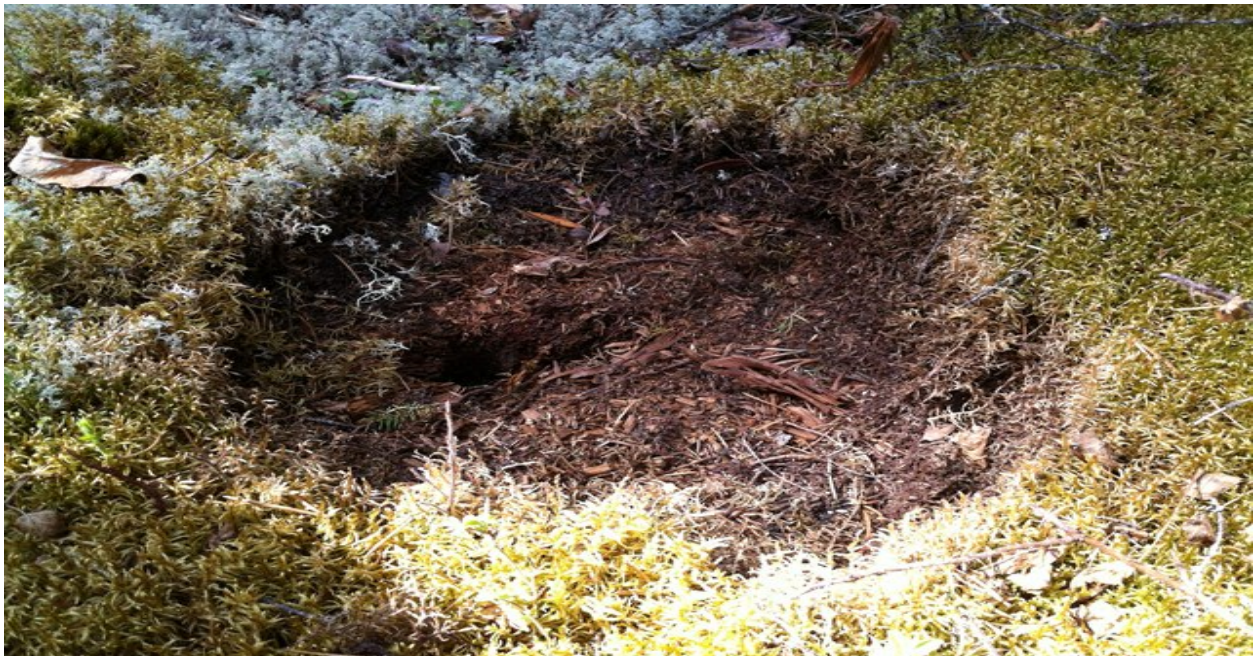
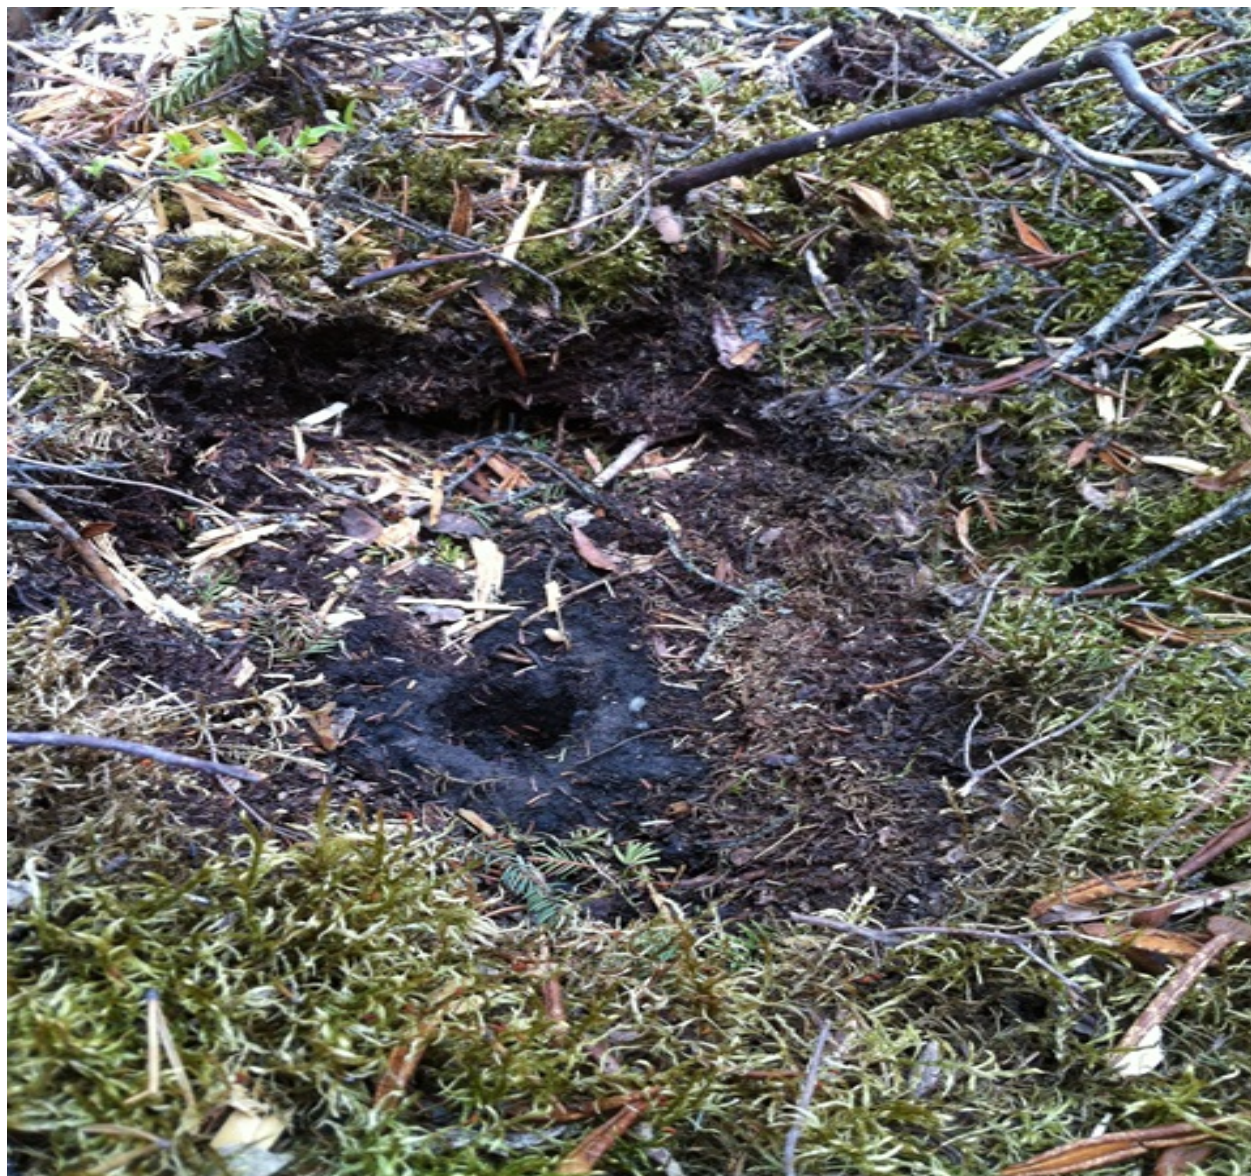
These pictures below show the evidence of proper placement techniques for the DSU sensors used on the Lalor Lake 3D

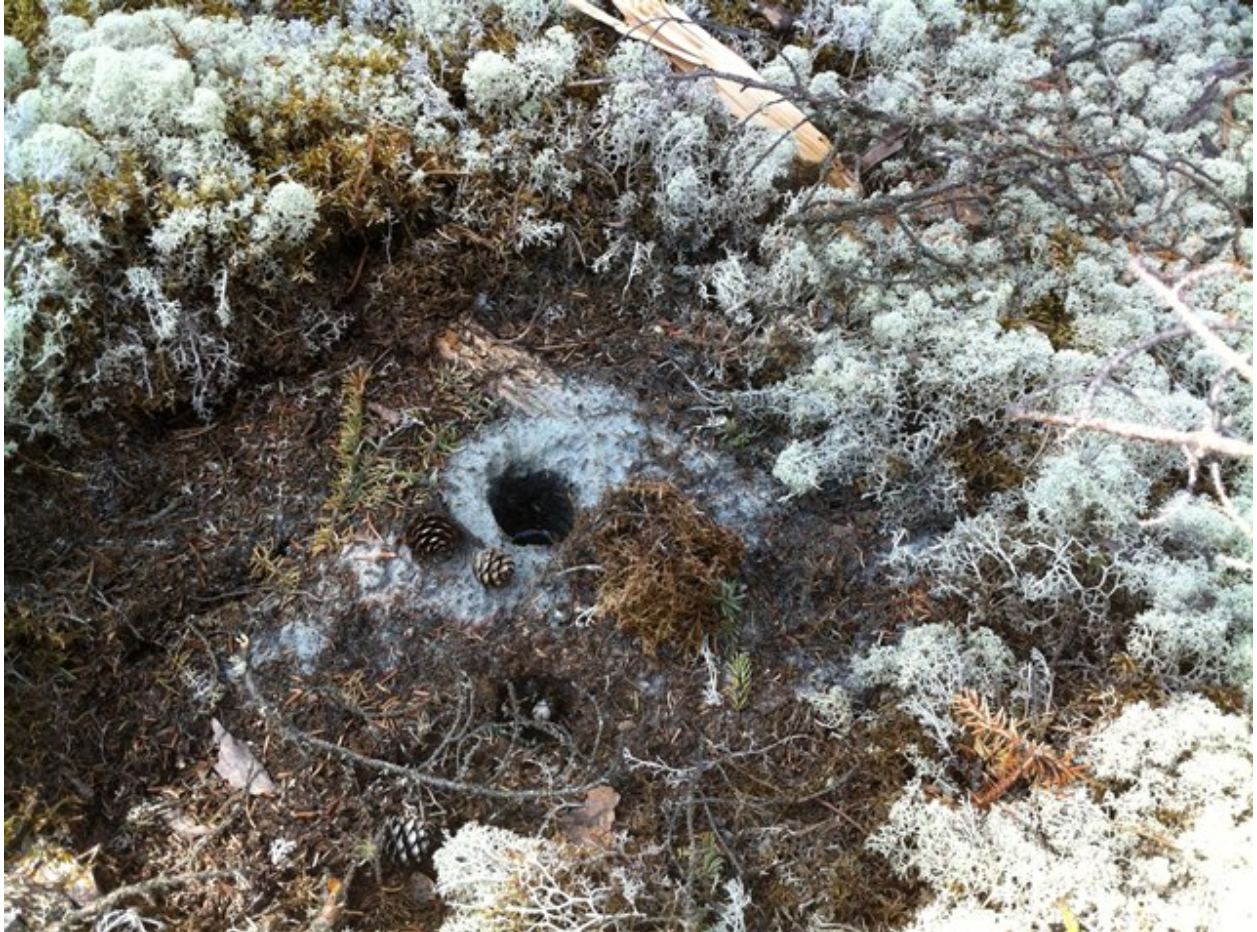
This picture illustrates a hole that was drilled in using the hammer drill in solid rock
