GEOLOGICAL SURVEY OF CANADA MISCELLANEOUS REPORT 62

GEOMORPHIC EFFECTS AND IMPACTS OF SEVERE FLOODING: PHOTOGRAPHIC EXAMPLES FROM THE SAGUENAY AREA, QUEBEC

> **G.R. Brooks** and **D.E.** Lawrence

1998

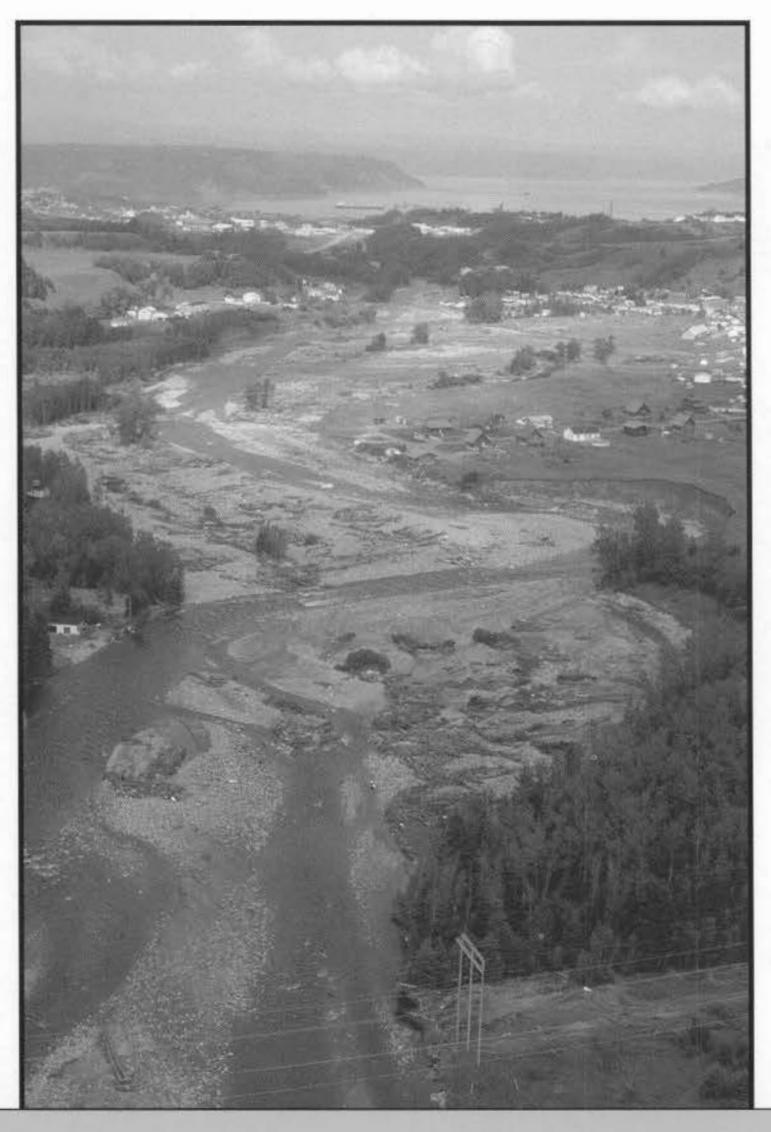
Figure 7. Along some river reaches, once a certain discharge level is surpassed, the strength (or stream power) of the flow exceeds the threshold of resistance of the valley bottom to scouring, and large-scale erosion of both the channel perimeter and floodplain can occur (Baker and Costa, 1987). Stream power reflects not only the discharge, but also the flow gradient and the flow width, while the resistive threshold relates to hydraulic roughness, vegetative cover, morphology, and composition of the valley bottom. Thus, resistance thresholds vary both from one river to another and from one reach to another along a single river, although in some cases, the threshold will not be exceeded under any plausible flood discharges. Once the resistive threshold is exceeded, the amount of erosion that occurs during any given flood will reflect the recent flood history of the river and the duration of the flow above the threshold (Kochel, 1988; Costa and O'Connor, 1995).

Along the lower 10 km of the à Mars River, the stream power of the flood was sufficiently high that the threshold of resistance to erosion was exceeded. Large-scale erosion of the valley bottom resulted from a combination of concavebank erosion, channel avulsion, and the reactivation/creation of channels (Brooks et al., 1997). The net result was the formation of a broad flood channel 50 to 380 m wide, which in places is many times wider than the pre-flood channel. The post-flood channel also exhibited a multi-channel or braided planform in contrast to the predominantly singlechannelled meander planform of the pre-flood river. The photograph shows the wide flood channel and divided morphology of the post-flood à Mars River, looking downstream from about 5 km above the river mouth. Similar processes also caused extensive channel widening along the lower 3 km of the Ha! Ha! River. Photograph taken on July 27, 1996. (GSC 1997-42X)

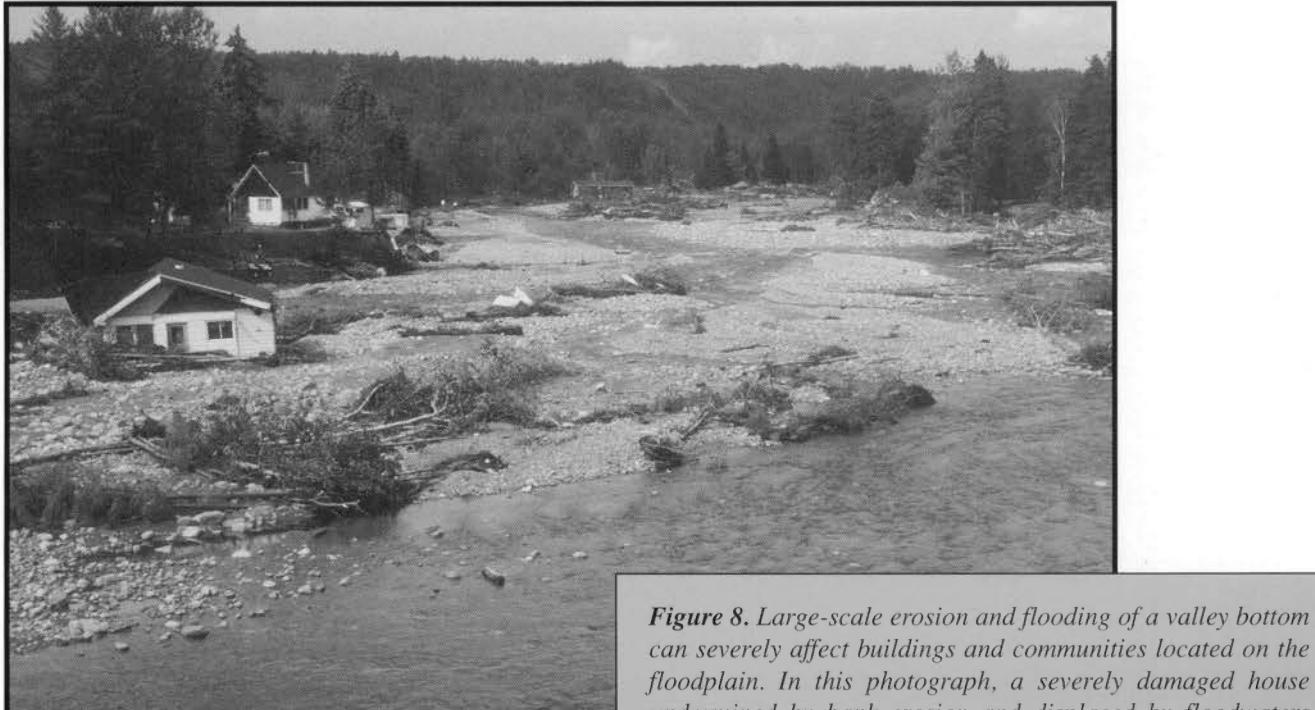
can severely affect buildings and communities located on the floodplain. In this photograph, a severely damaged house undermined by bank erosion and displaced by floodwaters rests on a gravel bar within the flood channel of the à Mars River. Photograph taken on July 27, 1996. (GSC 1997-42CC)

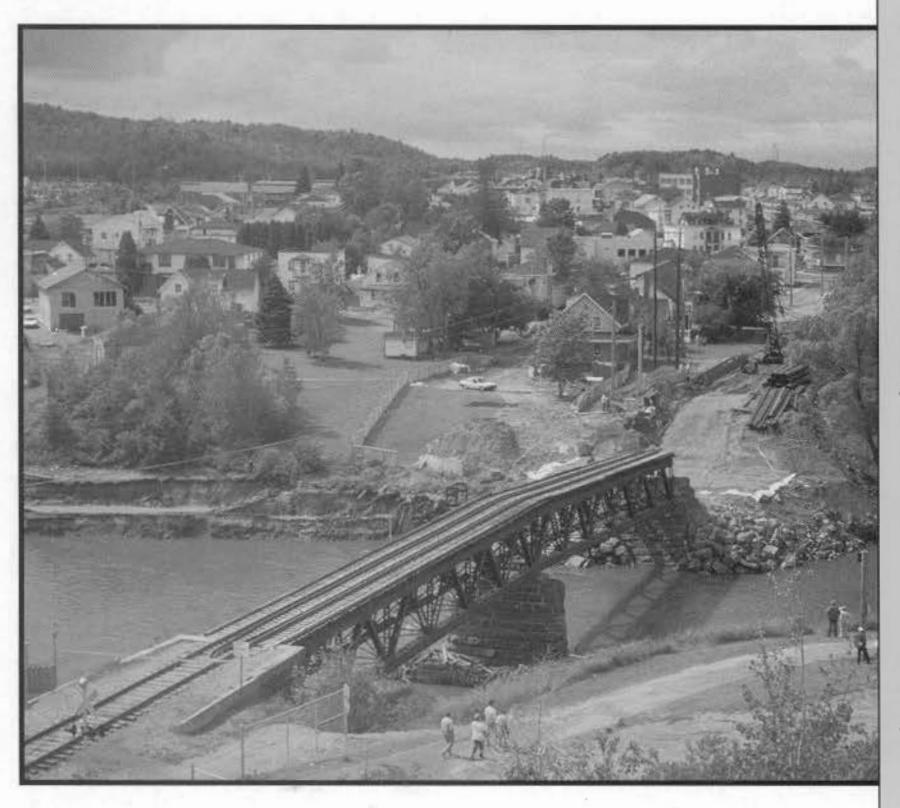
Figure 12. Bank erosion occurs naturally along the concave (or outer) bank of a river meander. Bridges crossing a river at the apex of a bend can be vulnerable to damage from concave-bank erosion. An extreme example of such damage occurred at this site along the à Mars River. During the flood, about 75 m of concavebank erosion completely removed the left abutment of a railway bridge on the far side of the channel, causing the left span to collapse into the river. The railway tracks, undermined by the collapsed span and further erosion of the concave bank, remain suspended across the post-flood river channel. Photograph taken on July 27, 1996. (GSC 1998-015D)

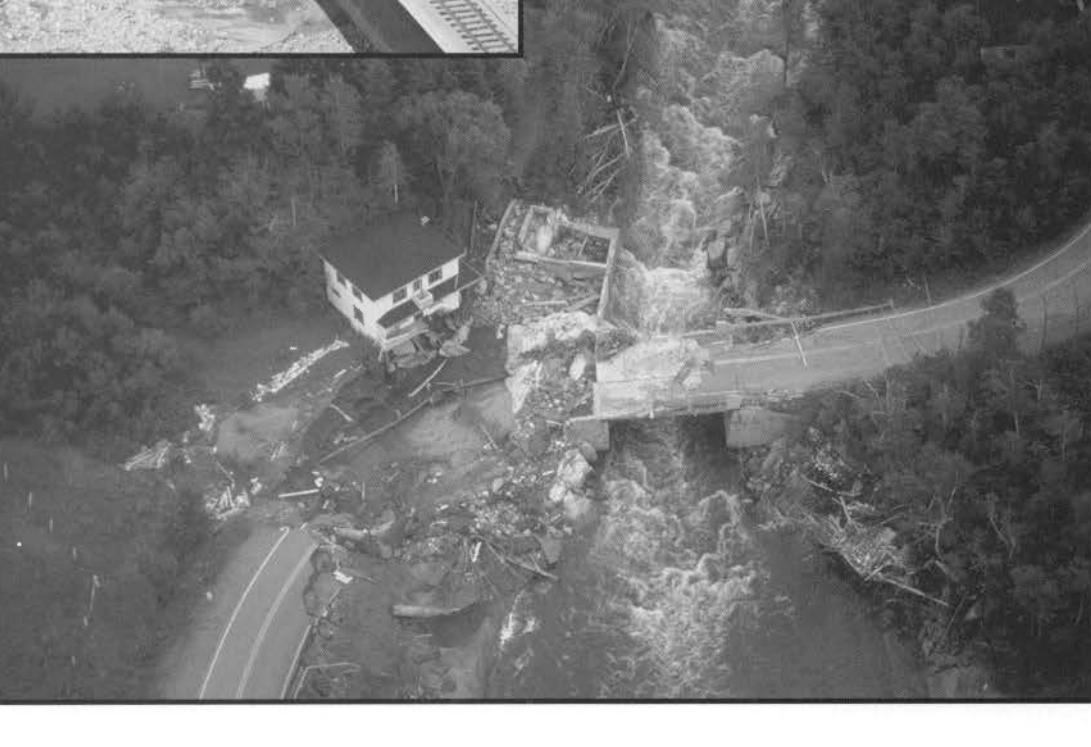
Figure 14. When the influx of water into a reservoir exceeds the outflow, the reservoir level will rise and water may eventually overtop the dam(s) and/or dyke(s). This happens because the total outlet capacity of the dam(s) is surpassed and/or the outflow is impaired by, for example, the gates being only partly opened, malfunctioning, or being clogged with debris (Fig. 4; Jansen, 1983). The overtopping of a dam or dyke creates a very dangerous situation for areas that are immediately adjacent and downstream, especially if major erosion of the structure or an abutment ensues. During the Saguenay floods, a number of small dams were overtopped causing varying degrees and different types of damage depending upon the general setting of the dam. This photograph and those in Figures 16 to 19 all show problems at dams that impound small reservoirs.

This photograph shows a concrete dam that was overtopped causing a broad sheet of water to sweep through a residential-commercial area in downtown Chicoutimi. The resulting torrent stripped the vegetation and thin overburden from the bedrock, eroded roads, and damaged and destroyed buildings, some of which were literally washed off their foundations. A broad erosional 'channel' was created through the urban area. Sand and gravel eroded by the overflow were deposited, forming a bar in a broad pool where the flood water re-entered the river just above its mouth. The dam itself suffered only minimal visible damage from the overflow, and continued to impound water after the floodwaters had receded. Photograph taken on July 26, 1996. (GSC 1997-42S)

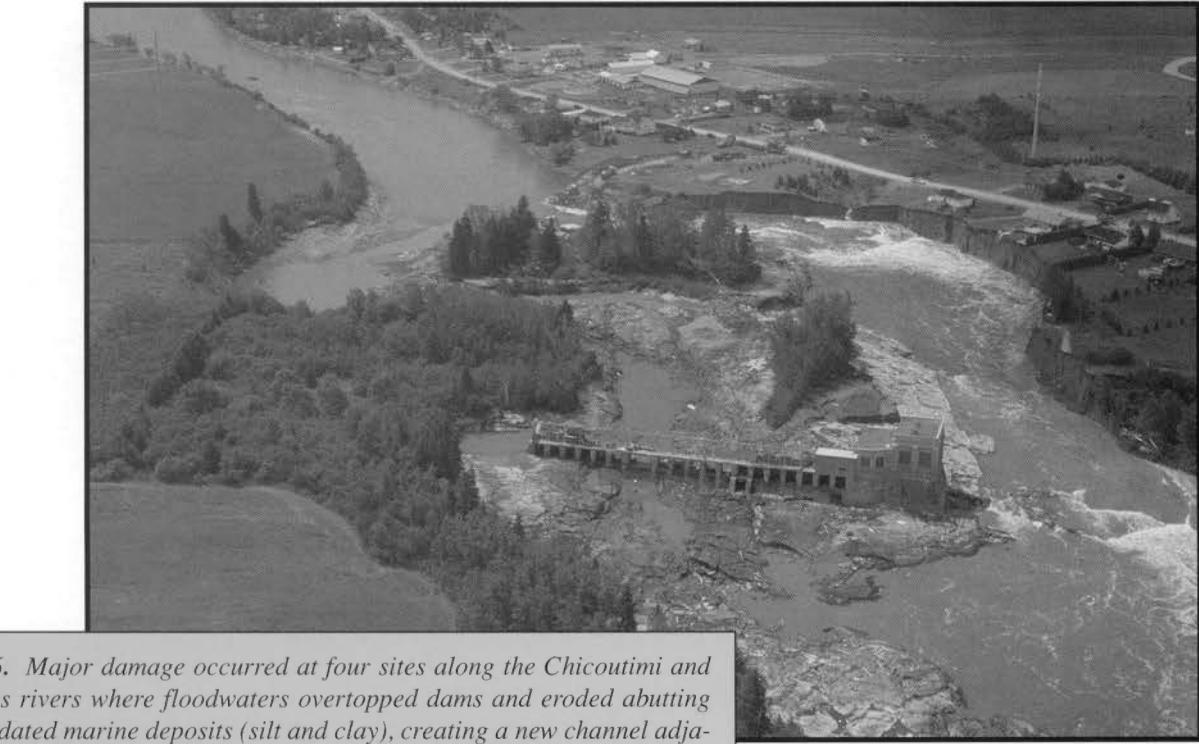
Figure 16. Major damage occurred at four sites along the Chicoutimi and aux Sables rivers where floodwaters overtopped dams and eroded abutting unconsolidated marine deposits (silt and clay), creating a new channel adjacent to each dam that drained the reservoir and 'captured' the entire river flow. In this photograph of the Chute-Garneau dam on the Chicoutimi River, a newly eroded channel carries the entire flow beside the dam, bypassing the penstocks and sluice gates. The dam remains intact, but is nonfunctional. Photograph taken on July 26, 1996 (GSC 1997-42N)

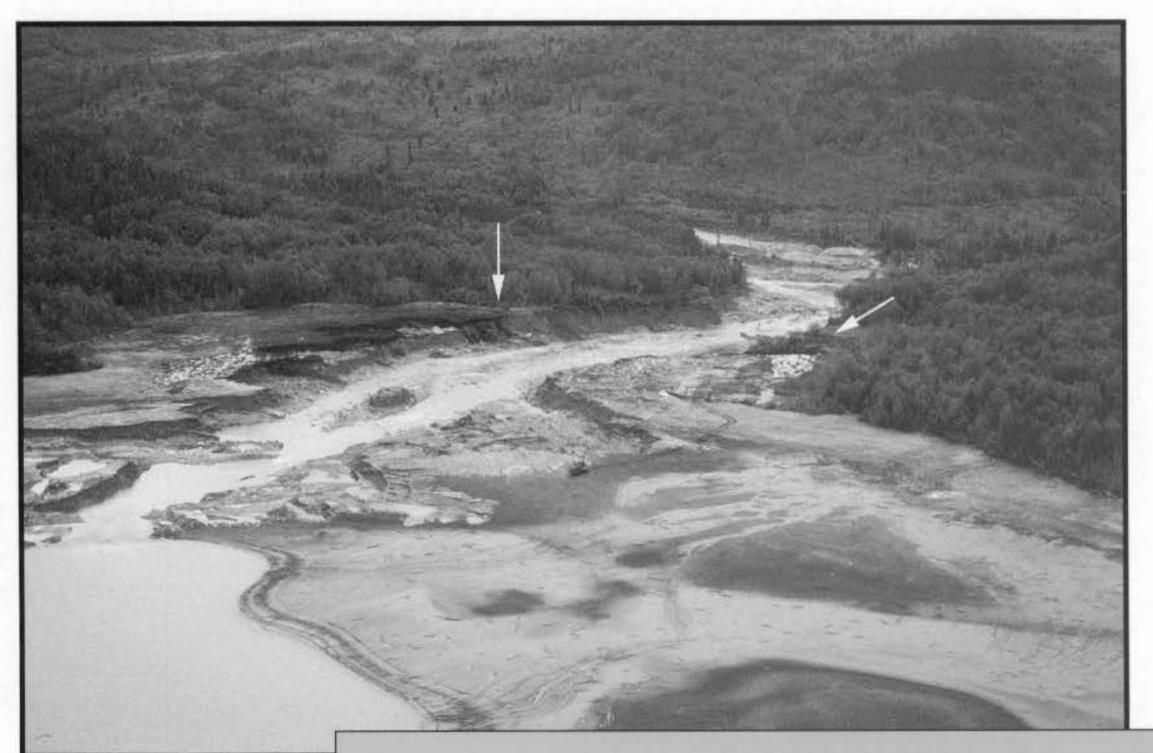
Figure 19. The overtopping and erosion of a dam or dyke can form a breach that progressively enlarges over time, increasing the outflow of water. The rate of erosion of the breach depends on a number of factors including the shape, height, width, length, and composition of the dam or dyke and the volume of impounded water available for drainage. Outflow will begin to decrease when the supply of water wanes as the reservoir level falls or outlet erosion slows. Breaching of a dam or dyke can result in the catastrophic release of water the discharge of which is generally directly proportional to the volume of water stored in the reservoir (see Costa, 1988).

While a number of dams were breached in the Saguenay area (e.g. Fig. 13 to 16), these impounded small reservoirs and the reservoir drainage did not significantly add to the flood discharge. However, this was not the case with the Ha! Ha! Lake reservoir (surface area of 8.1 km²). During the rainstorm, the influx of rainfall runoff caused the waters of Ha! Ha! Lake to rise and overtop a narrow earthfill saddle dyke 162 m long and 2 to 3 m high. Subsequent erosion of the dyke and underlying surficial material resulted in the drainage of Ha! Ha! Lake. The water thus released greatly increased the storm runoff downvalley, producing a flood that was about an order-of-magnitude or more greater than the previously recorded maximum instantaneous discharge of 114 m³s⁻¹ (Brooks et al., 1997). Drainage of the lake occurred rapidly over a period of roughly 18 hours (Commission scientifique et technique sur la gestion des barrages, 1997), but not catastrophically because of the general resistance to fluvial erosion of the silty sand diamicton underlying the saddle site. Nevertheless, the flood discharge along the Ha! Ha! River was the largest in the area relative to the size of the drainage basin. The view in this photograph is downstream into the new outlet. The subaerial lake bed and residual water surface are visible in the foreground; the arrows show the remnant margins of the dyke. The photographs in Figures 19 to 22 show selected downstream effects of the resulting deluge. Photograph taken on July 28, 1996. (GSC 1997-42B)

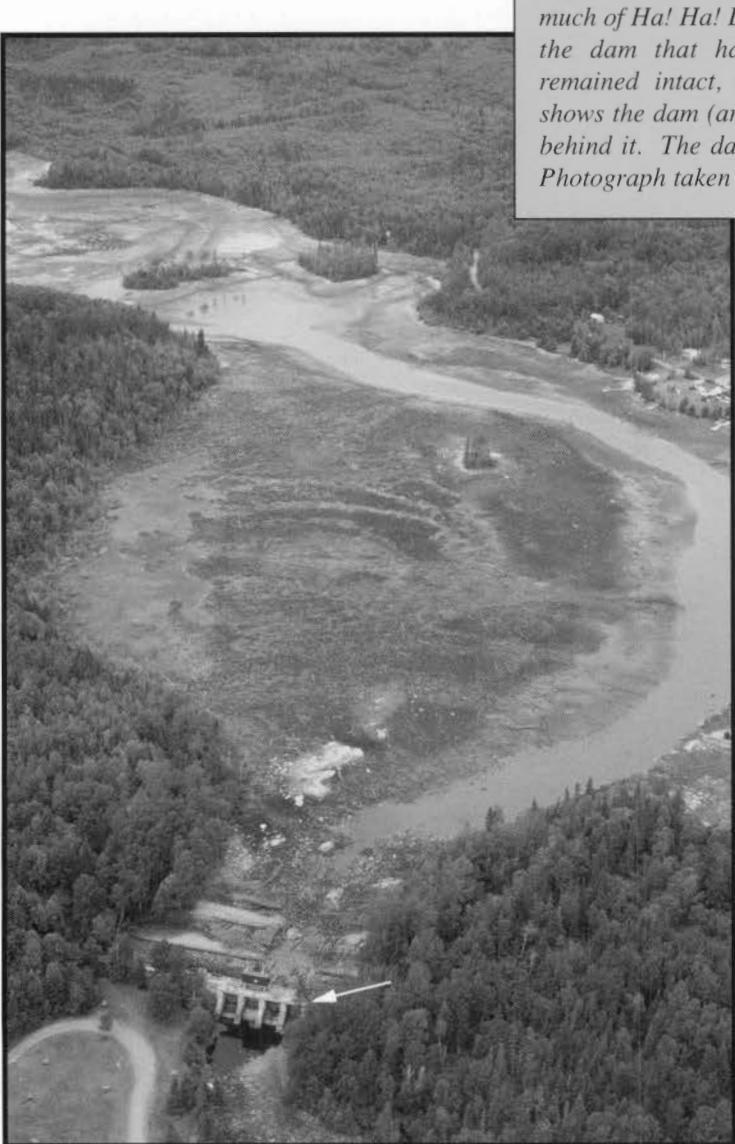
Figure 20. Although the saddle dyke was destroyed and much of Ha! Ha! Lake was drained, following the flood, the dam that had previously impounded the lake remained intact, but nonfunctional. This photograph shows the dam (arrow) with the bed of the drained lake behind it. The dam was not overtopped by lake water. Photograph taken on July 28, 1996. (GSC 1997-42D)

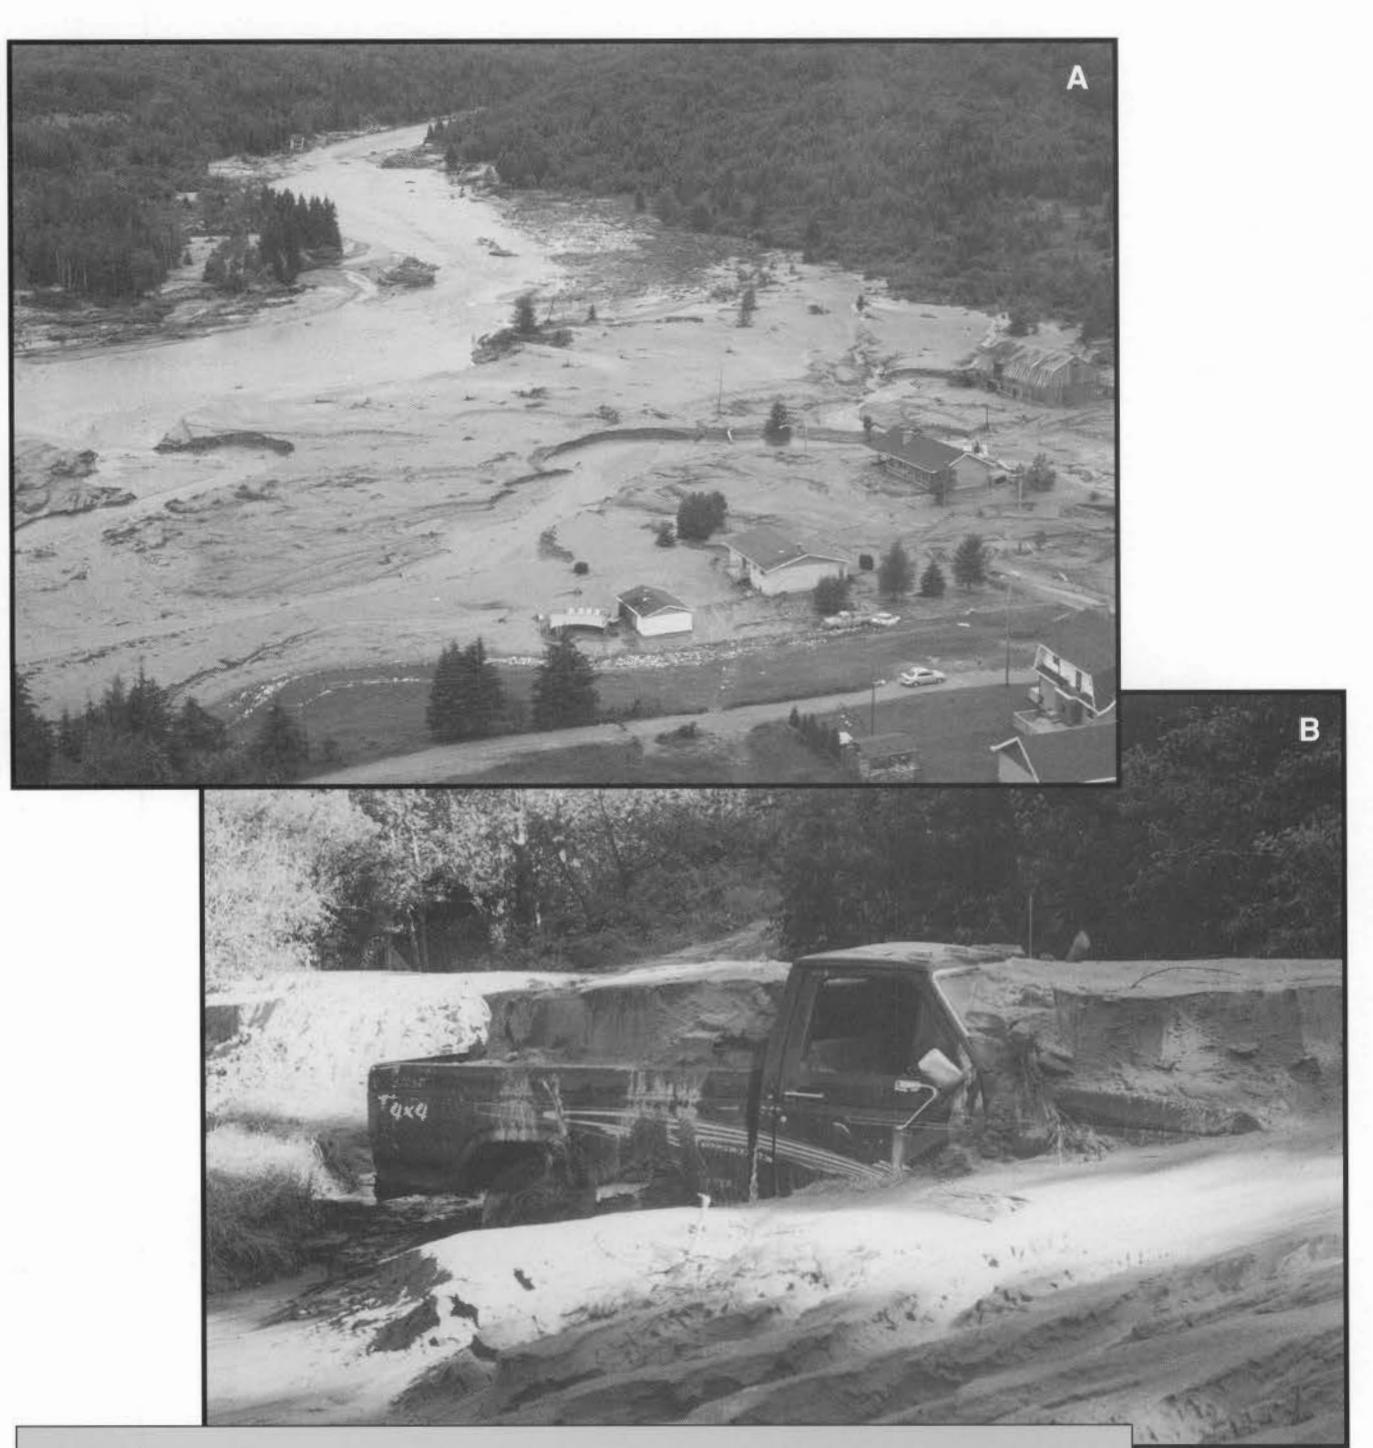
Figure 21. Extensive aggradation occurred downstream on the Ha! Ha! River along relatively gently sloped valley reaches. (A) At about 10.5 km above the river mouth, aggradation occurred along a broad section of the valley bottom and several properties were covered with up to about 2 m of sand eroded from upstream (GSC 1997-42KK). (B) About 2 km downstream of the location shown in (A), a truck was inundated during the flood and buried in sand, literally to the roof top (GSC 1998-015F). Photographs taken on July 29, 1996. **Figure 22.** Floodwaters eroded steeper reaches of the Ha! Ha! River. Here, channel incision and widening occurred along a narrow section of the valley bottom. The post-flood channel perimeter is formed by a bouldery lag and by diamicton and bedrock that were previously buried under river alluvium. Note the houses on the river terrace that were damaged by undermining from the lateral erosion of the right bank; some nearby houses (marked by empty driveways) collapsed into the river during the flood. Photograph taken on July 28, 1996. (GSC 1997-42NN)

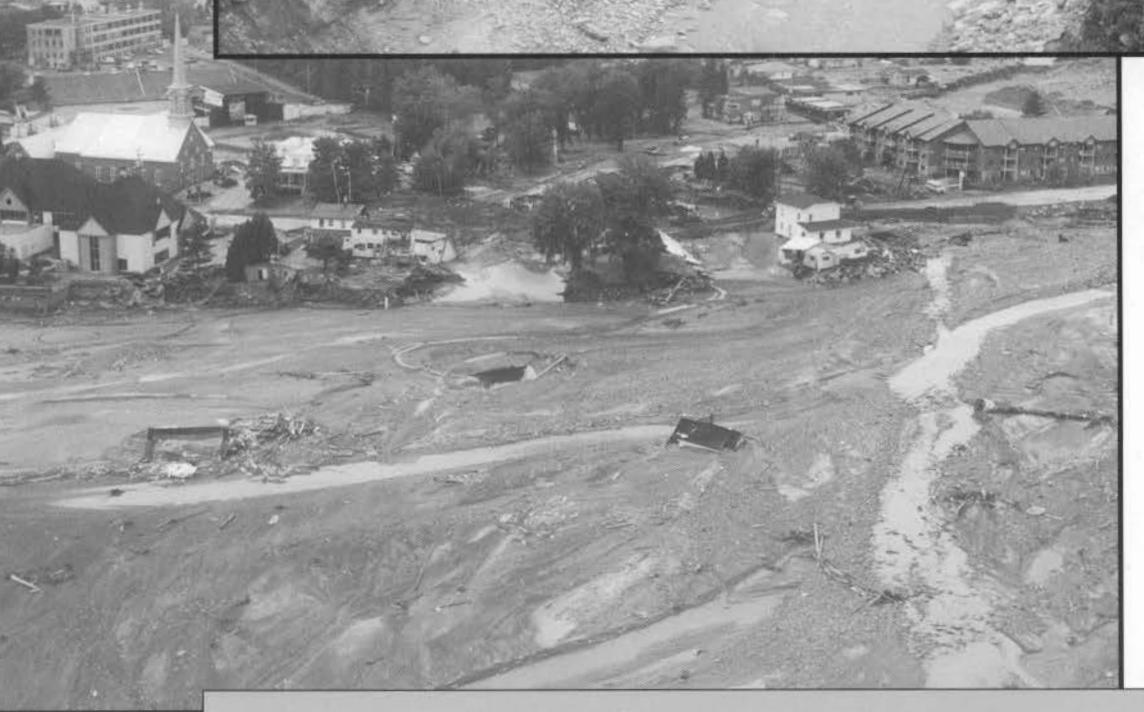
Figure 23. At the mouth of the Ha! Ha! River, sediment and debris eroded by floodwaters upstream were carried out onto and aggraded the tidal flats (foreground), greatly increasing the subaerial extent of the flats, especially at low tide. As a striking example of the power of this flood, a bank located at the river mouth within the city of La Baie was destroyed during the flood and its 35 tonne safe was carried about 300 m out onto the tidal flats (Plan, 1996). The safe was located about three weeks later. Photograph taken on July 25, 1996. (GSC 1998-015G)

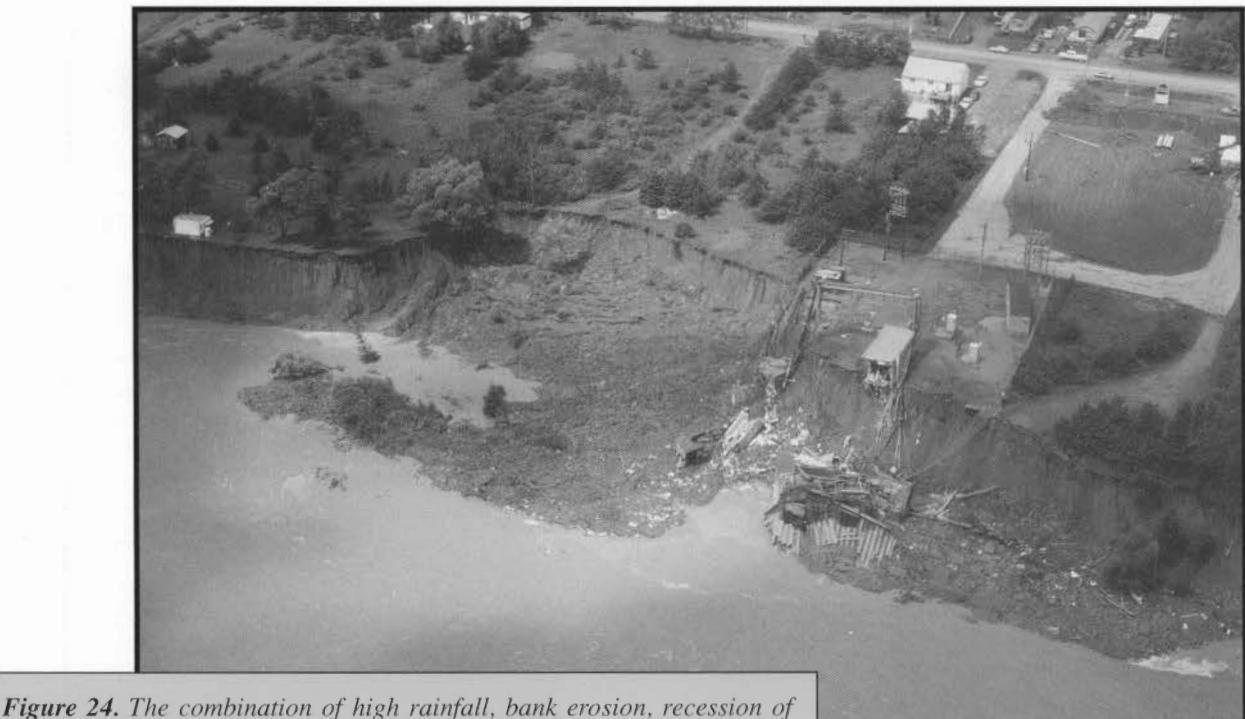
Figure 24. The combination of high rainfall, bank erosion, recession of flood levels, and drainage of reservoirs creates conditions conducive to landsliding along riverbanks. Although easily overlooked because of the widespread extent of other flood damage and geomorphic change, a number of small landslides occurred along the banks of the five rivers mentioned in this report. One of the larger failures was this retrogressive slide that occurred along the left bank of the Chicoutimi River within the reach formerly covered by the reservoir of the Pont-Arnaud dam. It occurred in fine-grained marine deposits in response to deepening of the channel bed and oversteepening of the bank by local river incision, and the drawdown of the reservoir. Photograph taken on July 26, 1996. (GSC 1997-42R)
