THE STABILITY OF SLOPES IN OPEN PITS

D. F. COATES

Preprint No. 42 of the Eighth Commonwealth Mining and Metallurgical Congress Australia and New Zealand - 1965 13th Technical Session

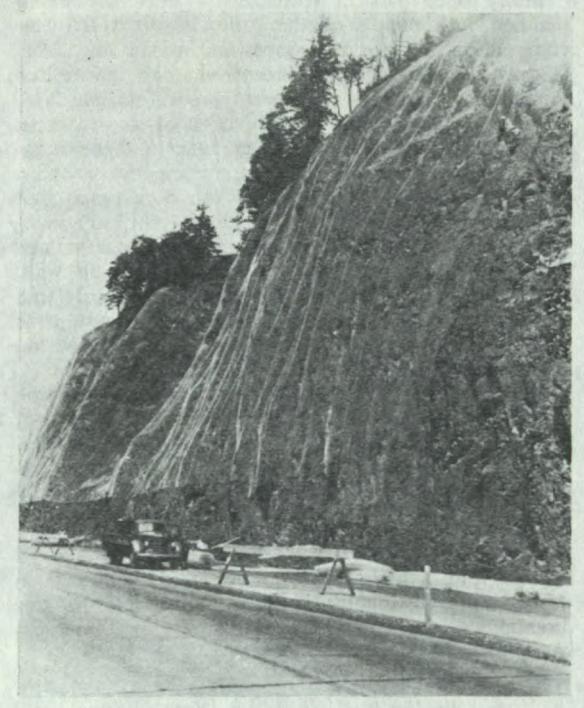
FIG. 4-Controlling rock falls with wire mesh.

it has been found to be preferable to pin the mesh only at the top, otherwise loose rock can develop and be temporarily retained until the load becomes excessive; then the mesh will fail and spill the accumulated rock down the slope.

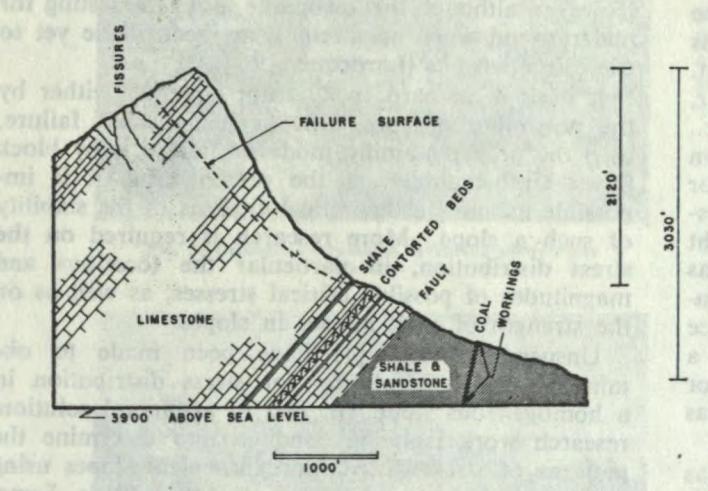
FIG. 5-The Frank Slide, Alberta, Canada.

An example of a probable block flow failure is provided by the Frank Slide in Alberta, Canada, where 80,000,000 tons of rock flowed as a fluidized mass two and a half miles in less than 100 sec. (Anon., 1912). Eye witnesses described the movement of the mass as being like a viscous fluid. The blocks varied in size from powder up to 40 ft with the common size being between 3 ft and 20 ft.

The geometry of the slope at the Frank Slide is shown in Fig. 5. The rock was a strong limestone with some layers of shale, sandstone and coal at the toe. The maximum slope angle was 53° with a height of 2,100 ft. The limestone dipped 49° into the slope and contained a well developed family of joints. The outline of the failed mass is also shown in Fig. 5.

Several factors combined either to increase the shear stresses or to decrease the shear strength of the mass so that failure occurred. First, the temperatures during the days preceding the failure varied from 70° F. during the day to 0° F. during the night causing melting of the surface snow in the day and freezing of the resulting water in the cracks at night. Second, ground water seepage added to the normal shear stresses. Third, compressible layers of shales and sandstones below the limestone at the toe of the slope probably aggravated the stress distribution. Fourth, underground workings in the toe area added to this affect. Fifth, earthquakes that occurred during the preceding months could have marginally affected the strength of the rock mass.

Failure in the toe zone must have started at least seven months' before the actual slide, as the coal in the underground workings had been breaking itself during this period of time. The excavation of the coal can be thought of as artificially decreasing the average strength and increasing the compressibility of the toe material so that failure would be initiated and ultimately would progress throughout the slope. The slide zone coincided exactly with the length of the workings along the toe of the mountain.

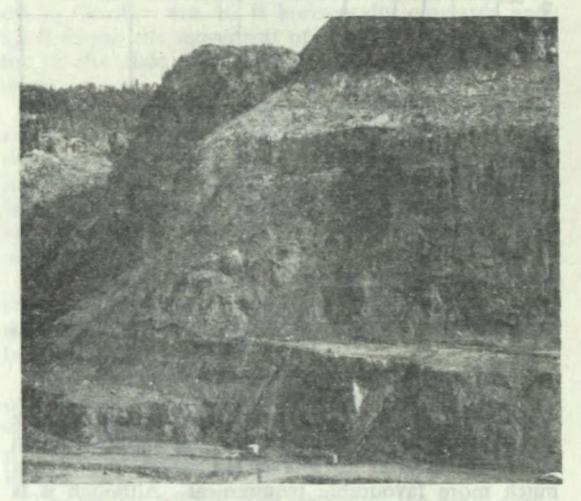
FIG. 7-A slide in a 215 foot high wall in soft rock.

soft rock. Fig. 7 is a photo of one of these slides. The angle of internal friction of this material was 37° , and it was assumed that the ground water level was equal to 50 per cent. of the height of the slope. If the more probable situation, that the ground water level had been close to the surface of the slope, is assumed for Slide No. 7, the average cohesion of this soft rock would be analysed to be 1,000 lb./sq. ft or 7.6 lb./sq. in. This was very close to the results obtained from laboratory testing.

It should be noted that for these nine slides the standard deviation of the cohesion is 240 lb./sq. ft, and the coefficient of variation is 22 per cent. From this it follows that 50 per cent. of the ground would have cohesions less than 7.6 lb./sq. in., and from statistical calculations it can be shown that one-third of the ground would have cohesions less than 78 per cent. of 7.6 lb./sq. in., or 5.9 lb./sq. in. Thus, to eliminate slides in this rock, slope angles considerably iess than those determined from the average strength would be required.

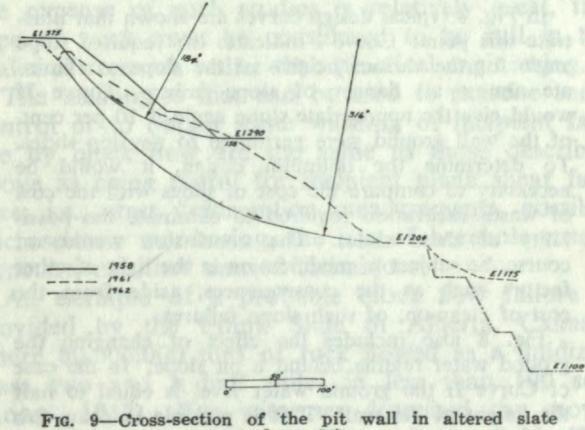
FIG. 9-Cross-section of the pit wall in altered slate and quartzite.

the ore. The ground consisted of a weak, altered slate and quartzite, which was massive and layered with beds dipping into the pit at angles between 40° and 75° .

In 1958 when the crest of the slope was at El. 375 and the bottom of the pit was at El. 290, a rotational shear slide occurred that caused the crest of the wall to move down some 9 ft and out 4 ft. The radius of the circle of failure was about 184 ft. The toe of the slide was subsequently cleaned up when excavating for the ramp that was required for the mining to proceed down to lower levels.

the toe at El. 175 with the ramp at El. 204. The movement of the wall was measured on several hubs placed on the surface of the ground. From this information it was deduced that the radius of movement was about 316 ft as shown in Fig. 9. The slide encroached on the ramp at El. 204, but the waste material only had to be dug out twice to permit mining to proceed.

The maximum hub movement, which was measured close to the crest, during the period from August to October was 16 ft horizontally outwards and 15 ft down; the movement of the hub closest to the toe of the slide moved 12 ft horizontally and 3 ft down.

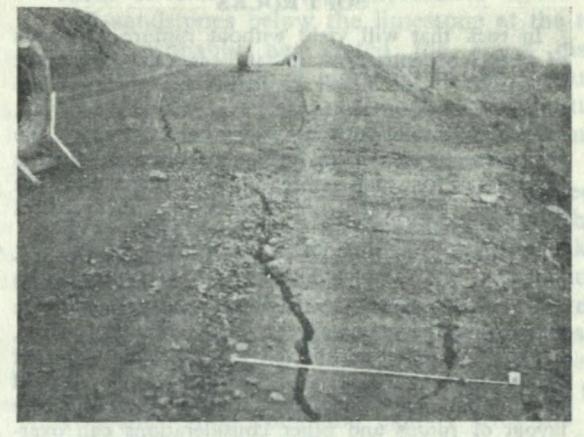
FIG. 10-Tension cracks appearing in the crest of the wall in Fig. 8, July 1961.

In July 1961 with the toe at El. 204, new cracks opened up in the crest of the wall. For a period of about two months the crest moved at the rate of about 5 in. per week outwards and 1 in. downwards. No slide occurred, nor was there any evidence of movement in the toe zone.

Fig. 10 shows the appearance of some of the cracks in the crest during July 1961. Fig. 11 shows the appearance of a small slide in the same wall just beside the main slide zone that occurred during July 1961. The movement of this small slide during its active period was at the rate of about 5 ft per month.

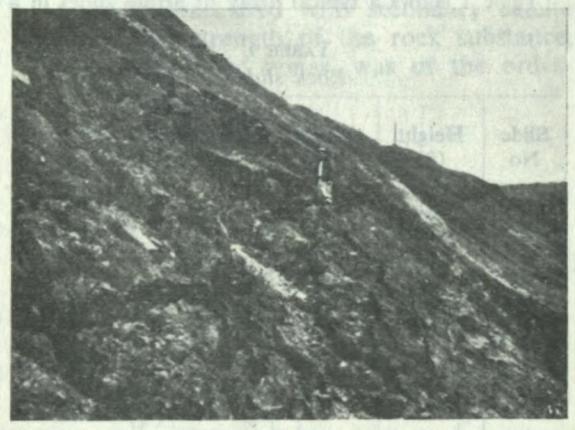
FIG. 11—A small slide in the same wall adjacent to the main slide zone, July 1961.

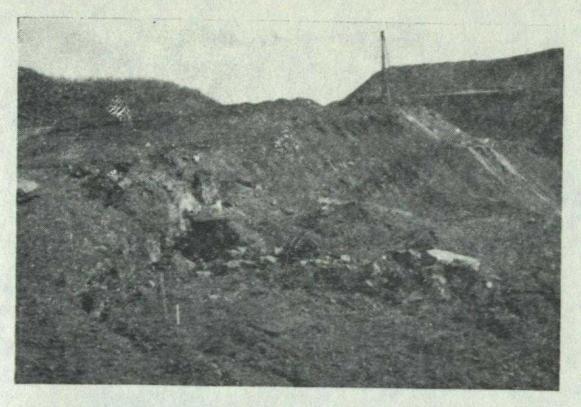
FIG. 12—The deterioration of the crest of the slope of Fig. 8, July 1962.

Fig. 12 shows the deterioration of the ground at the crest of the slope during July 1962. Fig. 13 shows the continuing cracking at the crest during September 1962.

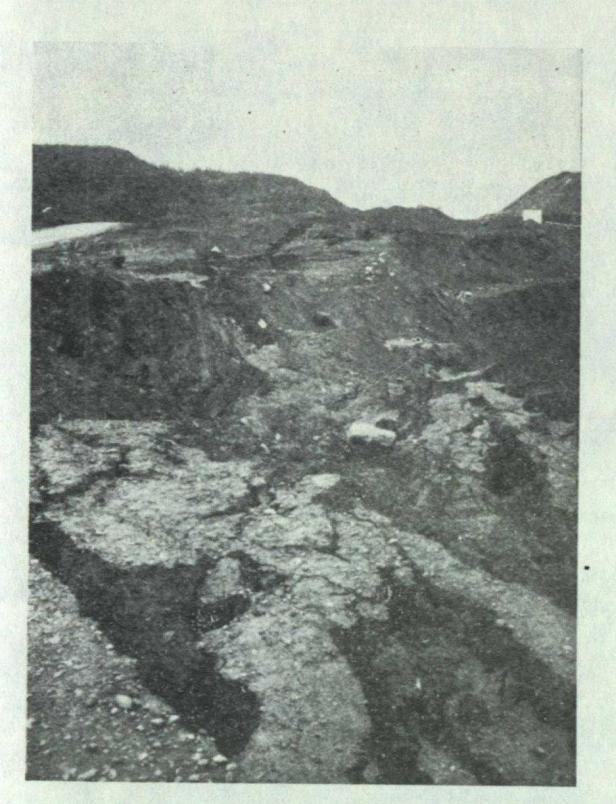
FIG. 13—The continuing cracking in the same crest, September 1962.
