Investigation No. 896.

Report on a Military Truck Hub, for D.C.I.A.(G), Department of National Defence, Ottawa.

September 19th, 1940.

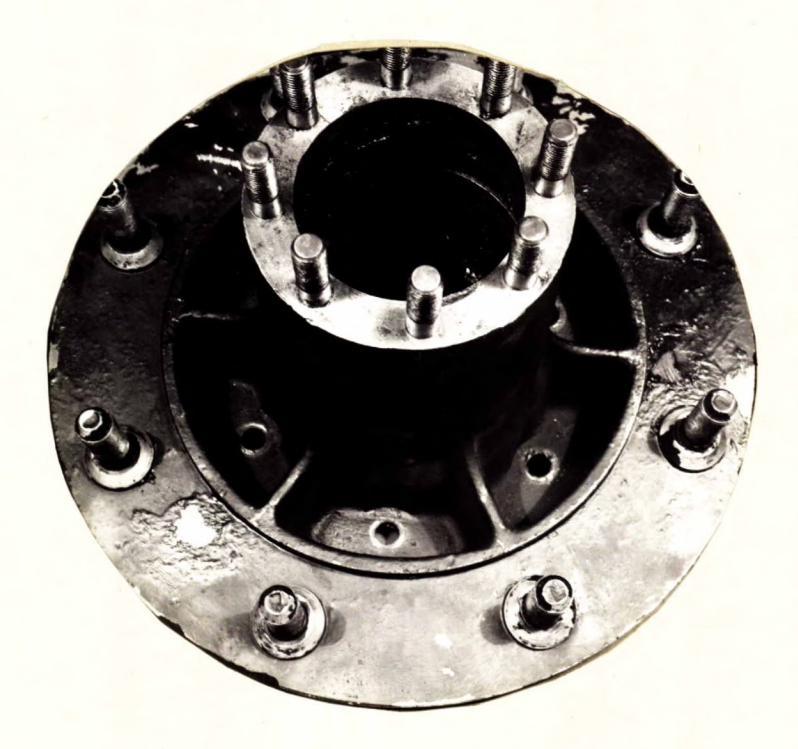
Figure 1.

Some of the radial ribs were cracked at the point where they joined the bowl section.

Casting as received.

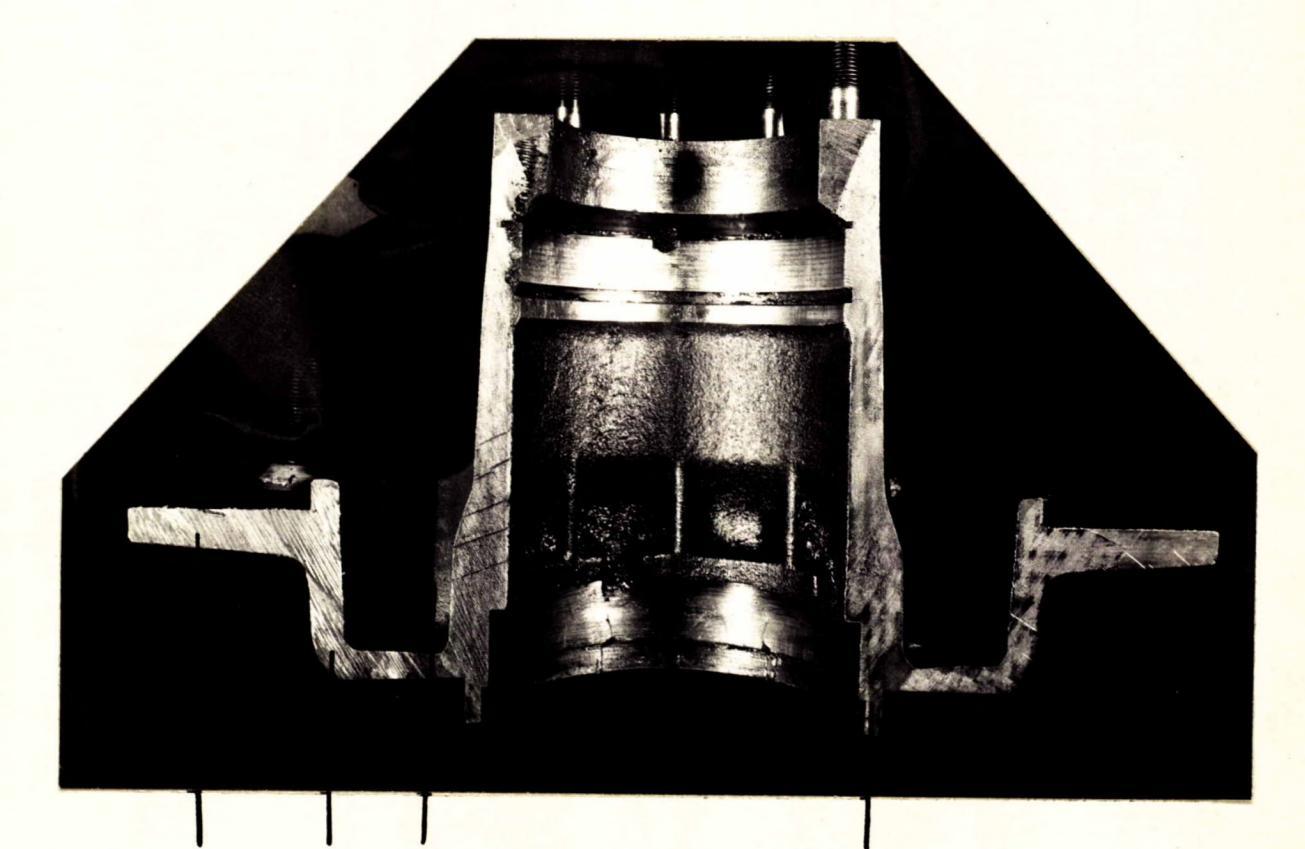
# Figure 2.

Casting as received.

Cross-section showing:

- (a) Hub.
- (b) Radial rib.
- (c) Bowl.
- (d) Disk.

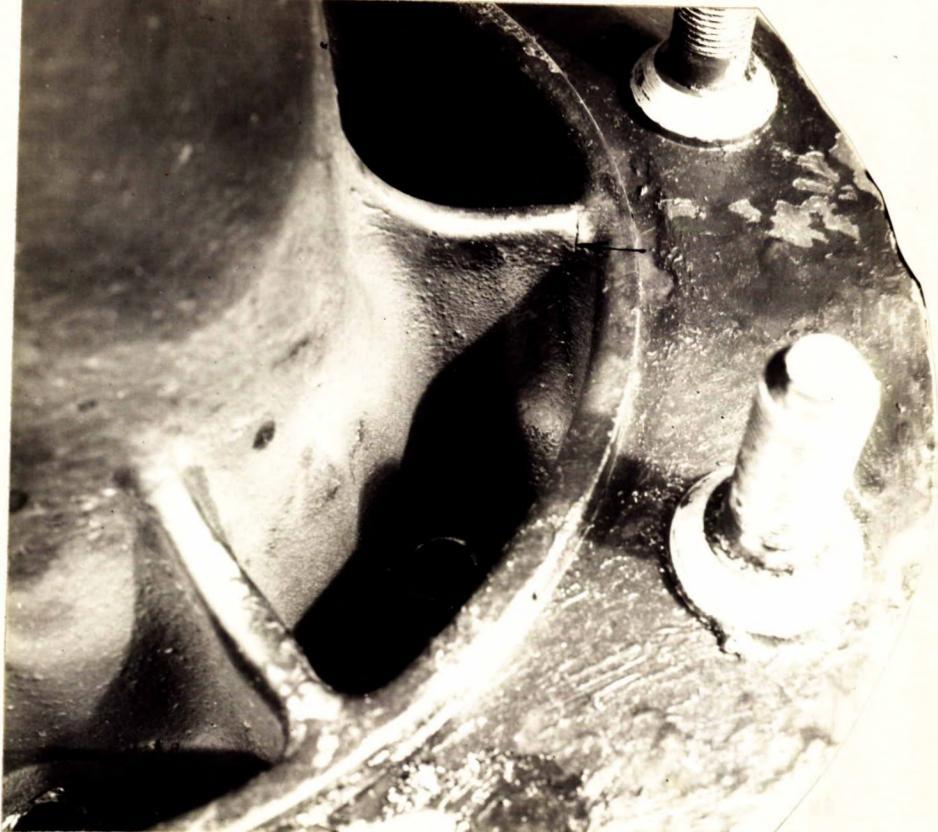
Casting as received, showing cracked radial rib.

On further examination it was found that the crack shown in Figure 3 was 2 inches deep and paint was found in the fracture.

It is obvious that the cracks occurred where a thin section joined a heavy section in the casting. Apparently the radial rib solidified before the bowl and disk section. The difference in contraction rates between the rib and the bowl set up forces which were great enough to crack the casting. In order to eliminate this difficulty, foundry practice must be altered in one or more of the following ways:

- (A) Change the casting design so that the ribs are thicker.
- (B) Cast "cracking strips" to strengthen the casting when hot. These strips or fins are removed before the casting leaves the foundry.

- (C) Leave the casting in the sand longer before shaking out.
- (D) Use a cooling oven to allow the castings to cool slowly to room temperature.
- (E) Maintain hot strength of cores and moulding sand as low as possible.
- (F) Distribute chills around the casting so as to obtain more uniform cooling.
- (G) Gate the casting so that the distribution of heat throughout the casting will result in more uniform cooling.
- (H) Pouring temperature and pouring time should be adjusted so as to get the minimum scrap.

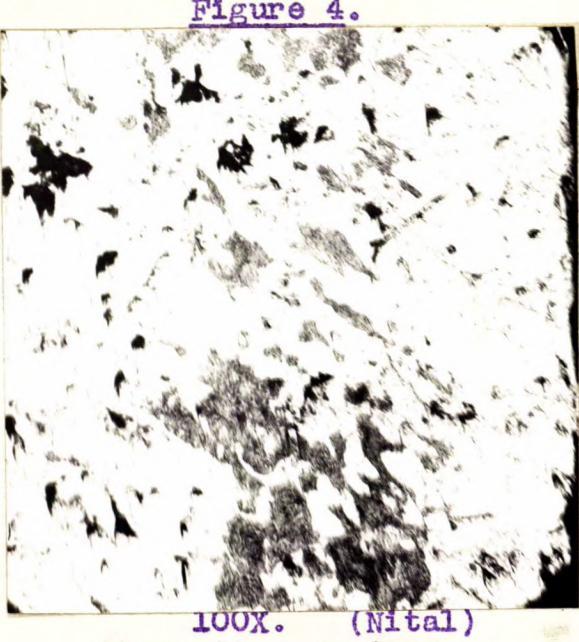
At casting surface.

A pearlite rim about 0.010 inch deep is found beneath the surface decarburized layer of 0.007 inch thickness. (See Figure 4). No primary graphite is present.

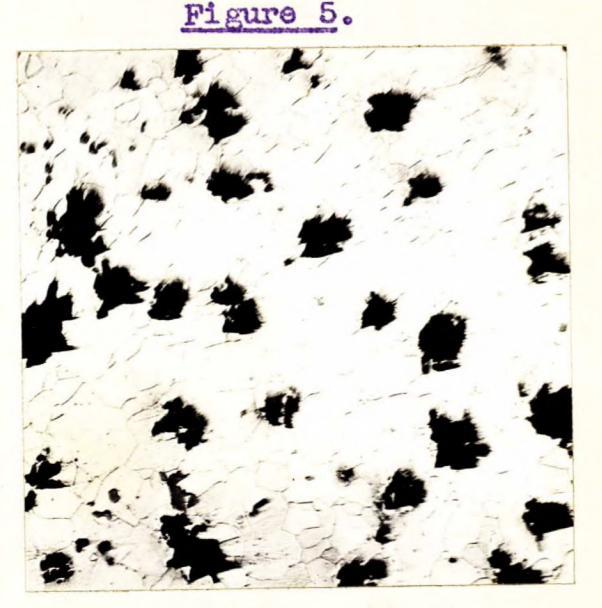
100X. (Nital) Centre of casting.

Figure 5 shows the distribution of graphite nodules (black) in a matrix of free ferrite (white). The above are all indicative of fairly good quality malleable iron.

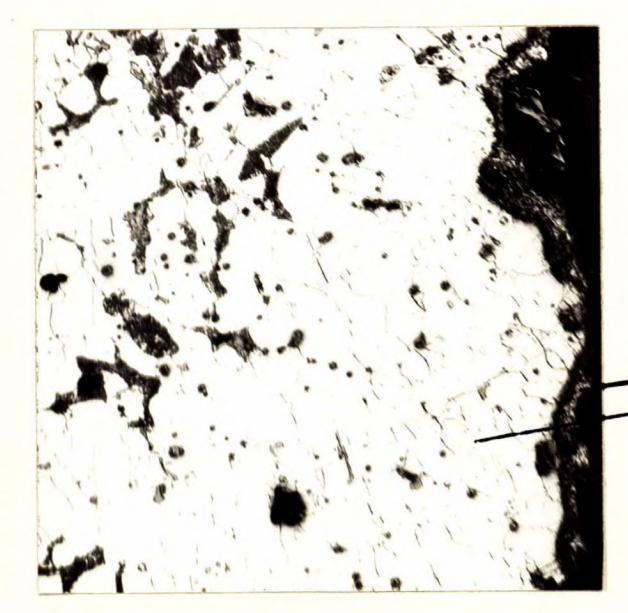
#### Figure 6.

100X. (Nital) At edge of fracture, showing: Paint. (a)Decarburization.

The fractured surfaces were decarburized during

annealing and then painted over in the final assembly.
