September 20th, 1941.

## ORE DRESSING AND METALLURGICAL LABORATORIES.

Investigation No. 1094,

Examination of Superheater Steel Tubes For Class "C"  ${\rm D}_{\odot}{\rm stroyers}$  .

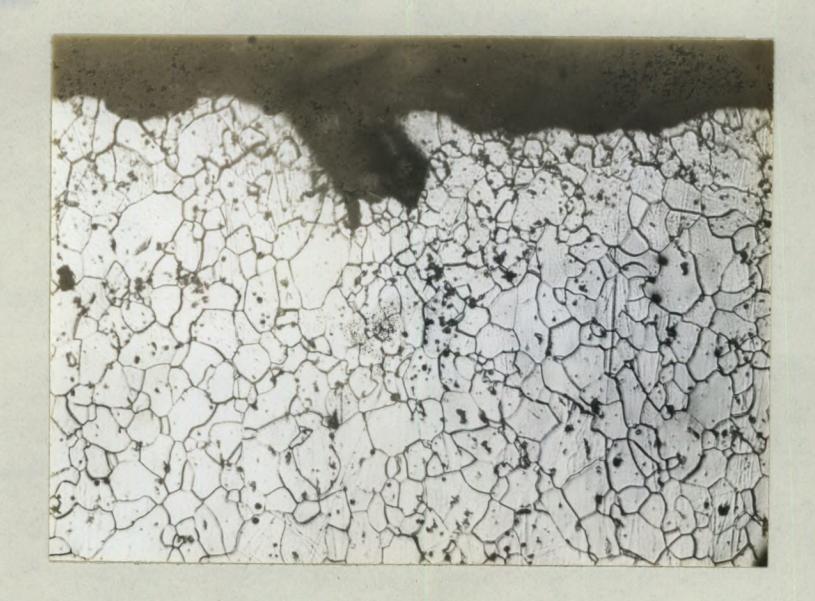
## Figure 1.

Samples cut transversely and longitudinally from each tube were mounted in bakelite and given a metallographic polish. Both steels were etched in a solution of 2 per cent nitric acid in alcohol. Figures 1 and 2 are photomicrographs, at X200 magnification, of Tubes Nos. 1 and 2 respectively. The structure of both steels consists of small ferrite grains and small areas of pearlite. The photomicrographs show the relative surface condition of the two samples.

The surface of Tube No. 1 was rougher than that of Tube No. 2. These surface conditions are illustrated in Figures 1 and 2, photomicrographs of Tubes Nos. 1 and 2 respectively. The structure of both steels is normal for low carbon steels.

The surface imperfections of Tubing No. 1 may be due to rolled-in scale or to faults in the die. The apparent failure of the steel to pass the temper test indicates that the steel may be defective. Additional tests would have to be made to substantiate this.

# X100, etched in 2 per cent nital. TUBING NO. 1.

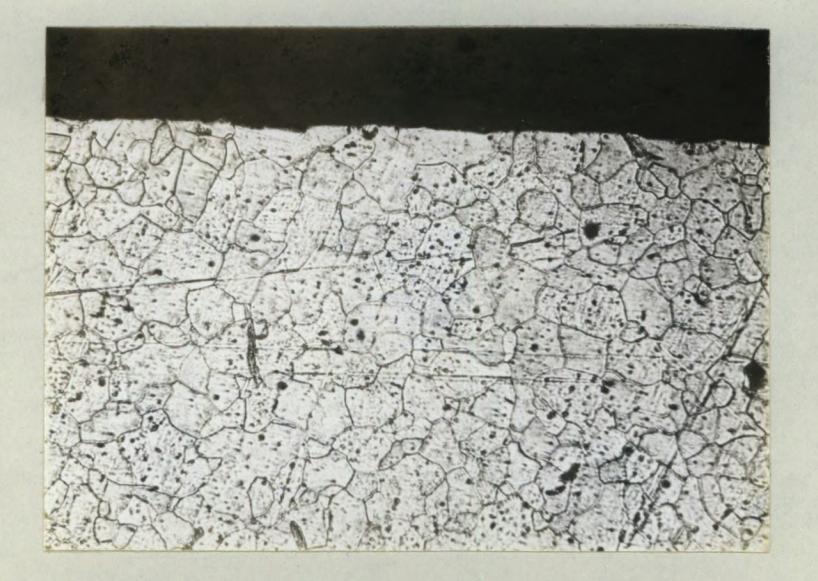
## Figure 2.

X100, etched in 2 per cent nital.

TUBING NO. 2.
