ORE DRESSING AND METALLURGICAL LABORATORIES.

Investigation No. 1258.

Examination of Two Attachment Nuts from a Kittyhawk Oleo Leg.

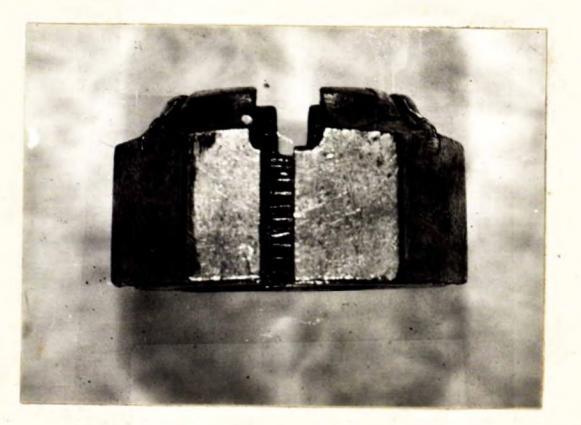
Figure 2.

On June 6th, 1942, Squadron Leader A. L. Smith, of the Department of National Defence (Air Service), Ottawa, Ontario, delivered to our laboratories two attachment nuts from a Kittyhawk Oleo leg. One nut was split and the threads were badly mutilated. This is illustrated in Figures 1 and 2.

The wide spread of the split in the fractured nut could only be explained by assuming that the nut had been forced open after actual fracture, very likely by the same forces that caused the failure.

Photograph of broken Oleo nut, showing mutilated threads.

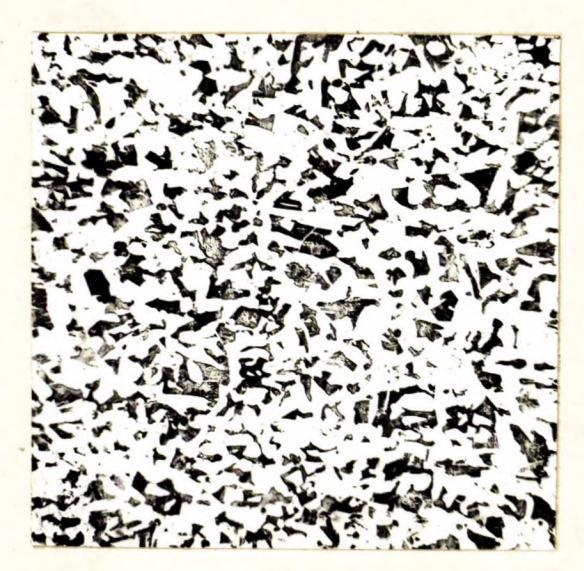
Figure 3.

The microstructure, as shown in Figure 3 (at 100 diameters), is normal for a medium carbon steel that has been air-cooled from some temperature not far above the upper critical.

The mut that failed appeared to have been fabricated in the normal manner from steel of a good quality. The structure is characteristic of that obtained by air cooling from above the critical temperature, which is a normal structure for hot rolled steel.

Photomicrograph showing structure of steel in broken nut.

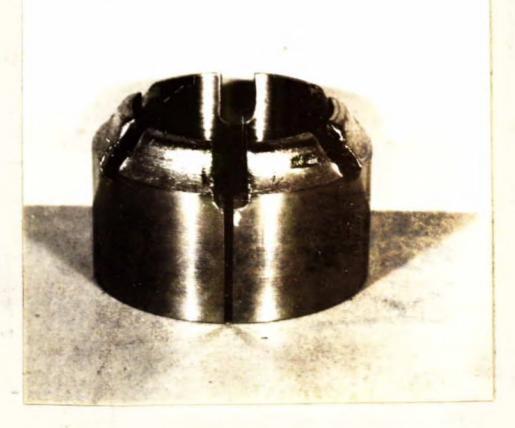
The unbroken nut was taken to the National Research Council gauge laboratory. There it was machined into a ring and slit as shown in Figure 4.

By substituting these values in the above equation, it is found that the residual tensile stresses in the ring machined from the aut are in the order of 8,200 pounds per square inch.

The intensity of the residual stresses found in the other nut is not too high. Stresses of this order may be considered normal.

Photograph of ring machined out of the unbroken nut and slit for determination of residual stresses. Actual size.
