OTTAWA December 30th, 1942.

ORE DRESSING AND METALLURGICAL LABORATORIES.

Investigation No. 1339.

Examination of Manganese Steel Crusher Jaw Plates from the Sorel Steel Foundries Limited, Sorel, Quebec.

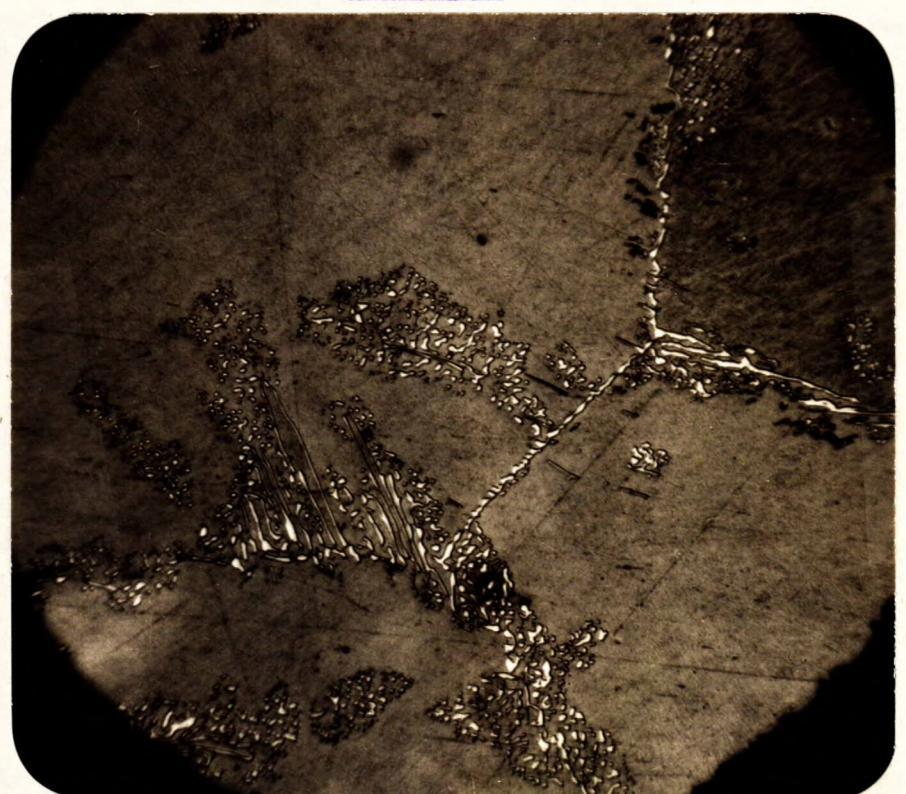
Figure 2.

Wal redained leeds esencenes to not the plates was polished obcourded the plates was polished bedown level the plates was polished bedown level the plates was polished bedown level the plates was polished obcourd the second the second the second as a network around the grain boundaries. This is illustrated in Figures 1 and 2.

The greatest single cause of failure is certainly the large amount of free carbide present, because manganese steel develops its well-known toughness only when all the carbon is in solution.

X1000, nital stch. "20 x 10" CRUSHER JAW PLATE.

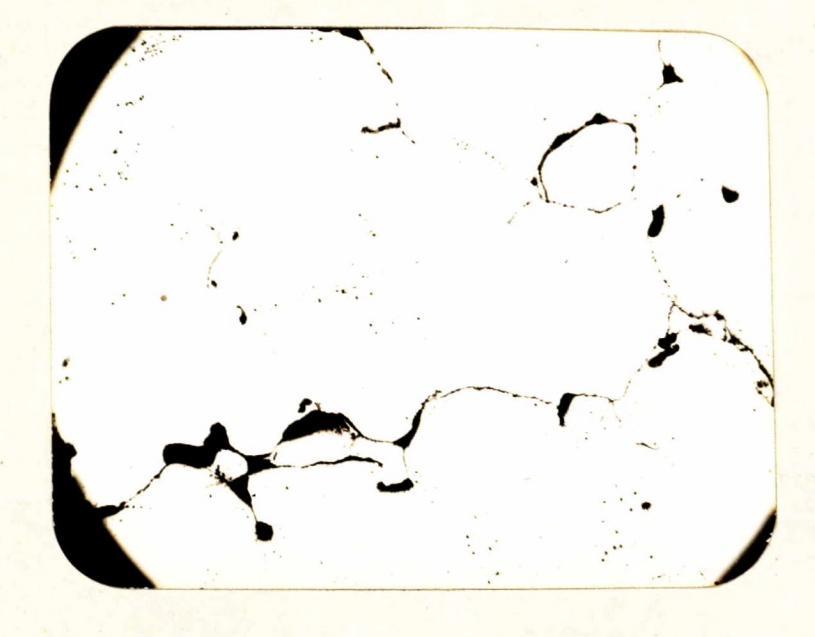
Figure 3.

Many globular inclusions, thought to be oxide, were discovered in both samples. The largest, found in the "20 x 10" plate, was approximately 0.018 inch in diameter. A shrinkage cavity discovered in the "20 x 10" plate is shown, was noted to be a state of the state

The porosity in the plates was caused by faulty casting technique. These pores would weaken the parts and for this reason may have contributed to their failure. The globular inclusions and the small shrink present in the castings are defects of minor importance.

X100, unetched: SHRINK IN "20 x 10" PLATE.
