ORE DRESSING AND METALLURGICAL LABORATORIES.

Investigation No. 1440.

Examination of Buckled and Distorted Boiler Tubing.

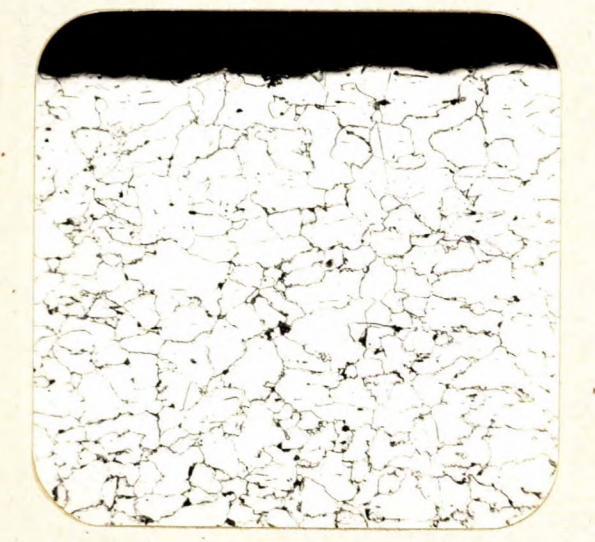
Specimens were removed from the buckled and distorted parts of the tube and polished on faces parallel to the long axis of the tubing. The structure of the steel in one of these areas is given in Figure 1. The duplex grain network observed - Page 3 -

in the ferrite is generally considered to be a gamma network superimposed on the alpha grains. According to work of Rawdon and Berglund⁴ it has little or no effect on mechanical properties. This gamma network is not nearly so noticeable in other samples of tubing in the lot submitted. The particular specimen photographed has its carbide constituent present both as pearlite and as globules along the grain boundaries, while in others the visible carbide is present as pearlite. The steel in the tubing was found to be quite clean.

X100, nital etch.

LONGITUDINAL SECTION FROM ONE OF THE BUCKLED AREAS.
