Examination of a Broken Main Inlet Copper Pipe.

Investigation No. 1456.

Examination of a Pitted Main Inlet Copper Pipe.

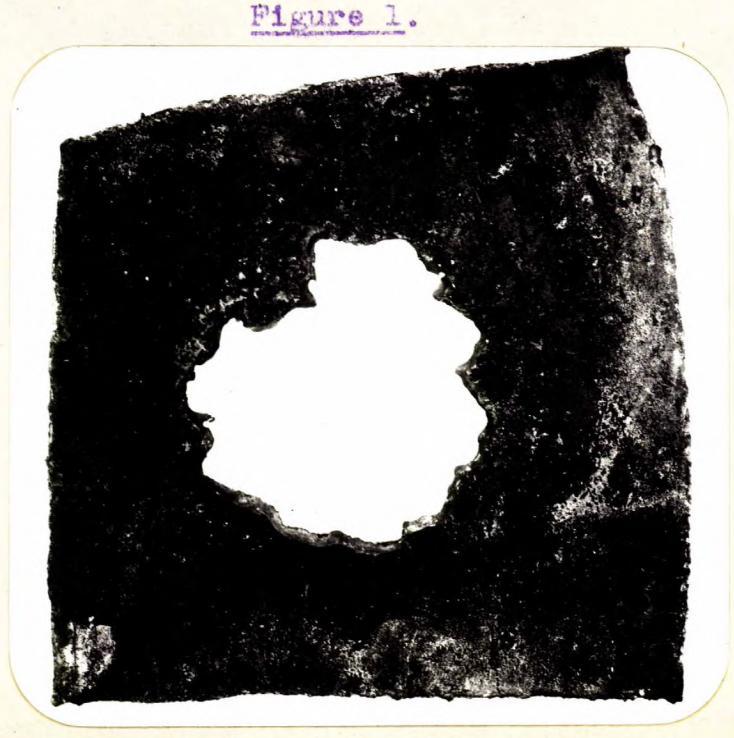
SAMPLE NO. 1. (Approximately 2 size).

Figures 1 to 3 show the samples "as received", revealing the cavitation caused by erosion and corrosion of the copper tube.

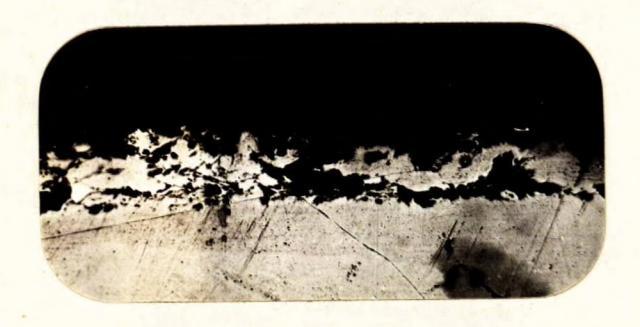
Figure 4.

Figures 4 to 6 show different stages of surface pitting.

X100, unetched.

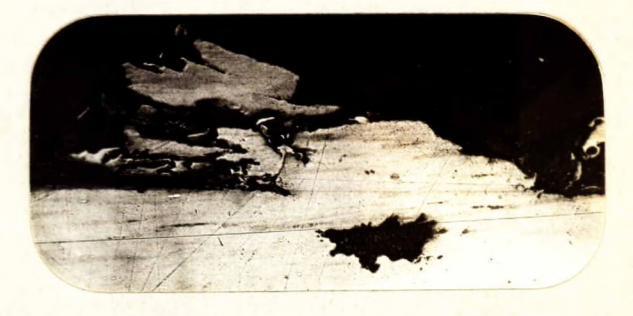
Figure 5.

X100, unetched.

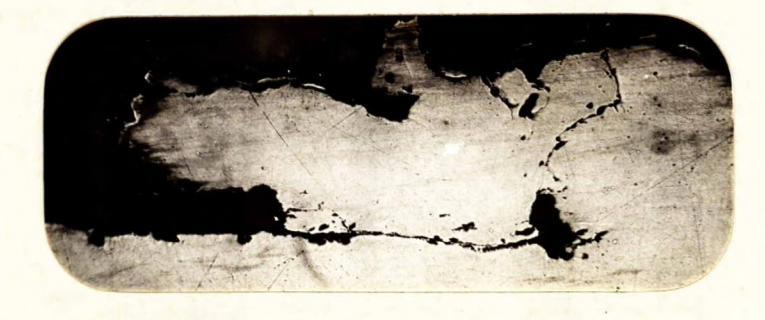
Figure 6.

X100, unetched.

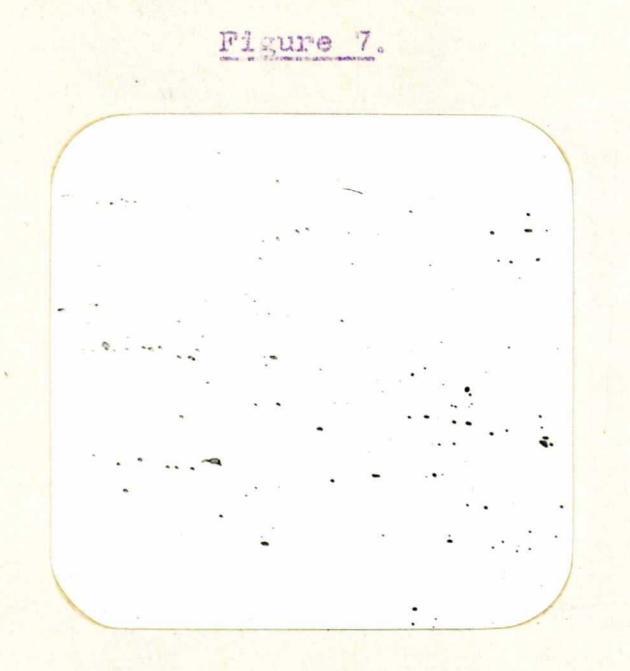
Figure 7 shows the copper oxide content, and Figure 8 the grain size, of a "sound" part of the copper tube.

X250, unetched.

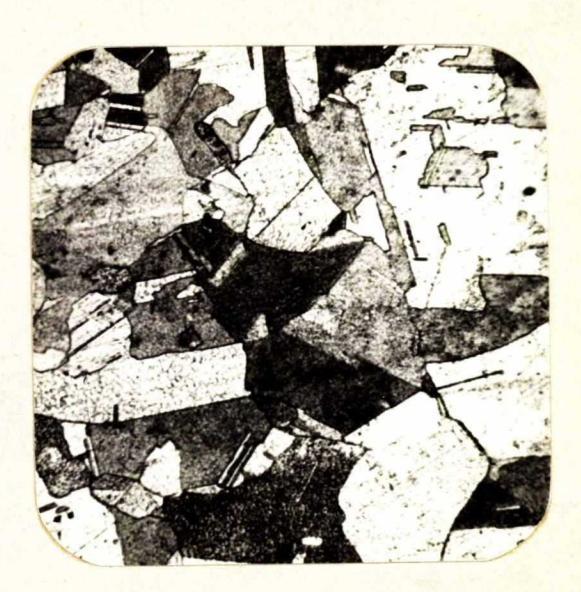
Figure 8.

The grain size shown in Figure 8, at X250 magnification, conforms to an average grain size equal to 0.045 mm. grain diameter at X75 magnification.

X250, FeCl Etch.
