REPORT

ORE DRESSING AND METALLURGICAL LABORATORIES .

Investigation No. 1471.

Examination of Defective Brass Rod and Primer Bodies,

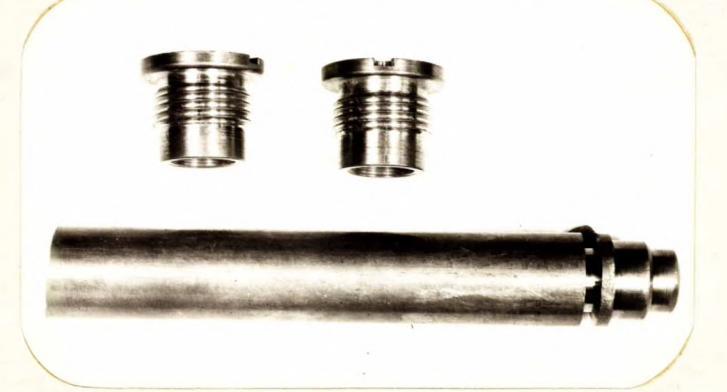
Figure 1.

Figure 1 shows the samples as received. The rod and both finished primers show longitudinal cracks.

SAMPLES AS RECEIVED. (Approximately ¹/₂ size).

The cracking of the submitted brass samples occurred as a result of "season cracking".

It seems to be advisable to introduce a mercurous nitrate test in the inspection of brass rods before release for the production of primers and similar machined components.

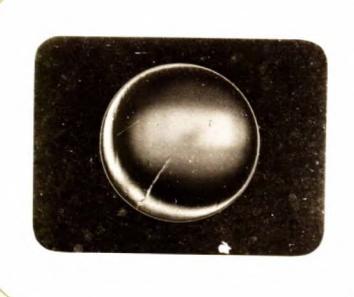
Figure 2.

Figure 2 shows the depth of the crack in the

brass rod.

CROSS-SECTION OF CRACKED ROD. (Approximately actual size).

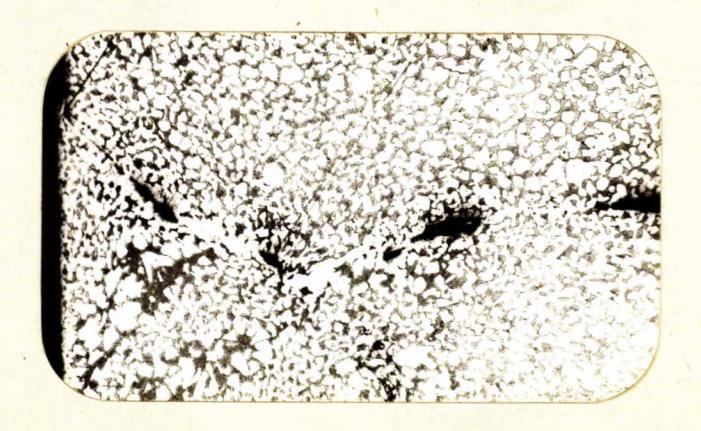
Figure 3.

Figure 3 shows the microstructure of the material around the crack.

X100, NH40H etch.

The appearance of the cracks on the submitted samples is typical of "season cracking". This phenomenon is a result of residual stresses in cold-worked material and is always accompanied by corrosion.

To avoid unnecessary machining costs of defective material and to ensure better quality of the product, it would be advisable to require an additional mercurous nitrate test on the brass rods before release for primer production.
