OTTAWA December 4th, 1943.

Investigation No. 1548.

Examination of Two Broken Piston Connecting Rods.

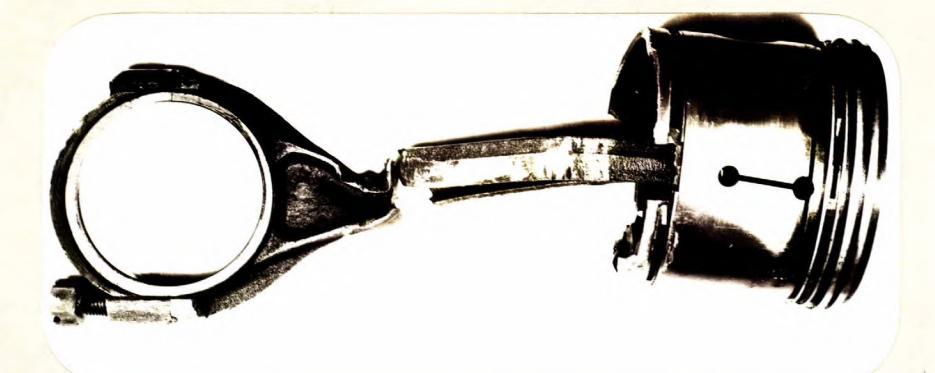
Figure 1.

One connecting rod was fractured into two pieces, while the other was broken into three parts. Figure 1 shows one of the connecting rods "as received".

The roughness of the surface indicated that the pieces had been shotblasted.

SHOWING A CONNECTING ROD AS RECEIVED.

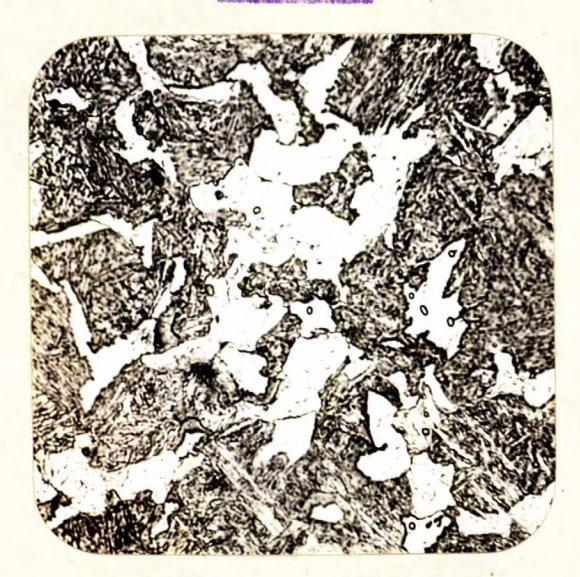
In the case of the softer connecting rod, the atructure consists of ferrite and tempered martensite, as shown in Figure 2.

The softer connecting rod has been quenched from a temperature well under the Ac3 point, as is shown by the composite structure, ferrite-tempered martensite. The harder connecting rod also shows ferrite, but both the mode of occurrence of this ferrite and its association with products of the Ar' range show that although the steel has reached the Ac3 point the velocity of cooling on quenching was too slow. Moreover, the steel was decarburized, and the considerable amount of ferrite present at the edge is especially objectionable.

X500, picral etch.

Parts, such as connecting rods, which require mostly fatigue strength should have a uniform structure, obtained by a proper quench-and-draw treatment. No decarburization should be present, in order to prevent the formation of ferrite (soft constituent, at which fatigue cracking might easily start).

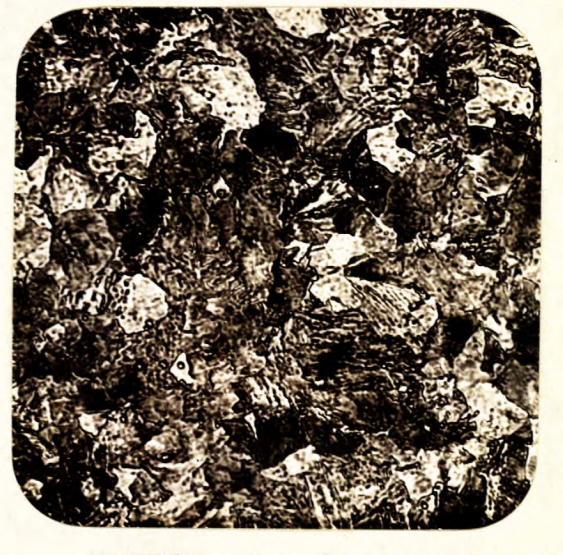
In the case of the harder connecting rod, no evidence of martensitic structure could be found and the transformation products are typical of those formed at the Ar' range of the "S" curve. Figure 3 shows the structure. Ferrite was found in a lamellar distribution in the centre of - Page 3 -

X500, picral etch.

SHOWING THE MICROSTRUCTURE OF THE HARDER CONNECTING ROD. Figure 4.

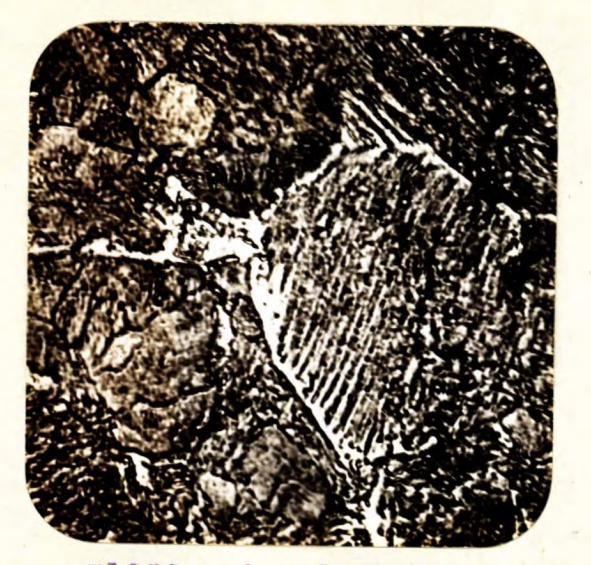
the specimens (c.f. Figure 4) and in larger patches at the edge (c.f. Figure 5). On the same specimen, bad surface irregularities were observed, as shown in Figure 6.

X1000, picral etch.

SHOWING MODE OF OCCURRENCE OF FERRITE IN THE HARDER AMOUNT OF FERRITE IN CONNECTING ROD (AWAY FROM EDGE). HARDER CONNECTING ROD.

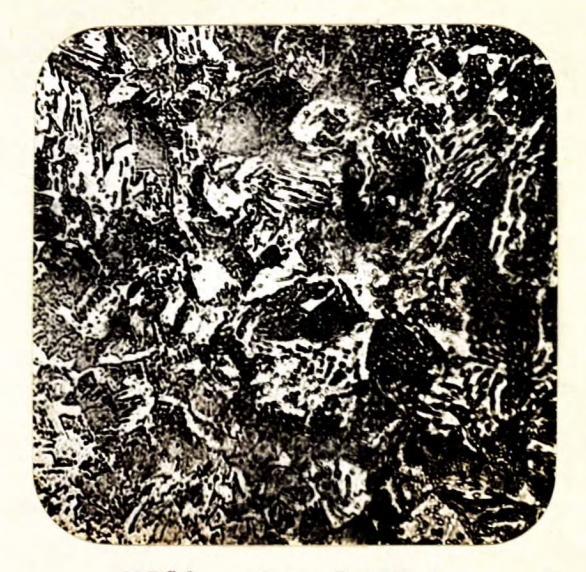
Figure 5.

X500, picral etch.

SHOWING CONSIDERABLE

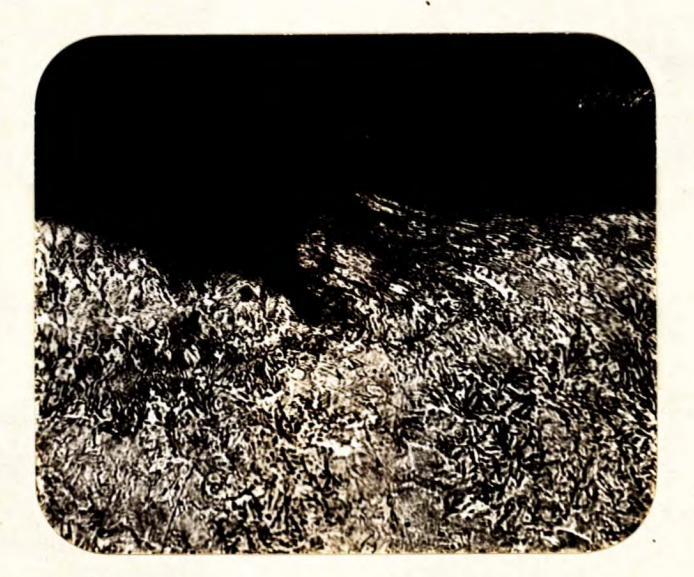
Figure 6.

The irregularities at the surface are also a possible cause of failure. As shown by the distortion along these irregularities, they have apparently been formed during the shotblasting operation. These irregularities are detrimental stress raisers in a part subjected to fatigue stressing.

A200, picral etch.

SHOWING SURFACE IRREGULARITIES IN HARDER COMMECTING ROD.

Note the distortion of metal.
