REPORT

ORE DRESSING AND METALLURGICAL LABORATORIES.

Investigation No. 1559.

Investigation of Universal Carrier Track Links and Pins After 4,913 Miles in Field Test.

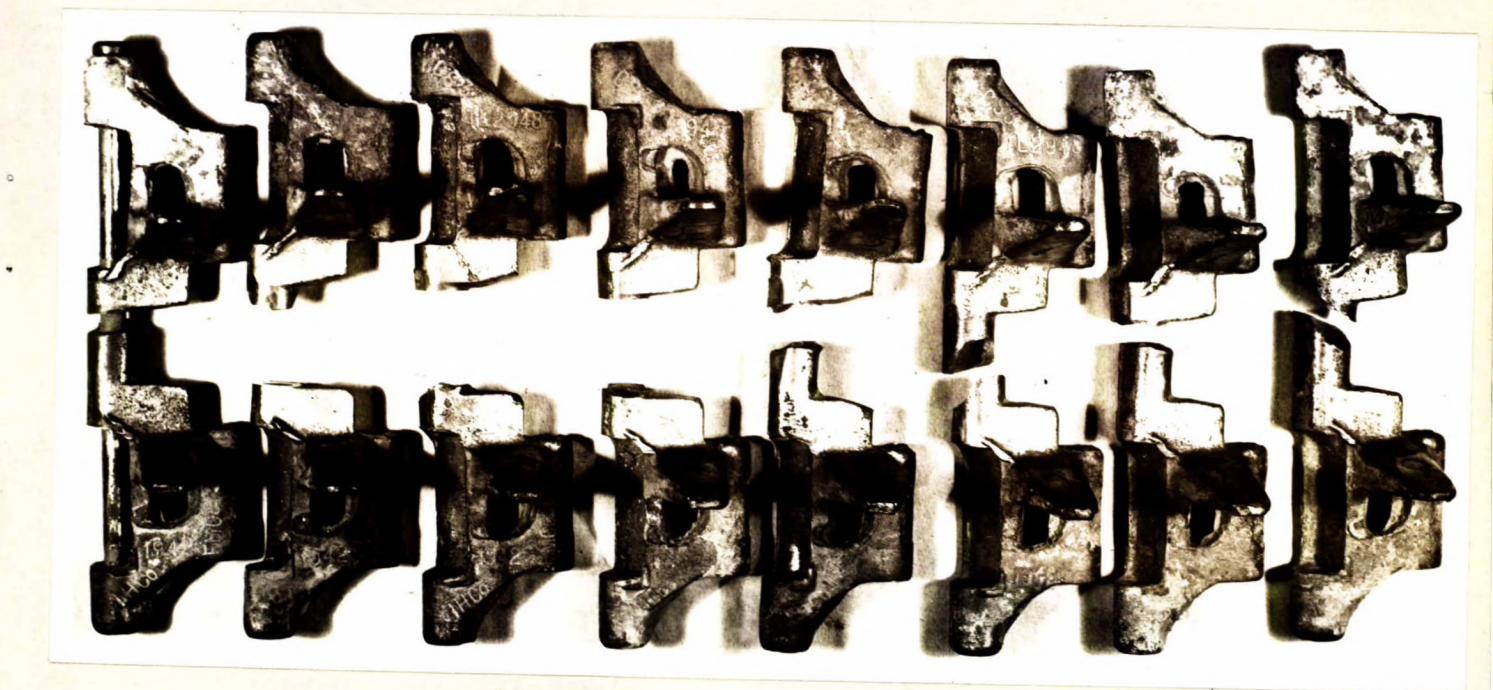
Figure 1.

LINKS AS RECEIVED.

Both types of links have failed at the same position across the centre of the barrel on the three-eys side. One link,

however, had the centre eye-hole wall worn to approximately 3/32 inch. The fracture of this link was fresh and non-duplex in character. Other link fractures were worn by service operation and showed very little that was of interest.

The non-duplex nature of the fracture on one of the specially treated links pointed to an impact failure. The condition of the other link fractures made it impossible to form any definite conclusions as to the mechanism of failure. These links apparently had been held together by gins and so operated after failure, this operation destroying any evidence that might be supplied by the fracture condition.

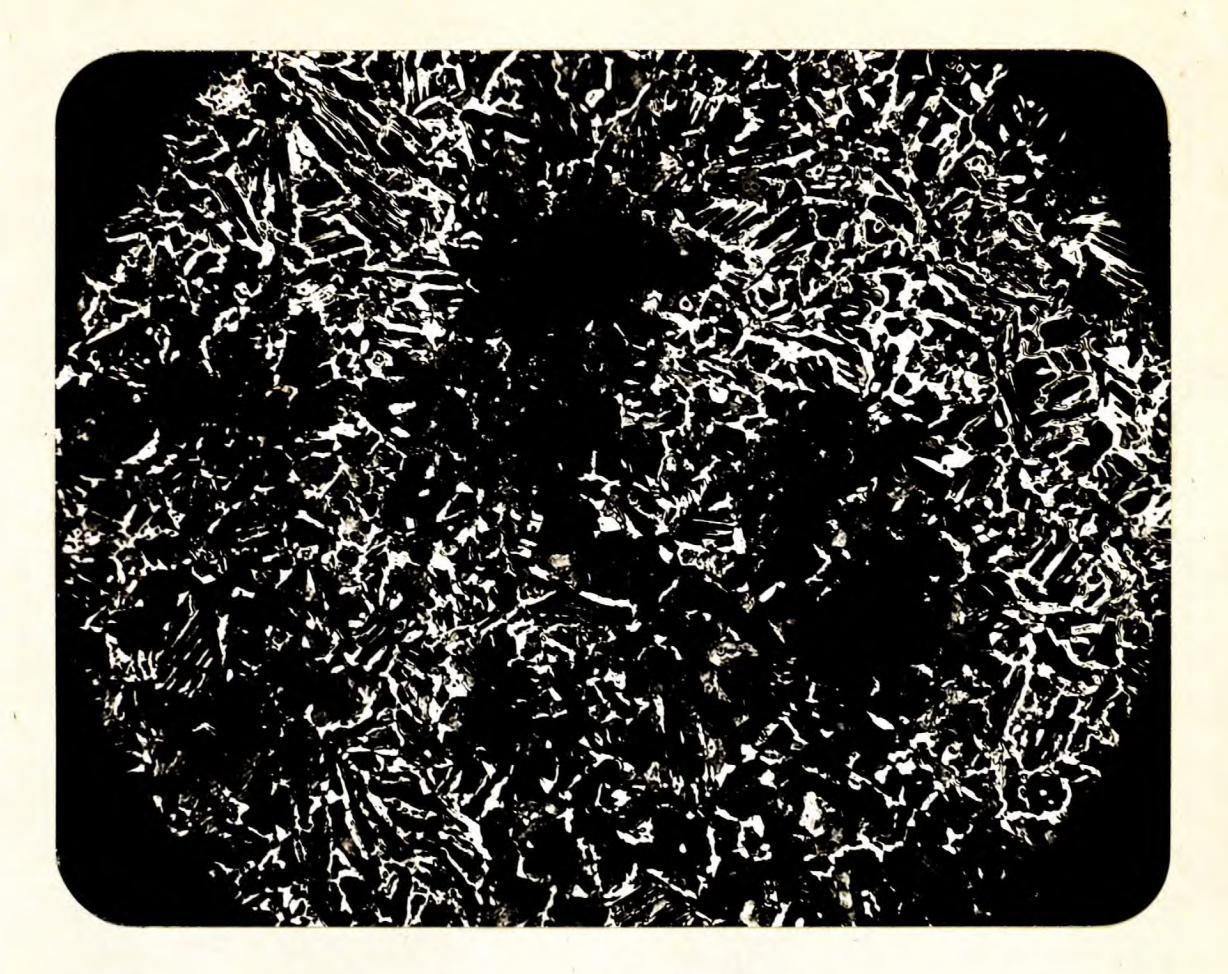
X250, nital etch. CENTRE OF GROUSER, SPECIALLY TREATED MALLEABLE LINK.

However, for the specially treated links no slow cooling, similar to the "dog-house" cooling of the standard malleable, follows the resoaking procedure. In the specially treated link, then, the presence of carbide definitely shows too fast cooling in the final stages of the anneal. Also, the absence of slow cooling of the core of the link accounts for the greater fineness of pearlite in the specially treated product (the final quenching of the standard malleable link only affecting the outer material).

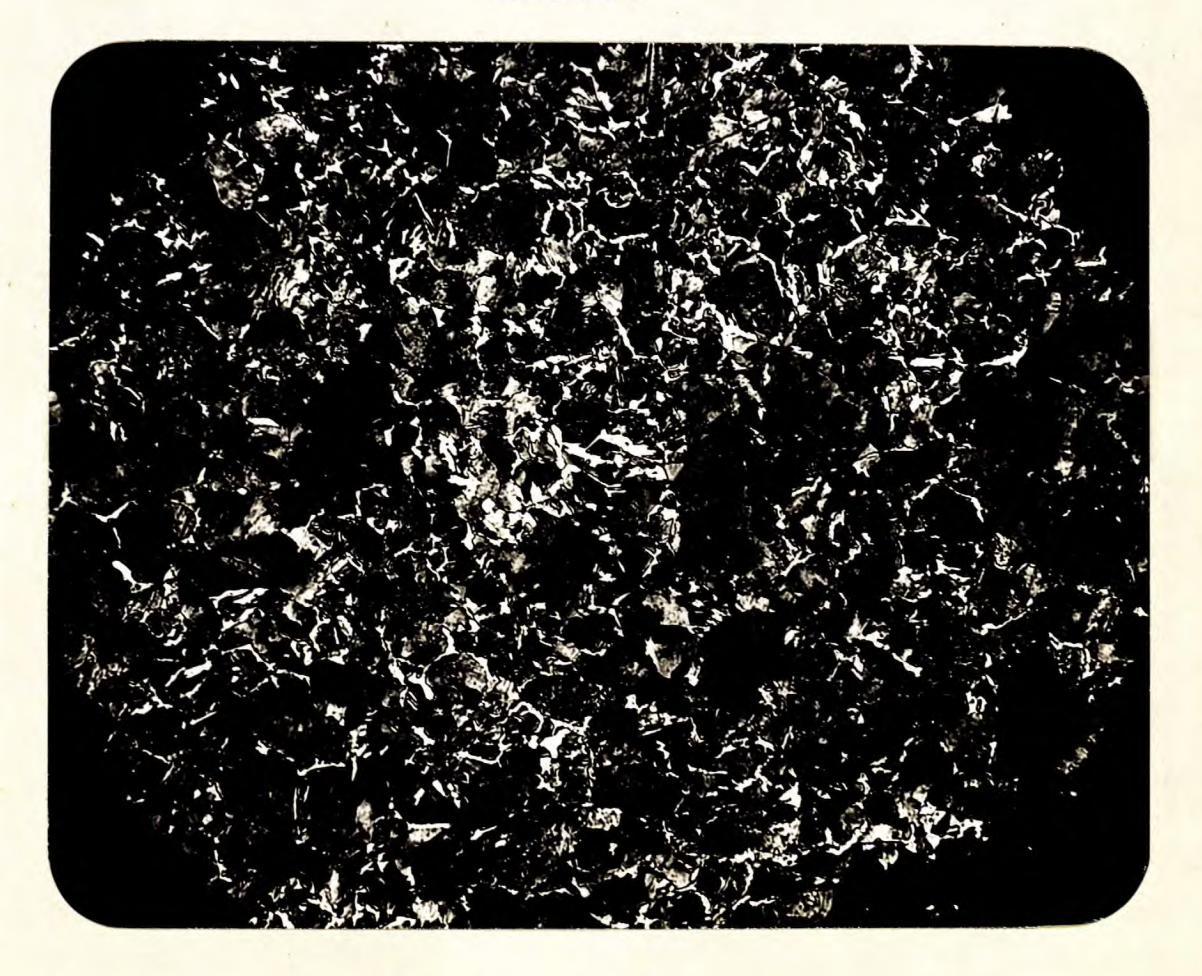
Figure 4.

X250, nital etch. CENTRE OF GROUSER, SPECIALLY TREATED MALLEABLE LINK. - Page 7 -

The presence of ferrite in the specially treated link definitely means that the material was given too short a soaking time in the final heat treatment.

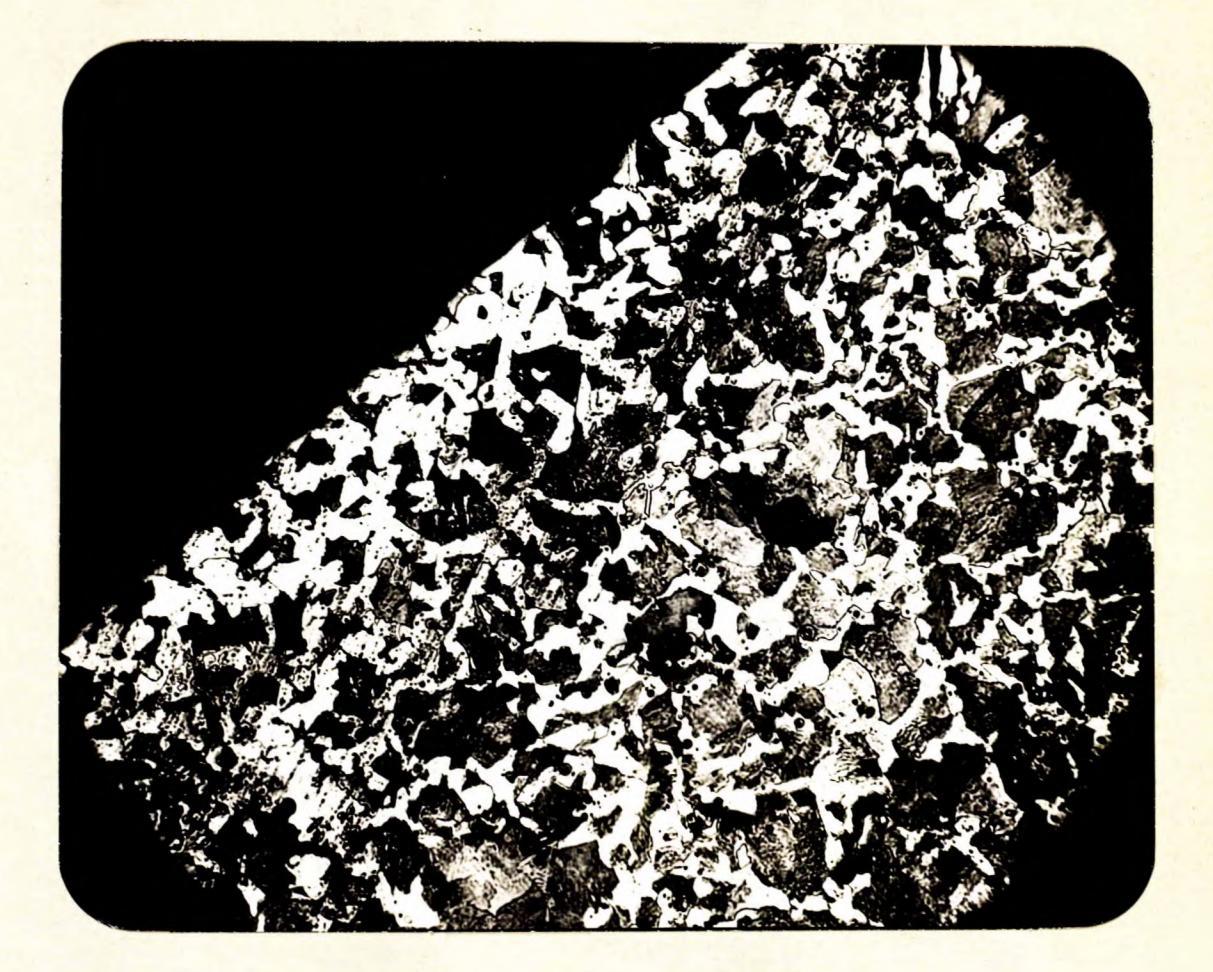
Figure 5.

X250, nital etch. EXE-HOLE SURFACE, STANDARD MALLEABLE LINK.

had been well worn off. Figure 5 indicates that for the standard malleable link, most of the ferrite layer (usually 0.015-0.030 inch) had also been eliminated.

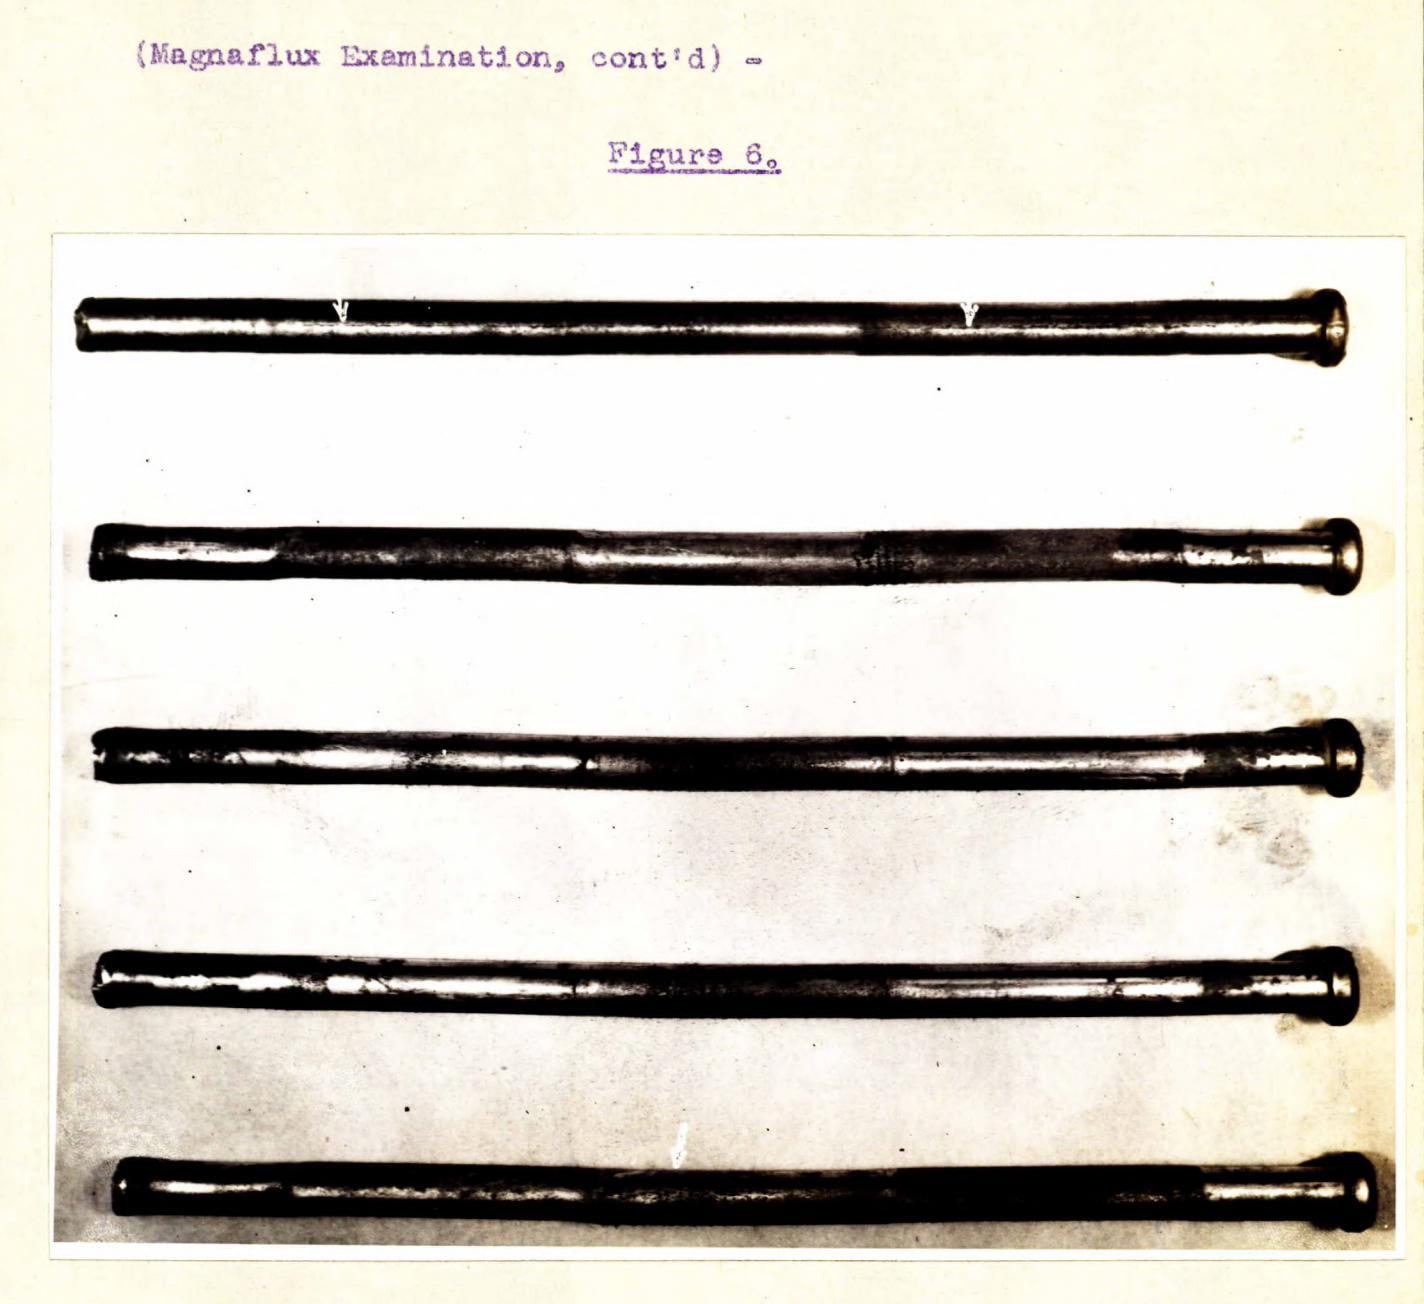
The pins were magnetized both longitudinally and transversely, using 1,050 amperes. Transverse surface cracks were observed in four of the pins. One pin had a longitudinal seam. This had been worn down so that it was approximately 0.003 inch in depth. Figure 6 illustrates the magnafluxed pins. The white arrows indicate the points at which cracks are observed.

MAGNAFLUXED PINS.

Four of the ten Acme pins examined by magnaflux showed cracks in the surface. These have been caused by bends in the pins, some well over 0.25 inch deflection. These pins were bent eitheriby the blow which finally broke the links or by having to carry the whole load after the links failed.

The Allied Products pin showed evidence of a longitudinal seam. It is of extreme interest that this pin lasted for 4,913 miles without breaking. It would appear that seamy stock is not critical, so long as the seam does not penetrate too deeply. If more pins can be found which show the existence of longitudinal seams, conclusions may be reached as to the depth of seam permissible in the bar stock used as carrier pins. The above-mentioned pin is the first of the seamed type that has come to our attention after having been in service.

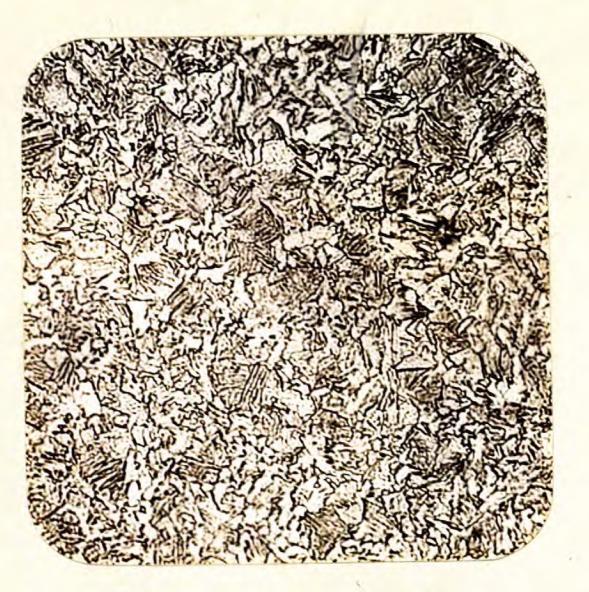
Figure 7.

X500, nital etch. CORE OF PIN NO. 2.

The cores consisted of low-carbon martensite and ferrite. The cases have been worn away considerably. The photomicrograph, however, taken at the surface of one of the Acme pins, reveals a tempered martensitic structure, tempering probably occurring in the preparation of the specimen.

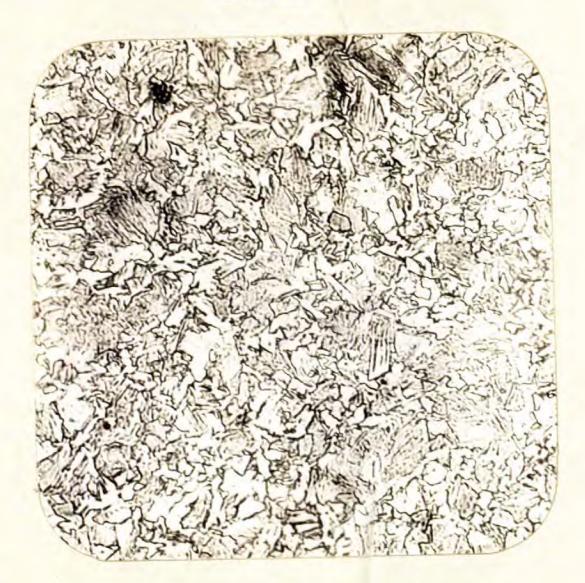
Figure 9.

X500, nital etch. CORE OF FIN NO. 9.

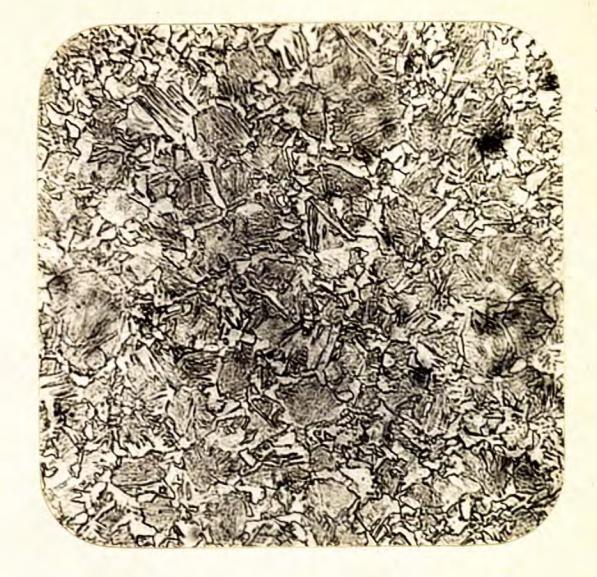
Figure 8.

X500, nital etch. CORE OF PIN NO. 8.

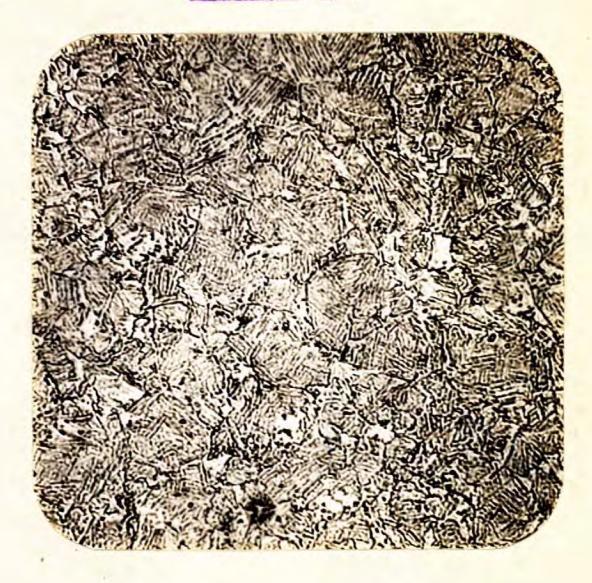
Figure 10.

X500, nital etch. CORE OF ALLIED PRODUCTS PIN.
