OTTAWA January 21st, 1944.

ORE DRESSING AND METALLURGICAL LABORATORIES.

Investigation No. 1578.

Examination of Steel Bolts From Welland Ship Canal Locks.

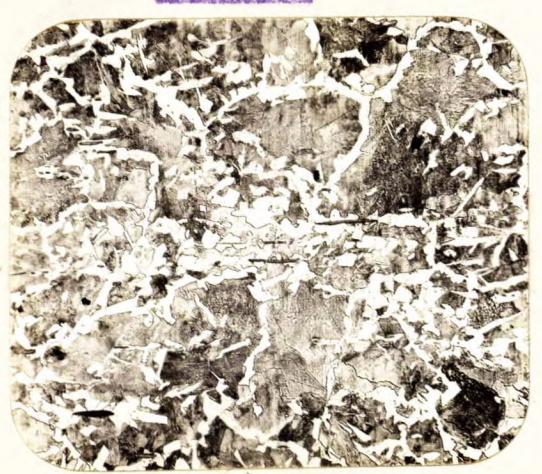
### Figure 1.

Specimens were cut from each bolt, polished, and then examined under the microscope in the unstched condition. Elongated inclusions of "manganese sulphide" appearance were observed to be present in all steels. Apart from this the steels were found to be fairly clean. The specimens were next etched in 2 per cent nital and re-examined. The microstructure indicated that all bolts had been made from rolled bar stock and had received a normalizing heat treatment. Steel 2 had a much coarser grain structure (see Figure 1) than the others (see Figure 2) and would appear to have been cooled from a considerably higher temperature. No metallurgical defects were observed in the two broken bolts.

(100, 2 per cent nital stch.

STEEL 2.

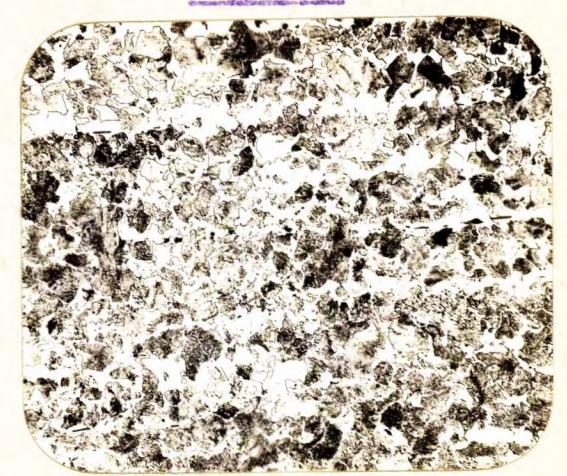
Figure 2.

X100, 2 per cent nital etch.

STEEL 3.

practically the same. The impact properties of these steels, while low, would appear to be sufficient for this service where failure under sudden stress is required. There were no metallurgical defects observed in the two broken bars. The duplex nature of the fractures indicates that these bolts failed by fatigue.

Intermuch as fatigue failure almost invariably starts as a result of stress concentration at the surface (in this case the thread caused a concentration of stress), the use of a rolled thread rather than a cut thread is recommended, if possible. Surface shotblasting would also improve fatigue strength. Indeed, it is quite possible that this treatment might make serviceable the bolts now in use, provided that these were first shown to be crack-free by a magnaflux inspection.
