Investigation No. 1593.

Investigation of Rivetting Tips, for the Canadian Dry Pin.

Investigation of Rivetting Tips for the Canadian Dry Pin.

Origin of Material and Object of Investigation: On January 22nd, 1944, Mr. C. V. Hacker, Superintendent, Hull Iron and Steel Foundries Limited, Hull, Quebec, submitted five pins, the tips of which had cracked on rivetting, for examination.

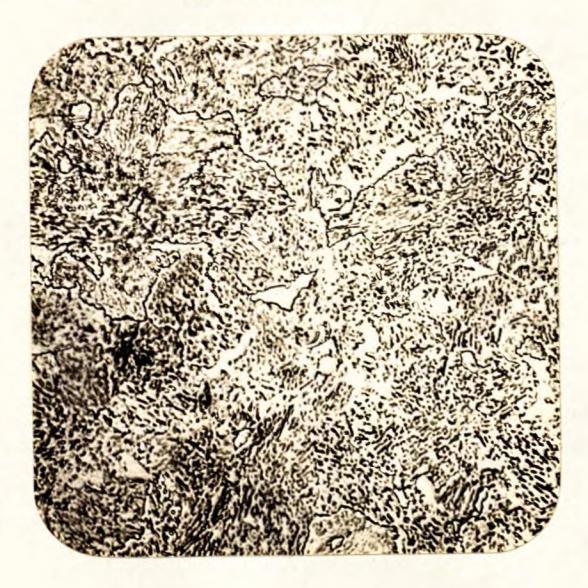
## Figure 1.

X500, nital etch. PIN NC. 2. Note spheroidal structure.

The tip-softening process is obviously out of control, as is indicated by the photomicrographs. The spheroidal structure (Figure 1) indicates alternate heating above and below the lower critical (1400° F. approximately). Figure 2 shows a tendency toward spheroidization but it has only started. Large islands of unbroken pearlite are present. Figure 3 is the typical structure obtained by quenching from below the upper critical temperature. It is evident that no attempt at spheroidization has been made for this tip. It is strongly recommended that more control be exercised on the tip-softening process.

3. The photomicrographs indicate lack of control in the tip-softening process. Greater care must be employed to ensure spheroidization.

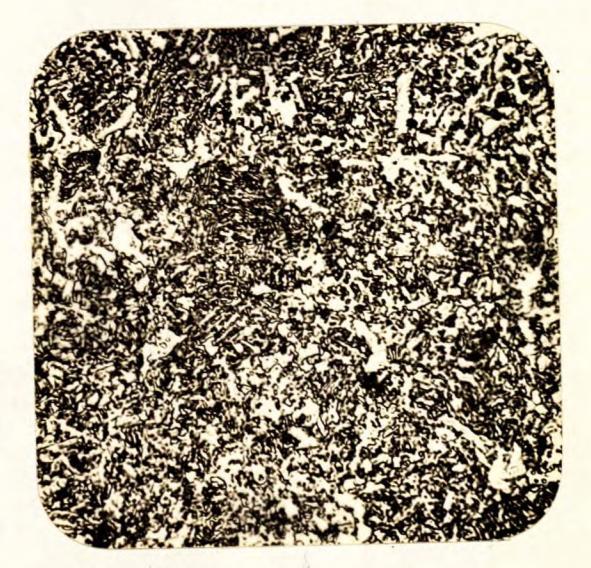
PIN NO. 1.

X500, nital etch.

Note nodular carbides, islands of pearlite, and ferrite.

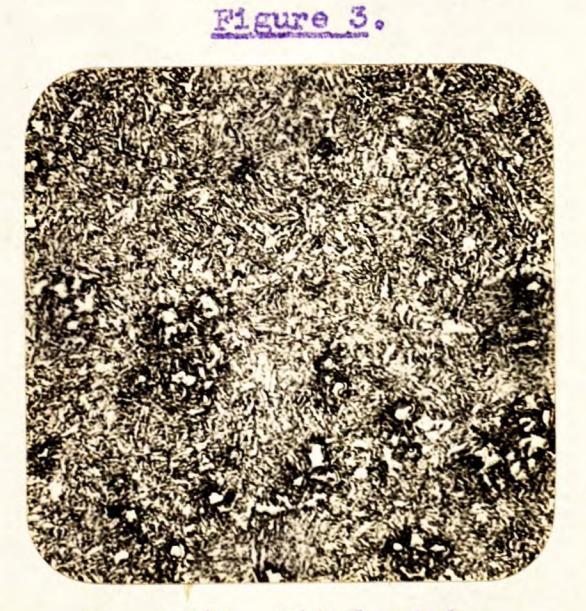
PIN NO. 5.

X500, nital etch.

Note tempered martensite and ferrite.
