Investigation No. 1642.

Metallurgical Examination of Three Sizes of Pivot Mechanisms for Fuge No. 208.

Metallurgical Examination of Three Sizes of Pivot Mechanisms for Fuze No. 208.

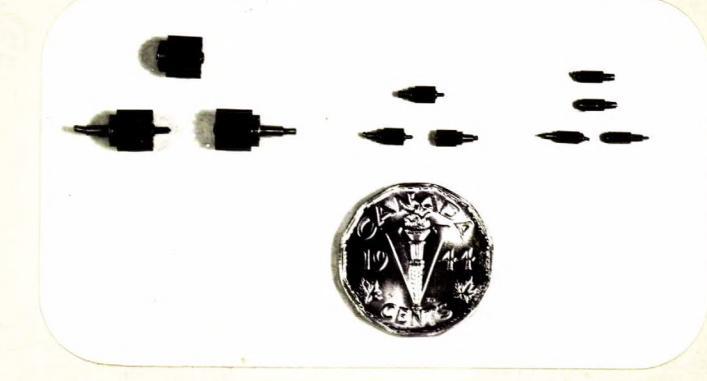
Visual examination of all the gears submitted showed that by far the most common location of failure was the breaking off of the short pivot (portion 4, sketch page 3). In most cases the pivot broke off flush with the gear face, but in a few instances it broke so that a very small section remained as a projection from the gear.

GEARS OF ALL THREE SIZES, SHOWING VARIOUS TYPES OF FAILURE.

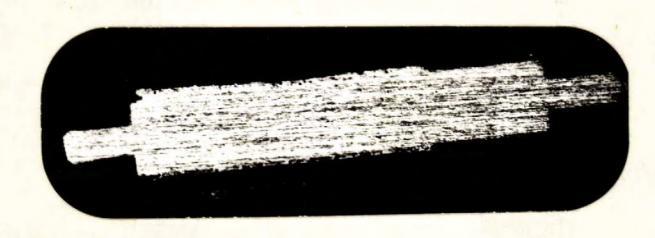
Figure 3.

The macroscopic examination showed no evidence of failure at the shoulders on any of the gears examined. The corners are all very sharp and these may act as stress raisers, thus contributing to the failures.

X10. SMALL-SIZED GEAR.

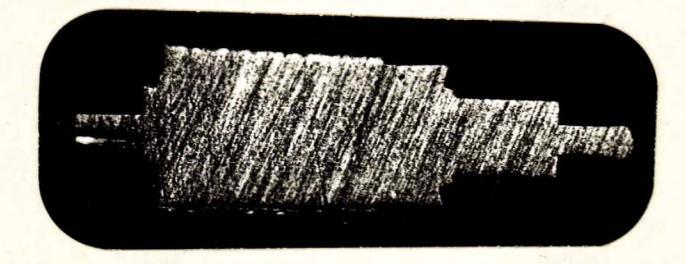
Figure 4.

X10. MEDIUM-SIZED GEAR.

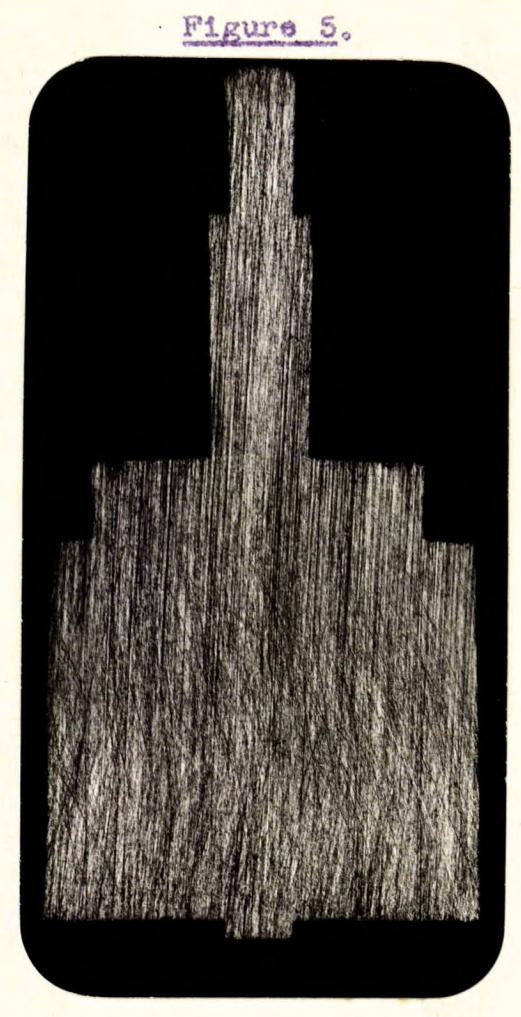
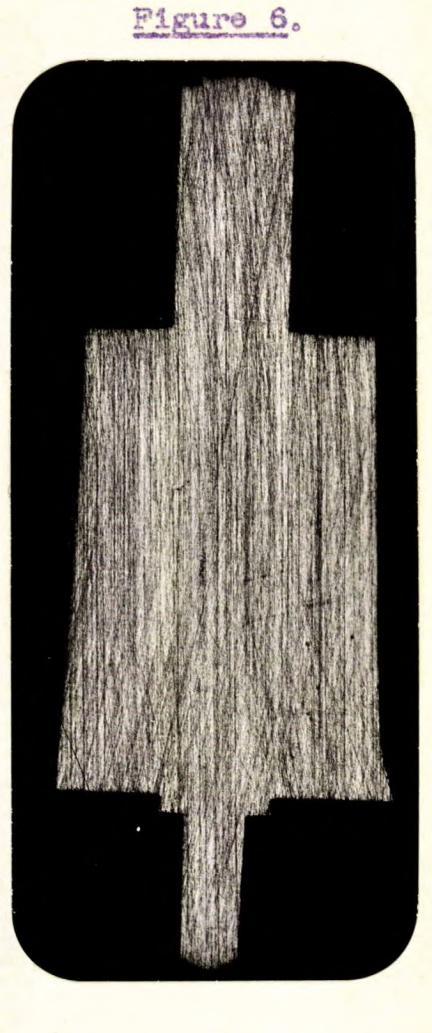
COMBINED TO SHOW COMPLETE LARGE-SIZED GEAR.

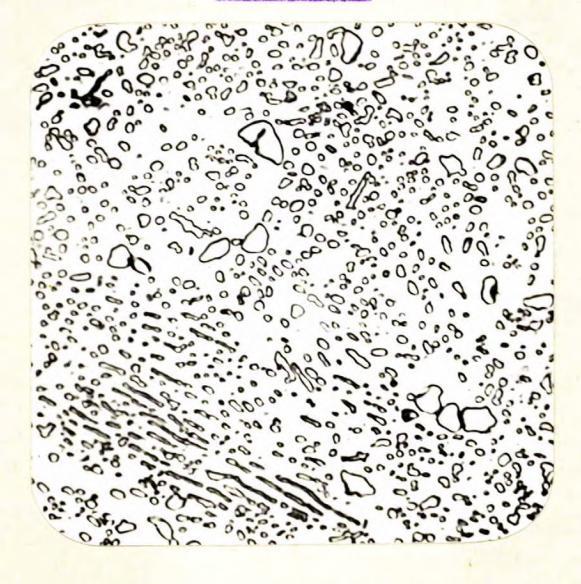
Figure 7.

Specimens of all sizes of gears were hand polished, etched in 4 per cent picral for 20 seconds, and examined under a microscope. The structure in all cases was similar. This structure is shown in Figure 7, at a magnification of 1,000 diameters. It will be noted that it consists entirely of spheroidized carbides in a ferrite matrix.

The structure revealed in the microscopic examination is that of a spheroidized, high-carbon steel. Steel in this condition is most readily machined but its mechanical properties, including toughness, are very low. This structure also explains the relatively low hardness as determined by the Vickers hardness machine. - Page 5 -

The spheroidized condition of this steel could be a contributory cause to the failure of the pivot since in this condition the steel is relatively weak and lacks toughness.

X1000, picral etch. STRUCTURE OF GEARS. Note spheroidal carbides.

SAE 1335 steel would seem to be the most suitable steel for these pivot mechanisms but if, because of stocks on hand or for some other reason, it is necessary to use a high carbon steel, austempering of the parts is recommended. This relatively complex treatment is not recommended unless a highcarbon steel has to be used. SAE 1335 steel should be found satisfactory.
