# FILE COPY

O T T A W A

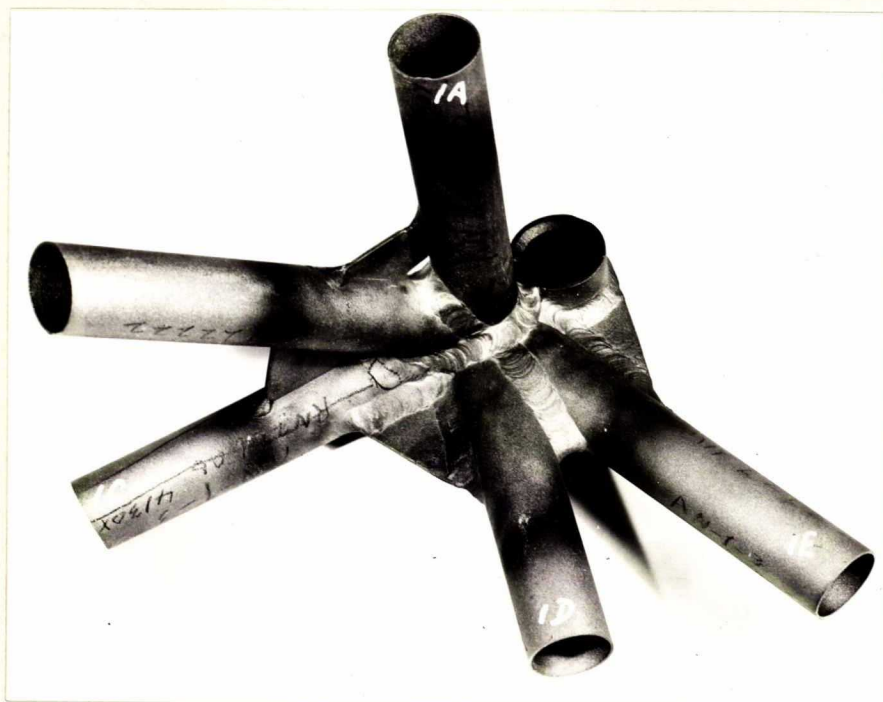
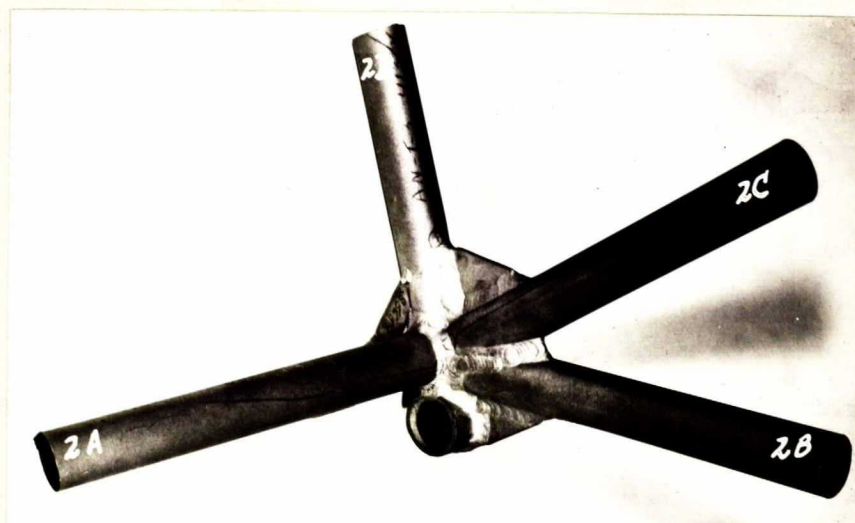
WELD CLUSTERS IN THE "AS RECEIVED" CONDITION.

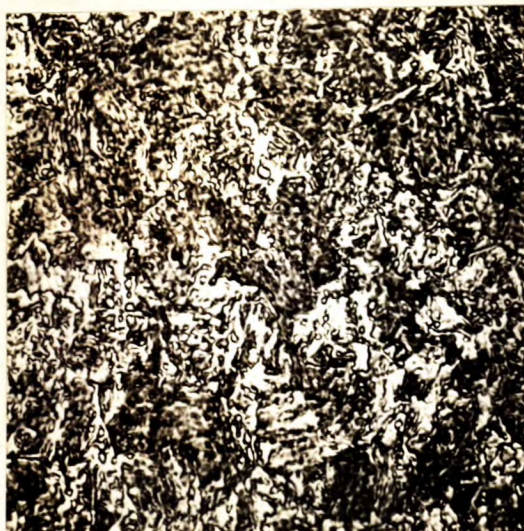
X1000, etched in 4 per cent picral.  
STRUCTURE OF TUBING REMOTE FROM WELDS.  
Pearlite in a matrix of ferrite.

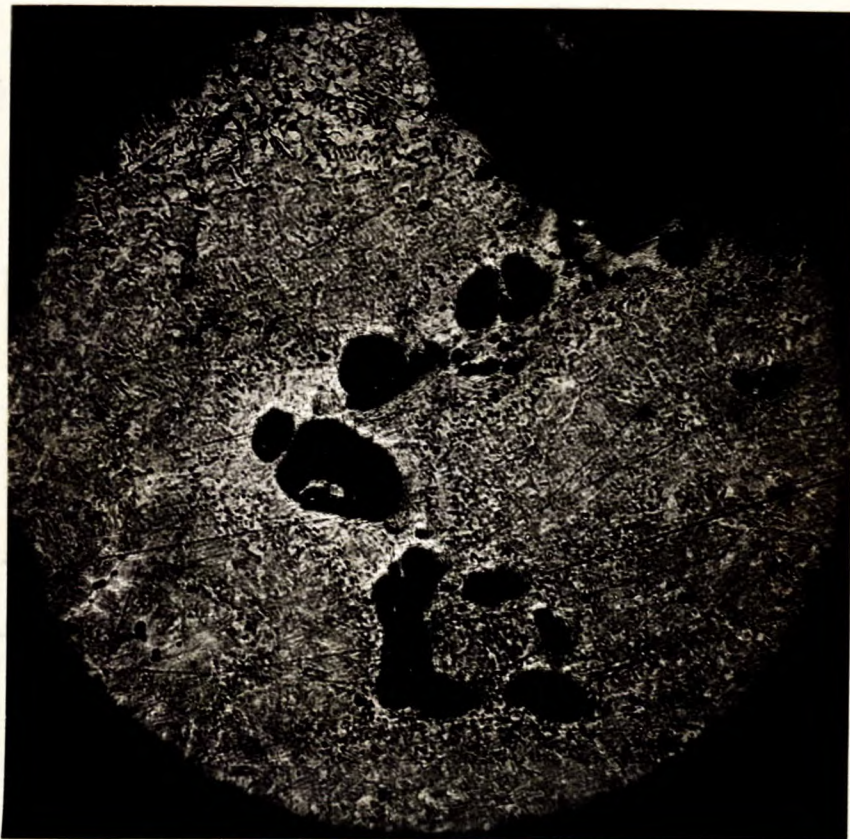
X40, etched in 4 per cent picral.  
POROSITY IN AN AREA OF CRACKING.

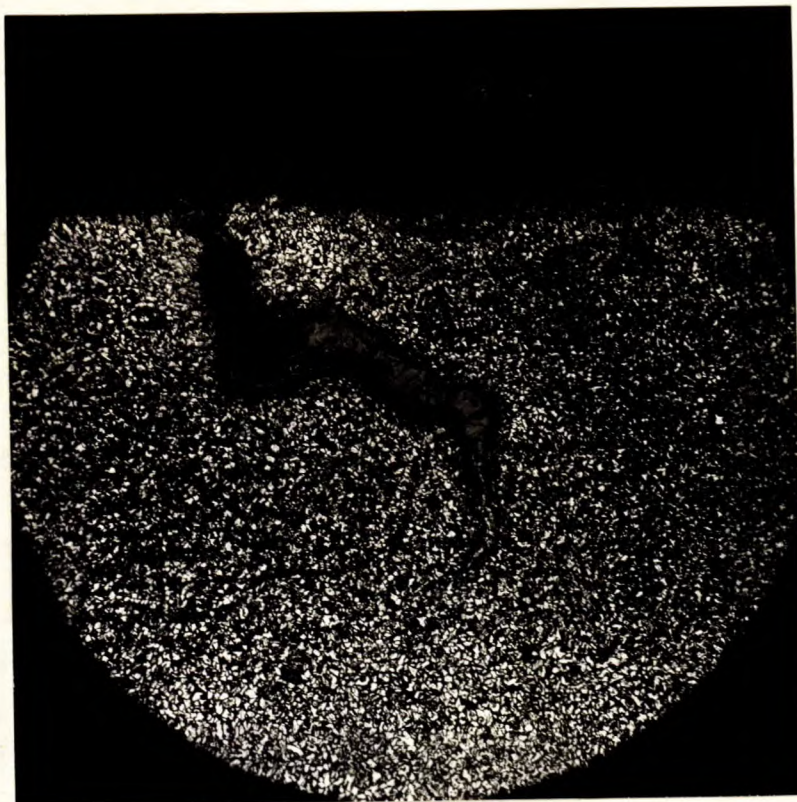
X40, etched in 4 per cent picral.  
CRACK PARTIALLY FILLED WITH OXIDE.  
This crack in tubing adjacent to a weld.

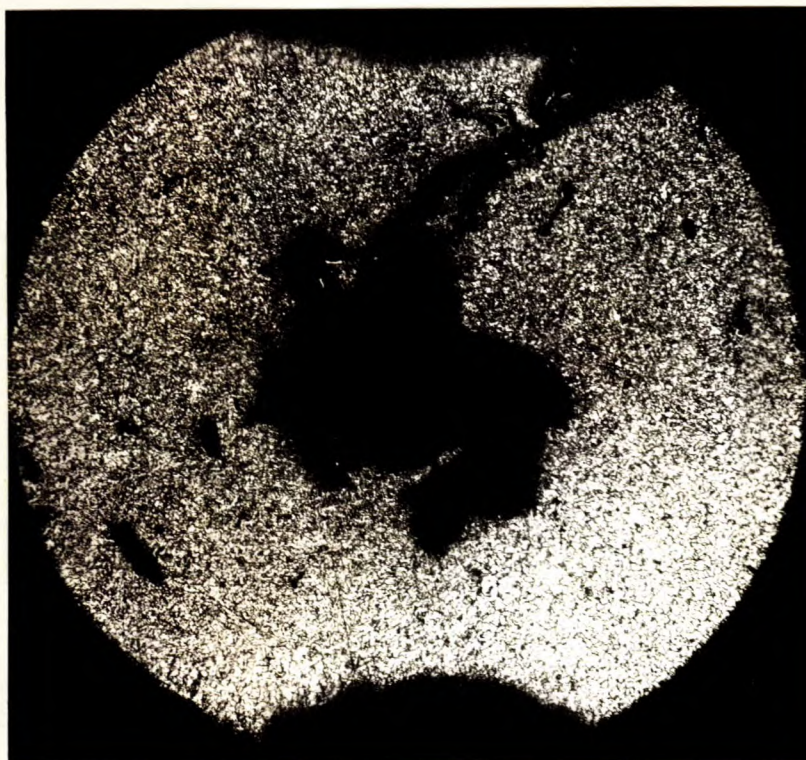
X40, etched in 4 per cent picral.  
POROUS AREA ADJACENT TO WELD, EXTENDING  
TO SURFACE OF TUBING.

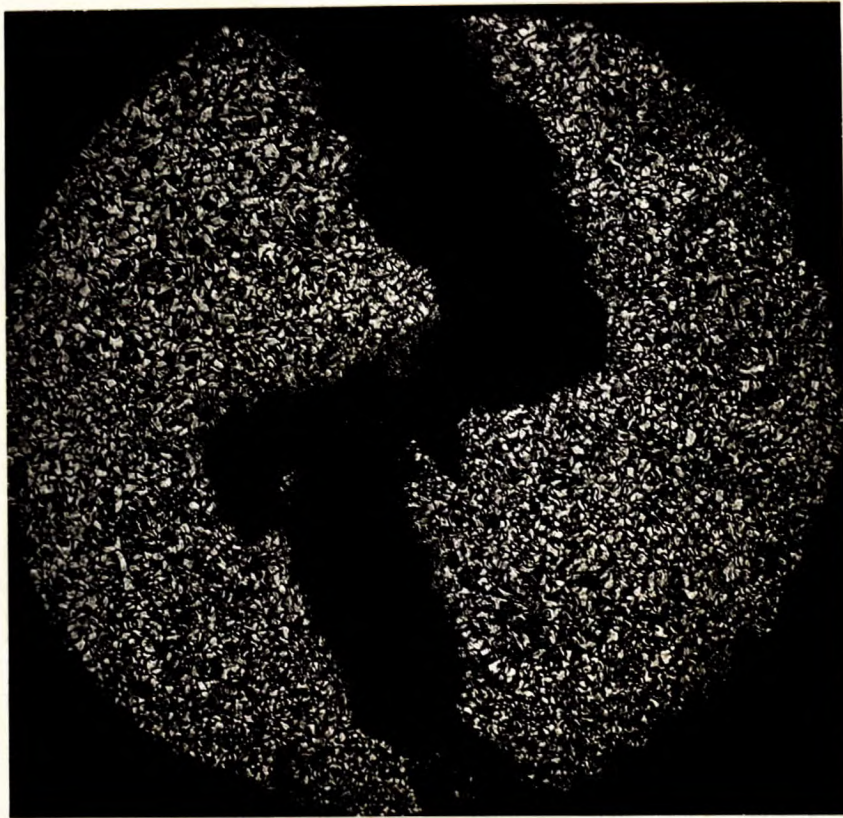
X70, etched in 4 per cent picral.  
CRACK IN TUBING ADJACENT TO WELD.  
Note oxide adhering to side of crack.

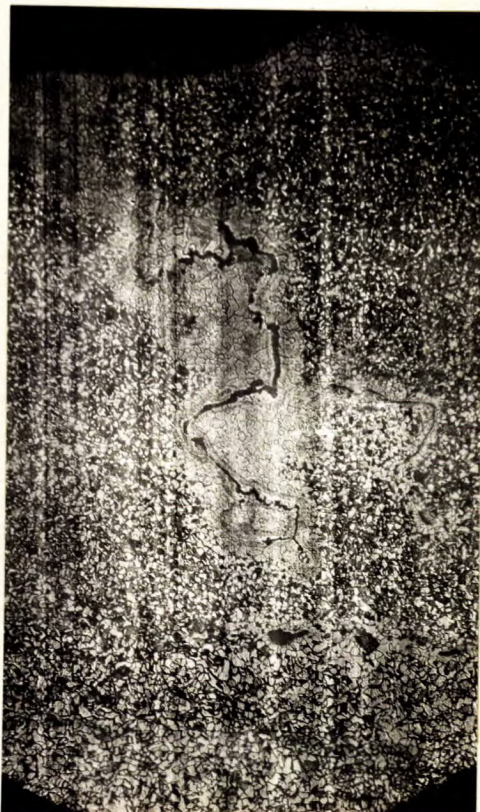
X30, etched in 4 per cent picral.  
SLAG IN A CRACK--PROBABLY LOW MELTING POINT CONSTITUENTS.  
Note decarburization around crack.

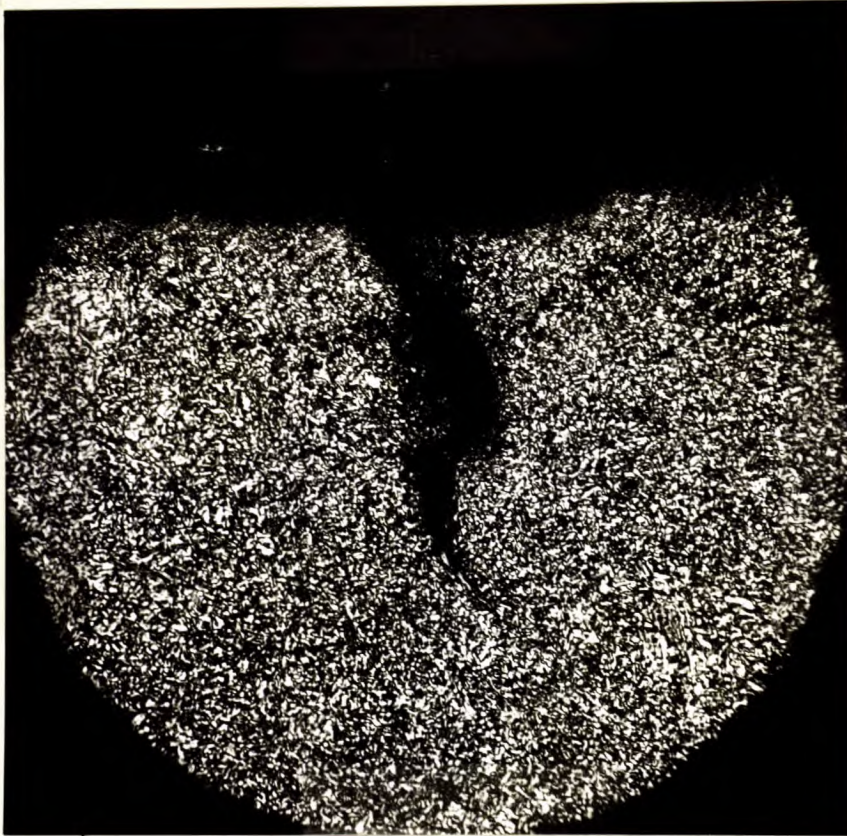
X70, etched in 4 per cent picral.  
CRACK IN TUBING ADJACENT TO WELD--  
PROBABLY OF MECHANICAL ORIGIN.  
Note absence of oxides.

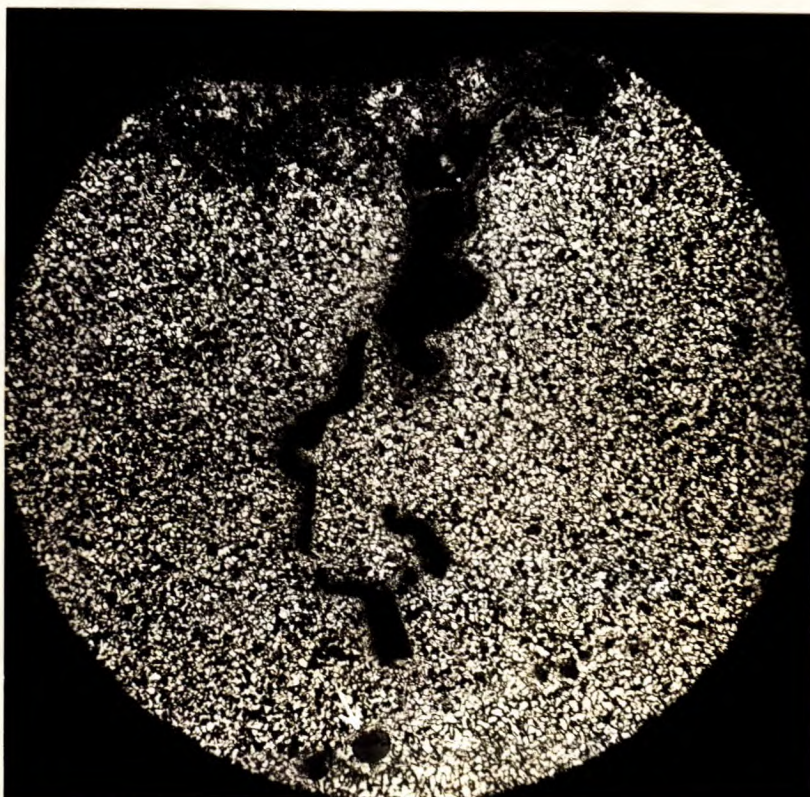
X40, etched in 4 per cent picral.  
POROUS AREA ADJACENT TO WELD.  
Note slag globule.
