#### Investigation No. 1790.

# Examination of Magnaflux Indications on Three Lancaster Aircraft Mainplane Attachment Bolts.

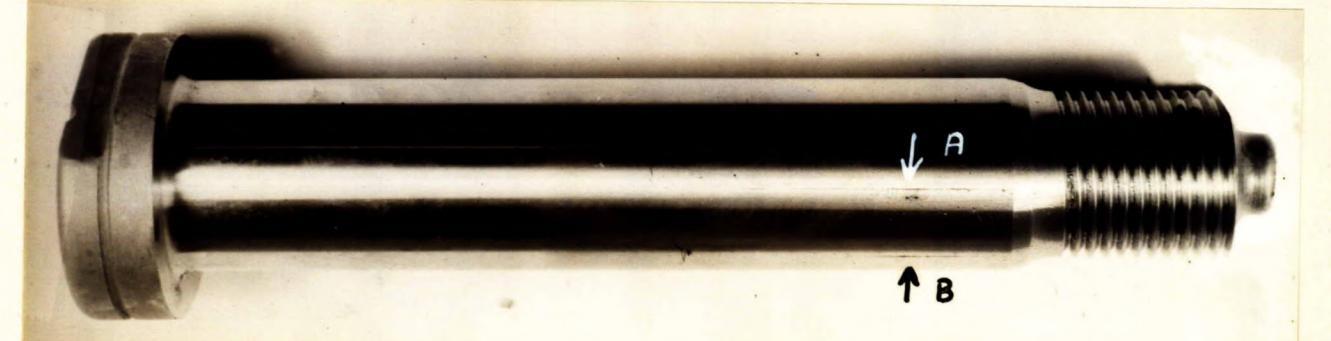
Figure 1.

Figures 1 and 2 illustrate the results obtained on Bolt No. 1. There are two longitudinal indications (A and B) on the main stem of the bolt and one on the thread. Figure 3 shows one of the longitudinal indications observed on Bolt No. 2. Bolt No. 3 had magnaflux indications on the thread, similar to that shown in Figure 2. All of the defects were again observed when the bolts were demagnetized and then remagnetized using 1100 ampères of current. When the amperage was lowered to 400 no indications were observed on Bolt No. 2 but those on Bolts Nos. 1 and 3 were still noticeable. Longidudinal magnetization revealed no defects on any of the bolts.

BOLT NO. 1, MAGNAFLUXID. (Approximately 2/3 actual size).

The photomicrographs indicate that these bolts have been made from seamy bar stock. In rolling down to size the inclusions have been trapped. The seams penetrate below the surface to 0.001 to 0.0015 inch on Bolt No. 1 which is representative of the worst condition.

2. The seams on Bolt No. 1 penetrate 0.001 to 0.0015 inch below the surface.

1. If tolerances allow, further machining would eliminate the defects on Belt No. 1, which is representative of the worst lat of rejects.

2. Acceptence or rejection of the part will depend on the type of stress it is required to undergo in service.

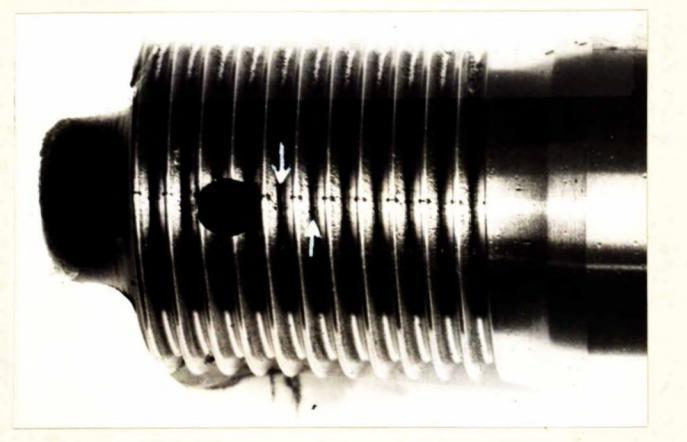
Figure 2.

# THREAD OF BOLT NO. 1, MAGNAFLUXED.

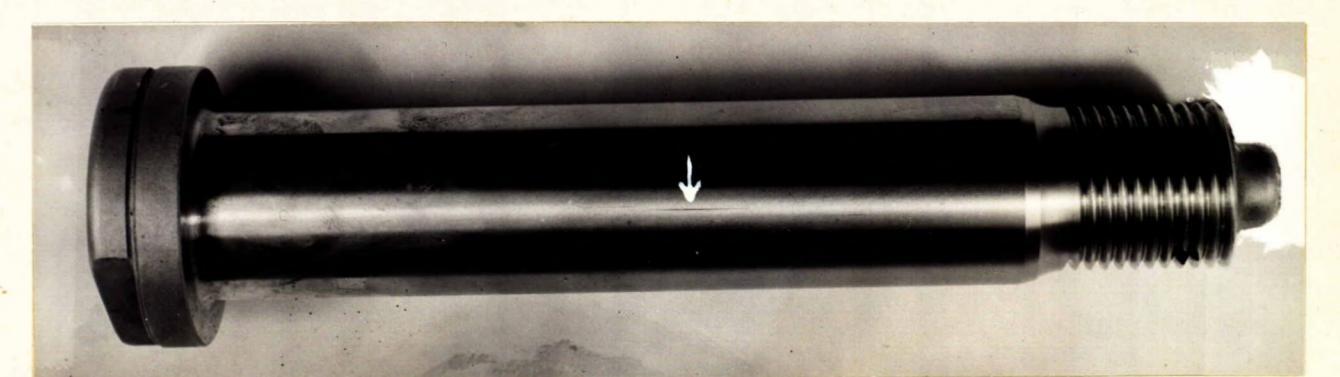
Figure 3.

BOLT NO. 2, MAGNAFLUXED.

The indications in Bolt No. 2 were so shallow that it was not possible to locate them under the microscope. It is interesting that this bolt revealed no defects when given 400 amperes. Bolt No. 3 was given a macro etch on the thread where the magnaflux indications were found. A double series of cracks coinciding with this magnaflux indication is now visible to the eye. This bolt will be submitted along with this report. The two rowsare very close together. This also is considered evidence of the presence of a seam.

3. The defects on Bolt No. 2 are too shallow to be

revealed by a 400-ampere current and could not be positively detected under the microscope.

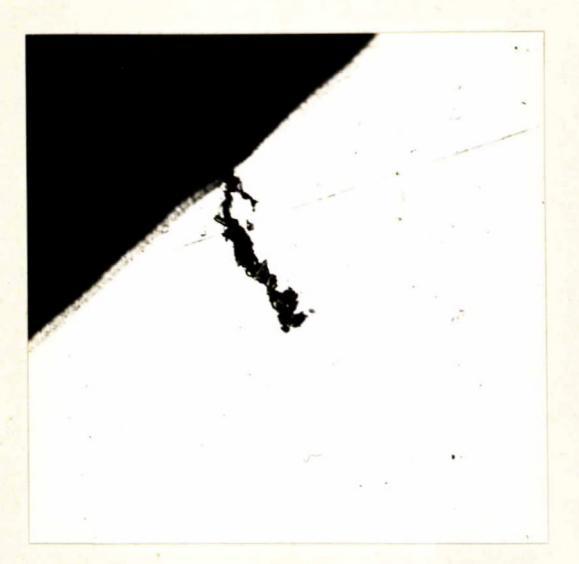
Figure 4.

Transverse specimens were cut from the three bolts, across the longitudinal magnaflux indications. These specimens were polished and then examined under the microscope in the unstched condition. Figure 4 (X500) illustrates the stringer of inclusions at the point of separation of metal. This is at the thread of Bolt No. 1. Figure 5 (X500) is a photomicrograph of one of the longitudinal lines shown in Figure 1, of Bolt No. 1. FeO and FoMn silicate appear to be present. No · Page 4 ·

THREAD OF BOLT NO. 1, TRANSVERSE SECTION.

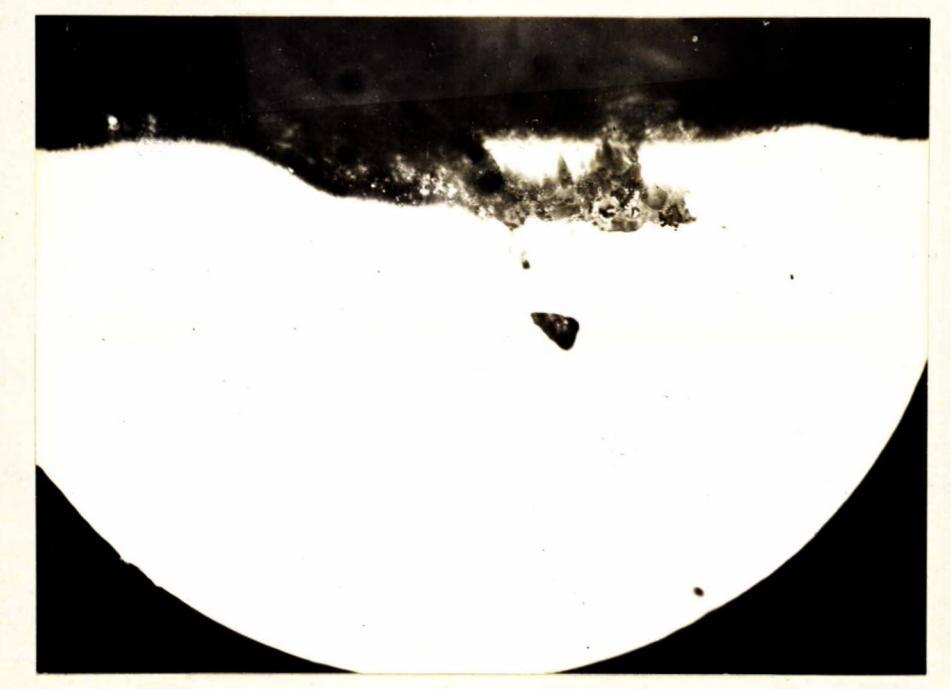
Figure 5.

TRANSVERSE SECTION OF LONGITUDINAL MAGNAFLUX LINE ON STEM OF BOIT NO. 1.
