ORE DRESSING AND METALLURGICAL LABORATORIES.

Investigation No. 1845.

Corrosion Protection Afforded to Steel by Shell Ensis Fluid 211 in the Dynamic Humidity Cabinet Test.

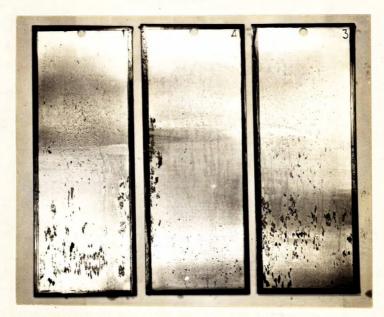
#### Figure 1.

When the six coated steel samples were removed from the humidity cabinet at the end of the test, all were found to have corroded considerably. Figure 1 shows the emeried sides of three typical panels. In addition to the corroded spots, areas will be observed in which the "protective" oil had formed into small droplets instead of spreading uniformly over the surface of the metal. Figure 2 shows the unemeried sides of these same panels. The encircled areas were visibly free from "protective" material, and considerable corrosion had taken place there during the test.

EMERIED SIDES OF TYPICAL STEEL PANELS COATED WITH SHELL ENSIS FLUID 211, AFTER TESTING FOR 150 HOURS IN THE DYNAMIC HUMIDITY CABINET.

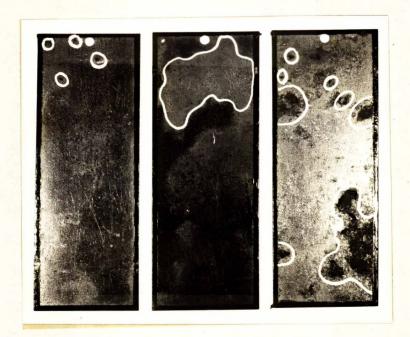
## Figure 2.

UNEMERIED SIDES OF THE PANELS SHOWN IN FIGURE 1.

Encircled areas were visibly free from the "protective" fluid and considerable corrosion had taken place there during the test.
