ORE DRESSING AND METALLURGICAL LABORATORIES.

Investigation No. 1882.

Protection Afforded by a Corrosion-Preventive  
Compound for Aircraft Engines  
(Specification DND C-27-587).

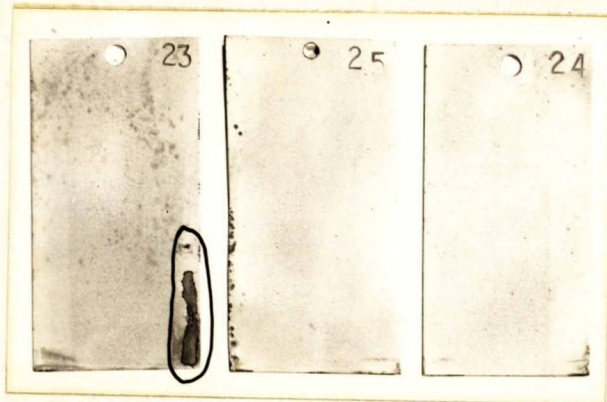
(a)

The appearance of the panels at the end of the "Protection" test is shown in Figures 1a and 1b. The encircled dark spots on Sample 23 and the reverse of Sample 25 were caused by other panels touching the surface during the test, and should be disregarded.

The spots along one side of Sample 25 were within approximately 1/8 inch from the edge, and should be disregarded. In addition, there were a few quite small, scattered, corroded spots and some areas covered with a light tarnish.

1. Although the samples were not corroded in the "Protection" test as badly as the one which came from the University of Manitoba laboratory, the corrosion-preventive compound cannot be accepted if the specification is to be strictly adhered to.

STEEL PANELS COATED WITH COMPOUND-  
LUBRICATING OIL MIXTURE, AFTER  
150 HOURS IN THE HUMIDITY CABINET.

Note: Dark encircled areas were due to other  
panels touching the surface during the test  
and should be disregarded.

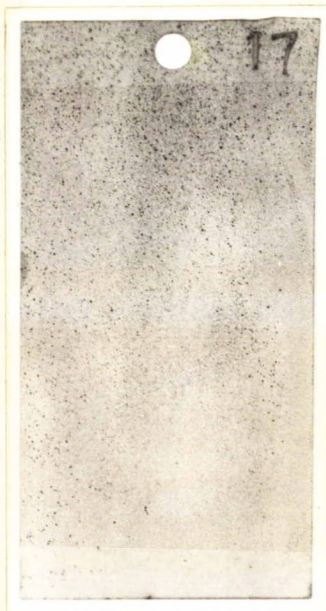
The appearance of a typical panel at the end of the Hydrobromic Acid Neutralization test is shown in Figure 2. Many small corrosion spots are to be observed.

2. The behaviour of the corrosion-preventive compound with regard to Hydrobromic Acid Neutralization definitely is poorer than that required by specification.

TYPICAL STEEL PANEL AFTER THE HYDRO-  
BROMIC ACID NEUTRALIZATION TEST.
