OTTAWA June 6, 1945.

Investigation No. 1885.

Metallurgical Examination of Fractured End Stud from Bogie Spring Rebound Chain Assembly (Armoured Snowmobile).

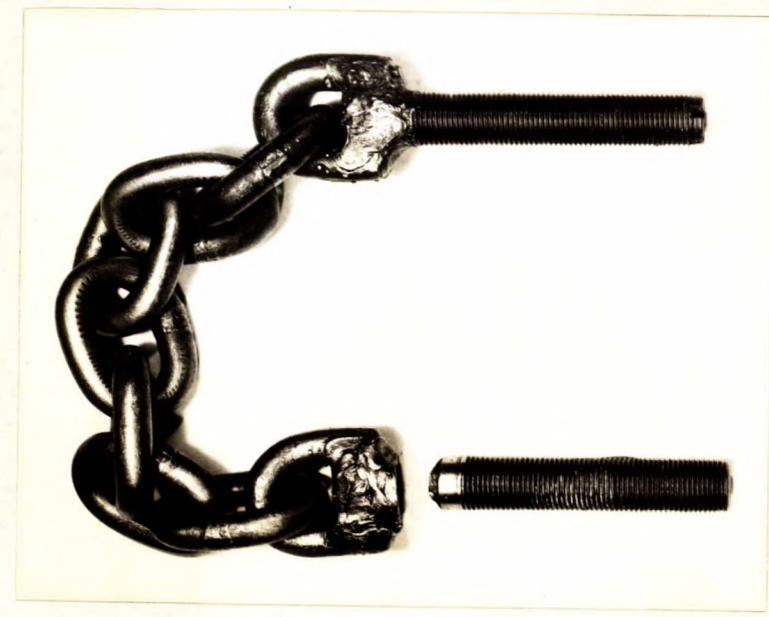
Figure 1.

On May 17, 1945, a broken upper bogie spring rebound chain assembly was received from Mr. W. J. Washburn, of the Army Engineering Design Branch, Department of Munitions and Supply, Montreal, Quebec. The end stud from the assembly had failed after having been installed but without seeing service. The accompanying letter (File 141-FU21) requested a metallurgical examination of the failed end stud to determine the cause of fracture and to ascertain whether the material in the stud was as specified.

VIEW OF BROKEN REBOUND CHAIN ASSEMBLY. (Approximately half actual size).

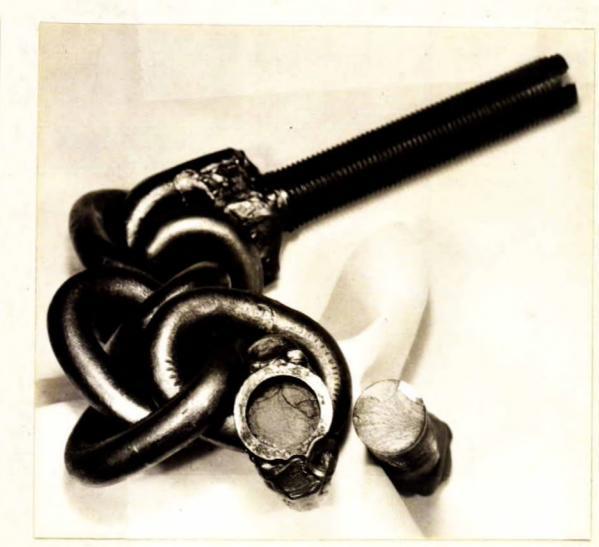
VIEW OF FRACTURE. (Approximately ± actual size).

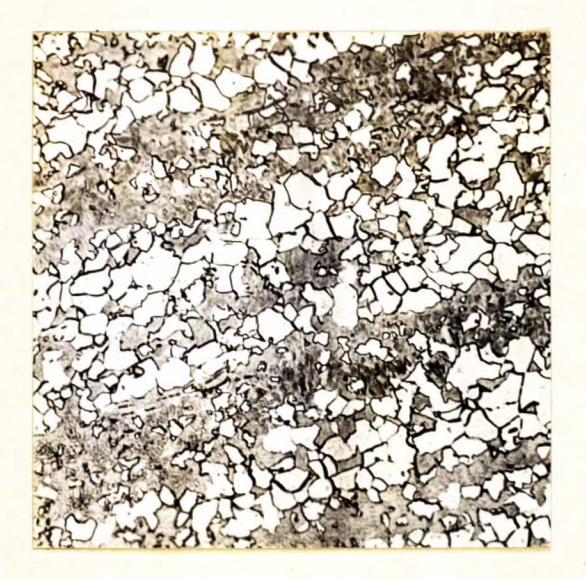
Micro specimens were taken from the locations shown in the sketch in Figure 2. The microstructure in each of the two zones shown in Figure 7 was studied. In the zone marked A in Figure 7, the microstructure had a banded appearance (prosutectoid ferrite and martensite), as shown in Figure 4.

X500, nital etch.

BANDED STRUCTURE IN END STUD (ZONE A IN FIGURE 7).

Ferrite and martensite.

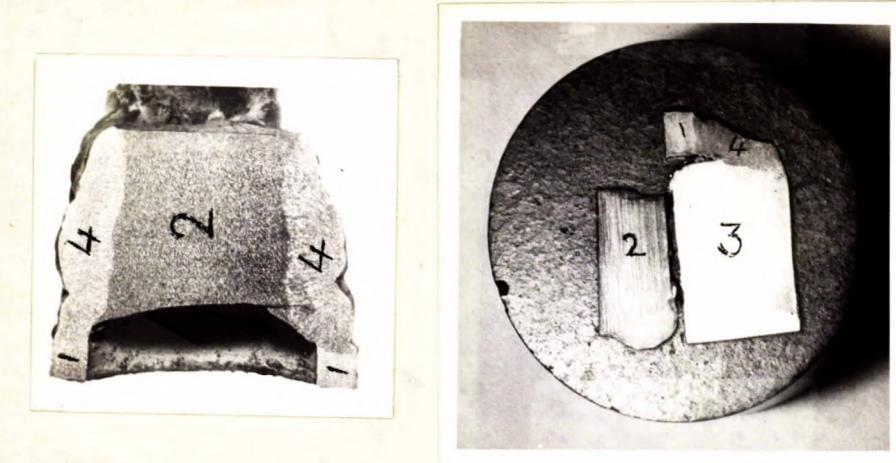
The banding in the end stud can be seen quite clearly in Figure 6.

TWO VIEWS OF STUD AND LINK WELDMENT.

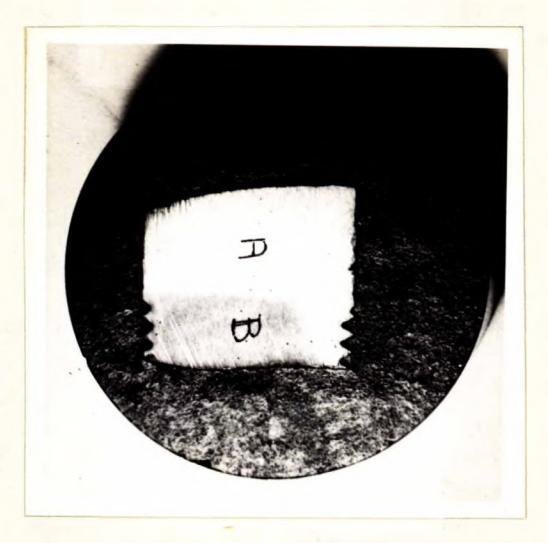
Figure 7.

SECTION THROUGH FRACTURE IN END STUD.

A. = Banded zone - nearest fracture. B. = Normal zone.

1. Quenching from the welding temperature has resulted in the formation of a banded zone in the bar to which ordinarily failure would be attributed.

2. Low temperature conditions, internal stresses due to welding, and rough handling are all possible causes of failure.

It is recommended that the weldment be normalized from 1600-1650° F. after welding, quenched in water from 1550° F., - Page 10 -

and drawn at 1000° F. This treatment would be expected to produce the following properties in the stud:

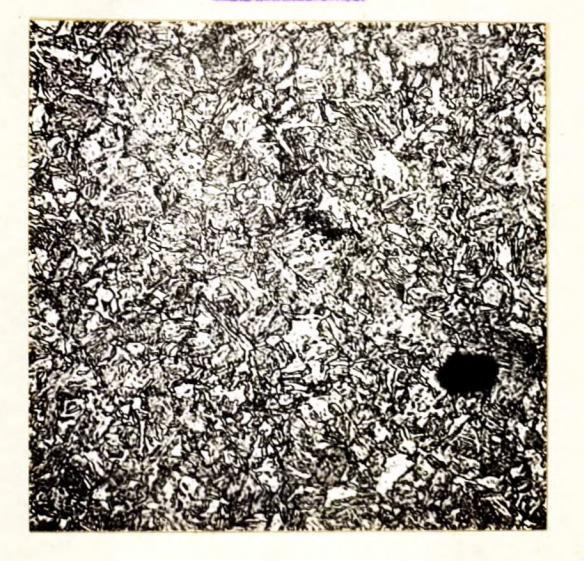
Figure 8.

For purposes of comparison the microstructure of the stud at the end farthest from the weld was examined. It was essentially the same as that shown in Figure 5, that is, drawn martensite with some ferrite showing around the primary grain boundaries (see Figure 8).

NORMAL STRUCTURE OF STUD AT END FARTHEST FROM WELD.

Note presence of ferrite.

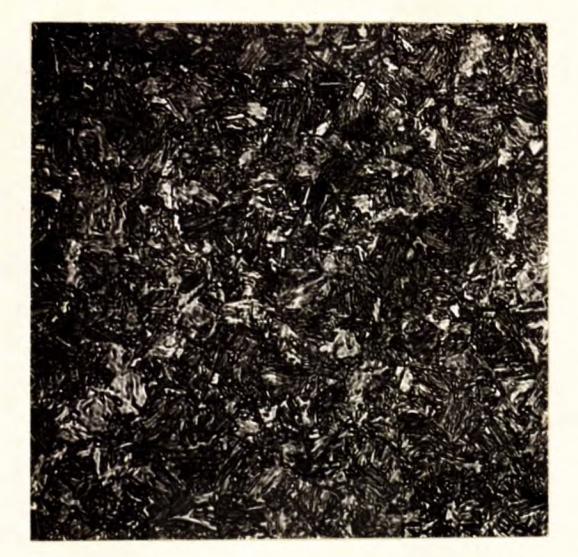
Figure 9.

X500, nital etch. MICROSTRUCTURE OF SAMPLE NO. 1. Martensite. (Izod value, 102 ft-1b.). Figure 10.

Apparently in Sample No. 1 the upper critical temperature has been depressed on cooling so that at 1350° F. the sample was still above the Ar₃ point. Sample No. 2, although quenched from the same temperature, was between the two critical temperatures, hence the banded structure of ferrite and martensite.

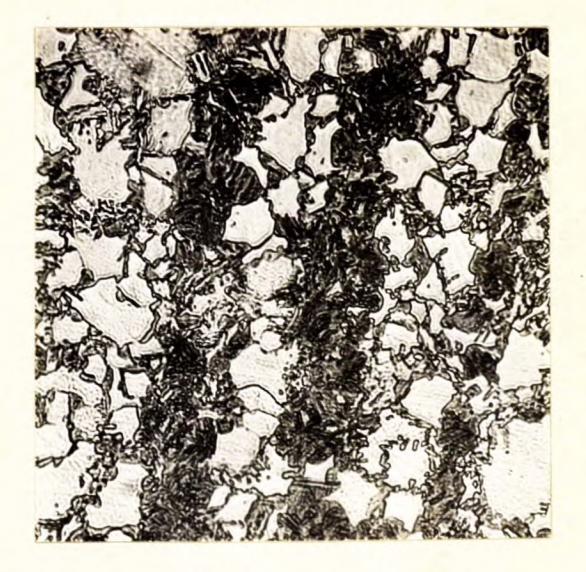
X500, nital etch. MICROSTRUCTURE OF SAMPLE NO. 2. Ferrite and Martensite. (Izod value, 104 ft-1b.).

Ordinarily the structure shown in Figure 10 would be expected to give low Izod values. Such was not the case, however, as can be seen from the Izod values under Figures 9 and 10.
