October 26, 1945.

ORE DRESSING AND METALLURGICAL LABORATORIES.

Investigation No. 1950.

Corrosion Protection of Exterior Rust
Preventive Compounds.

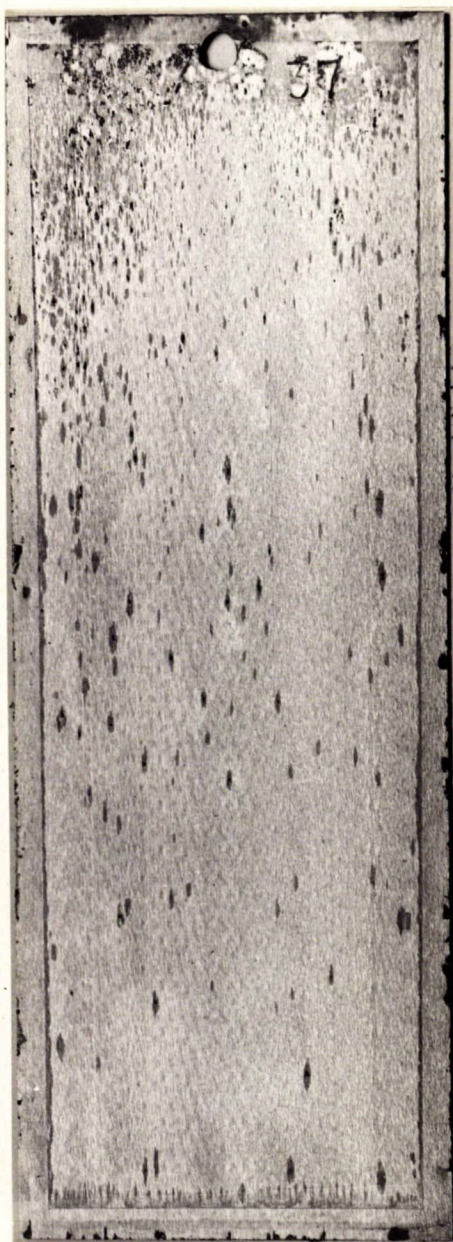
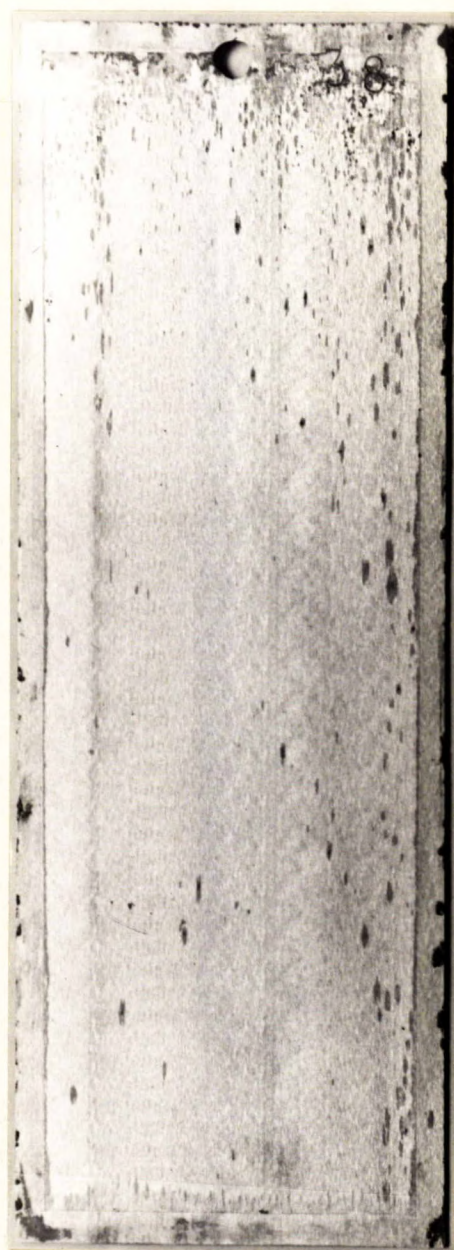
Figure 1.

Compound No.	RESULTS OF TESTS		
	PROTECTION AT HIGH HUMIDITY		SALT SPRAY TEST
	Without Air Passing Through The Cabinet	With Air Passing Through The Cabinet	
700-1	Passed.	Passed.	Failed (see Figure 1).
700-2	Passed.	-	Failed (see Figure 2).

PANELS COATED WITH COMPOUND 700-1, AFTER
200 HOURS IN THE SALT SPRAY CABINET.

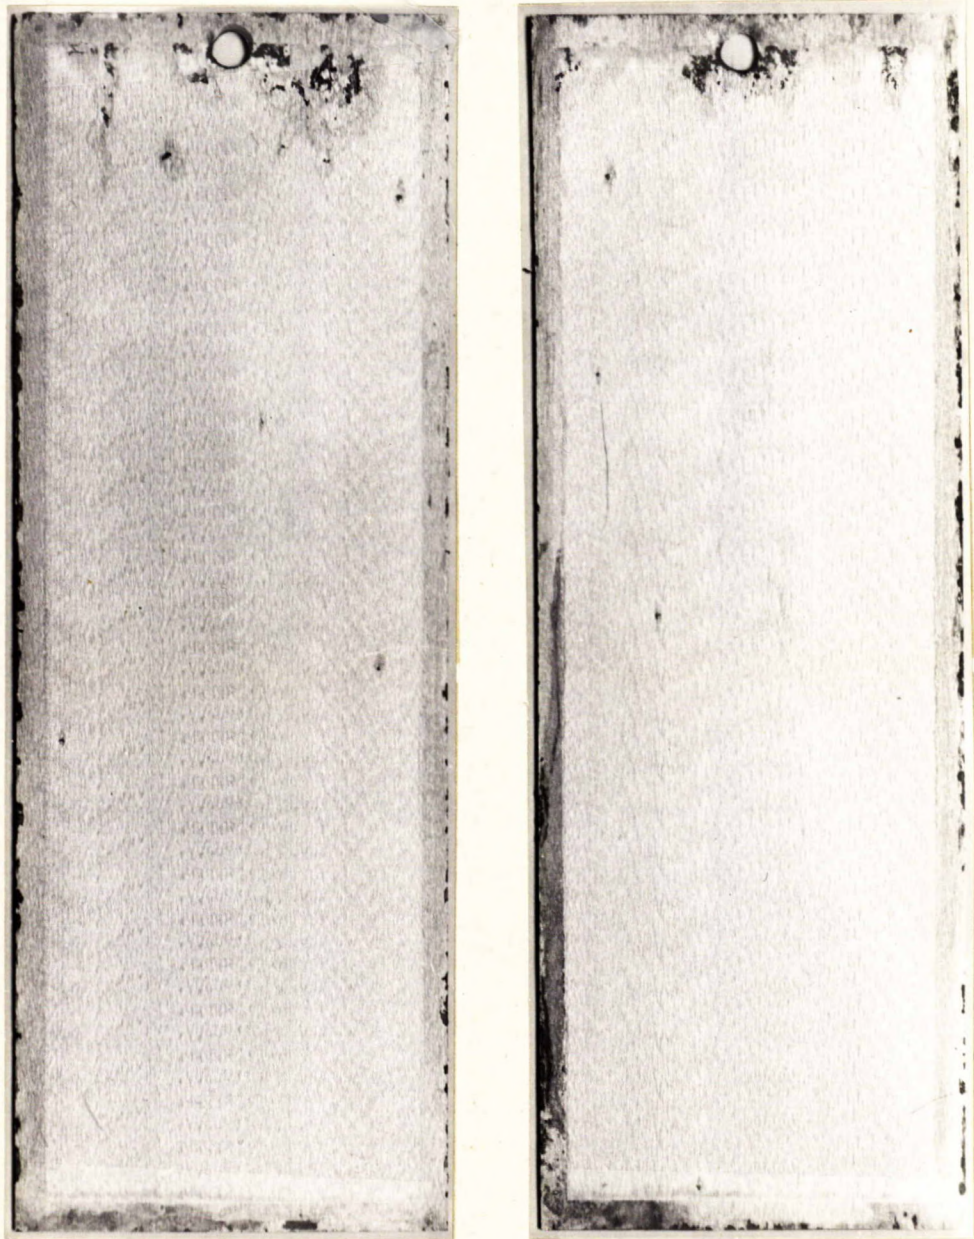
Figure 2.

PANELS COATED WITH COMPOUND 700-2, AFTER
200 HOURS IN THE SALT SPRAY CABINET.
