R E P O R T
of the
ORE DRESSING AND METALLURGICAL LABORATORIES.

Investigation No. 1954.

Corrosion Protection of Interior
Rust-Preventive Compounds.

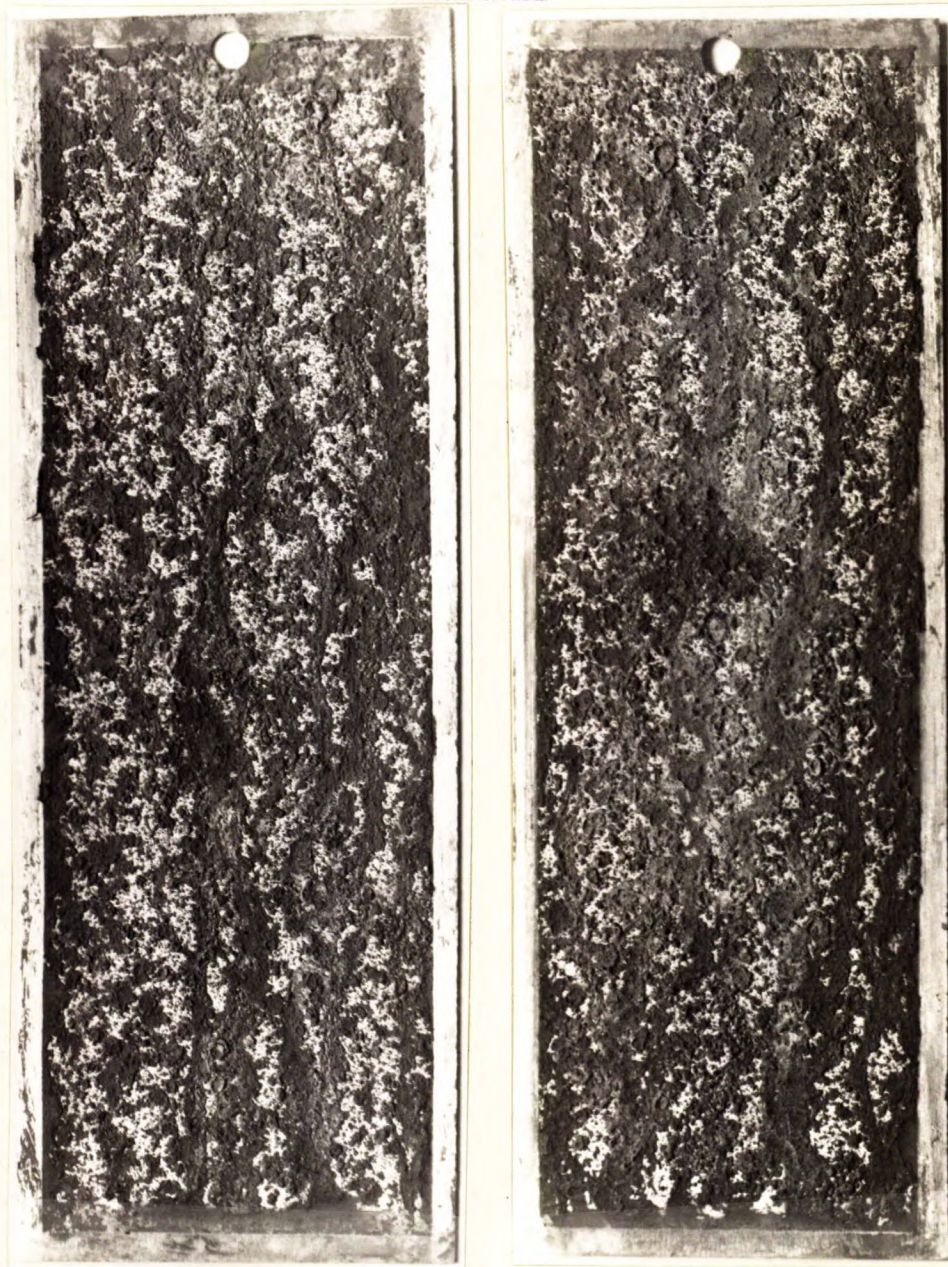
Figure 1.

Compound No.	RESULTS OF TESTS		
	SALT SPRAY TEST	PROTECTION AT HIGH HUMIDITY	
		Without Air Passing Through The Cabinet	With Air Passing Through The Cabinet
701-1	Failed (see Figure 1).	Failed (almost passed; see Figure 2).	Failed (almost passed; see Figure 3).
701-2	Failed (see Figure 4).	Passed.	
701-3	Failed (see Figure 5).	Passed.

PANELS COATED WITH COMPOUND 701-1, AFTER
200 HOURS IN THE SALT SPRAY CABINET.

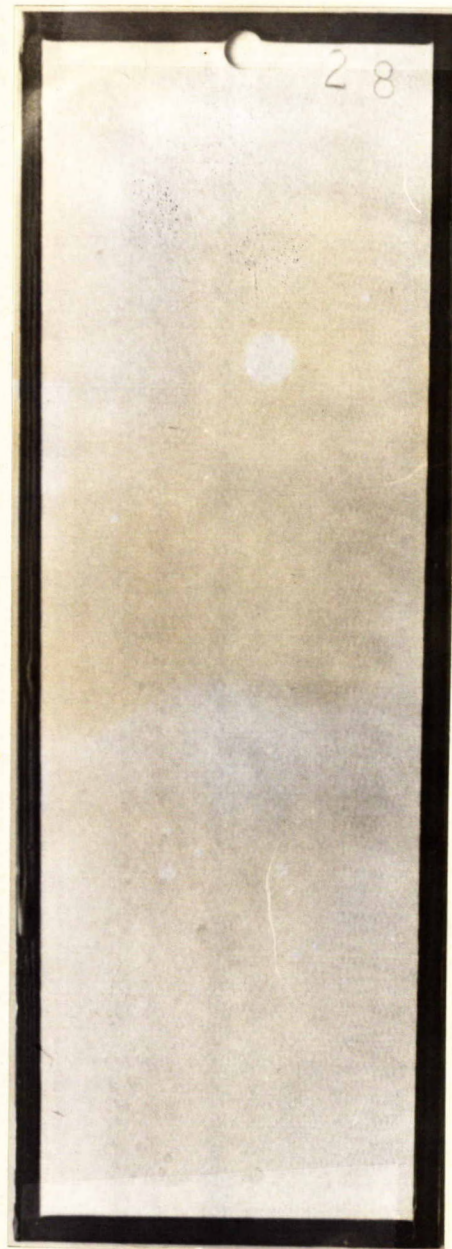
Figure 2.

1. In the Humidity Test, Compound 701-1 failed with and without air passing through the cabinet. The failure was slight in both cases.
2. The humidity cabinet used throughout this investigation was the one described by Todd in INDUSTRIAL AND ENGINEERING CHEMISTRY, Analytical Edition 16, 394, (June) 1944.
3. Information regarding the results obtained by other investigators would be much appreciated.

PANELS COATED WITH COMPOUND 701-1, AFTER
7 DAYS IN THE HUMIDITY CABINET
WITHOUT AIR PASSING THROUGH.

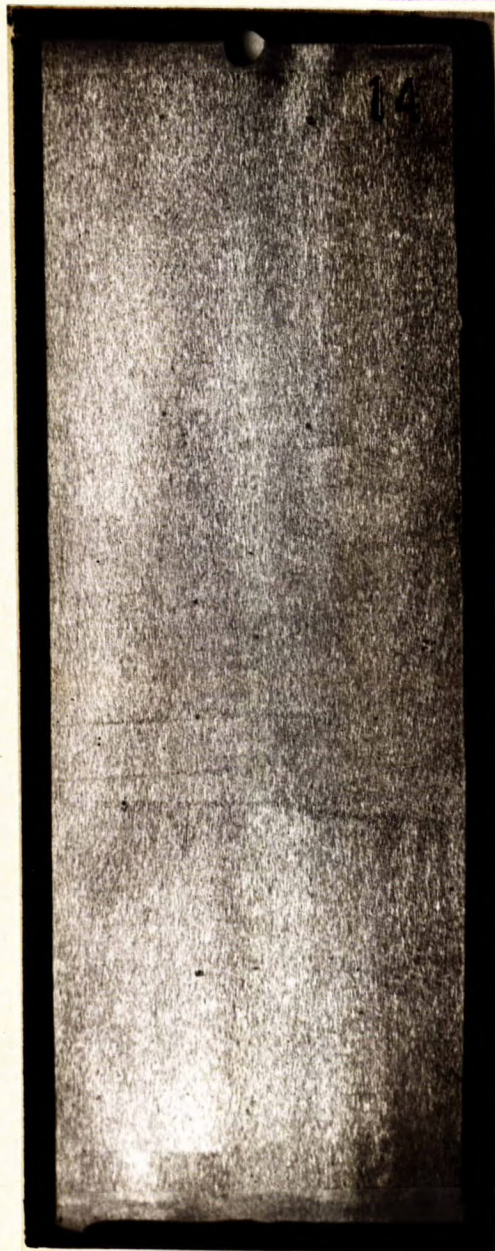
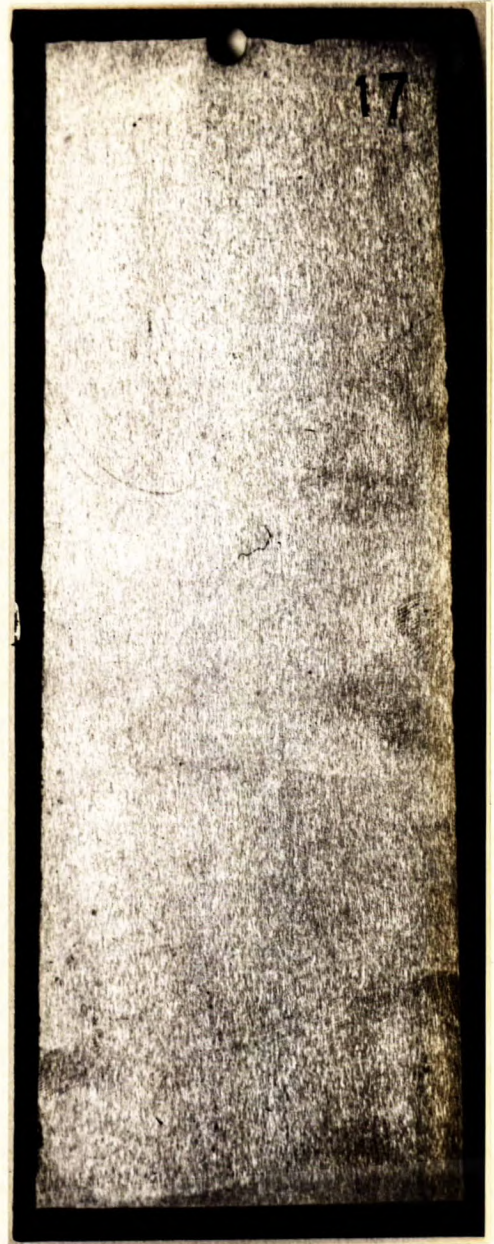
Figure 3.

PANELS COATED WITH COMPOUND 701-1, AFTER
7 DAYS IN THE HUMIDITY CABINET
WITH AIR PASSING THROUGH.

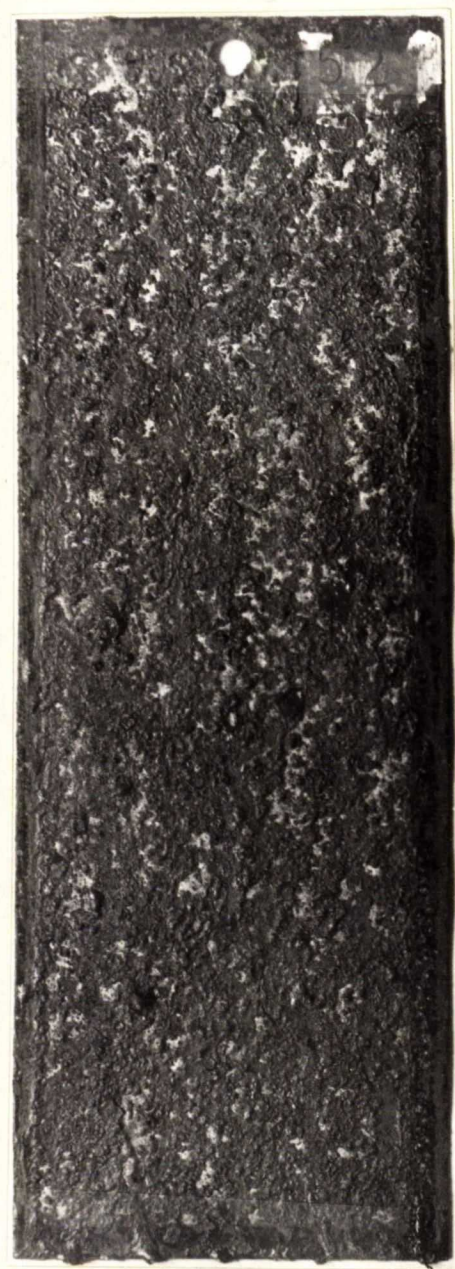
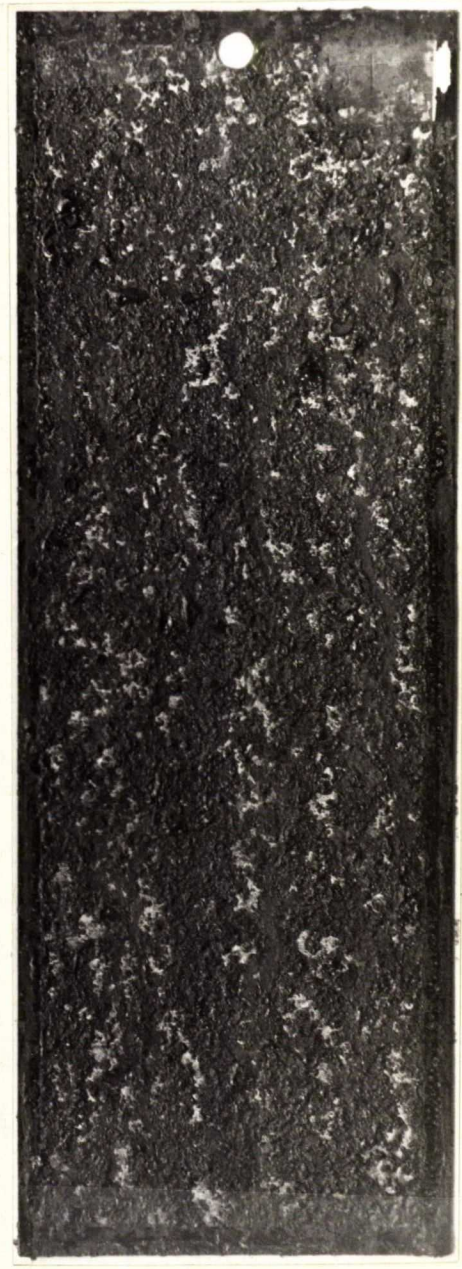
Figure 4.

PANELS COATED WITH COMPOUND 701-2, AFTER
200 HOURS IN THE SALT SPRAY.

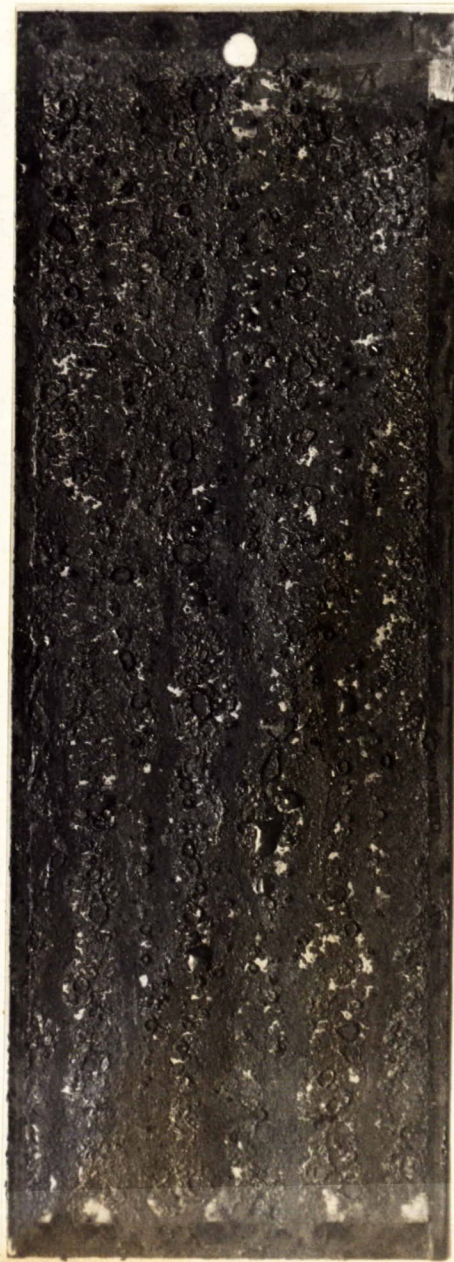
Figure 5.

TYPICAL PANEL COATED WITH COMPOUND 701-3,
AFTER 200 HOURS IN THE SALT SPRAY.
