DEPARTMENT OF MINES AND RESOURCES

ORE DRESSING AND METALLURGICAL LABORATORIES.

Investigation No. 2183.

Corrosion Resisting Properties of White Enamel  
Paints when Applied to Cold Rolled Sheet Steel.

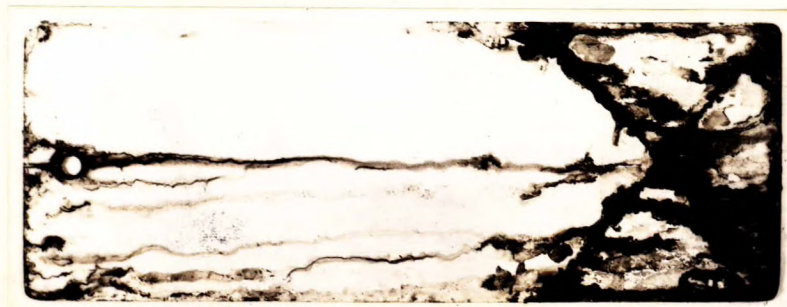
Figure 1.

No. 1 had slight rust at the top edge and a few marks over the surface. About 2/3 of the bottom two inches was covered with rust (see Figure 1). Also, slight peeling and a few tiny blisters were observed at various places on the surface.

No. 1. The paint chipped off in a few places at the "X" scratch.

No. 1. The paint peeled only at the blisters and the remainder of the surface had good adherence.

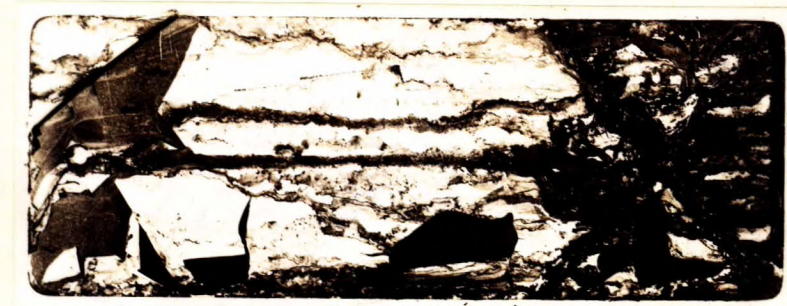
Figure 2.

No. 2 had considerable rusting at the top edge and down over the surface. The bottom two inches was covered with rust (see Figure 2). The surface appeared to be covered with small blisters.

No. 2. The paint cracked and nearly all peeled off the surface.

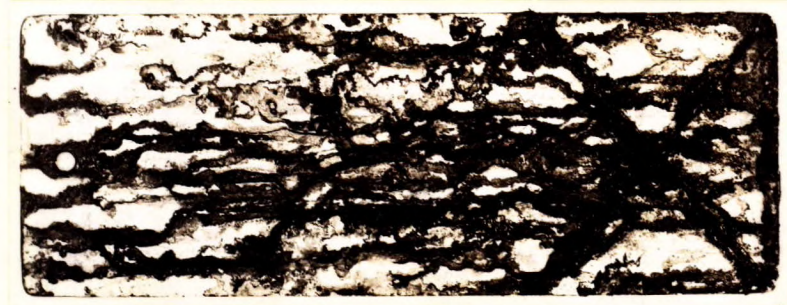
Figure 3.

No. 3 had considerable rust at the top edge and it was worse than No. 2. The bottom two inches was three-quarters covered with corrosion (see Figure 3).

The surface was partly covered with tiny blisters.

No. 3. Very slight cracking was noticed.

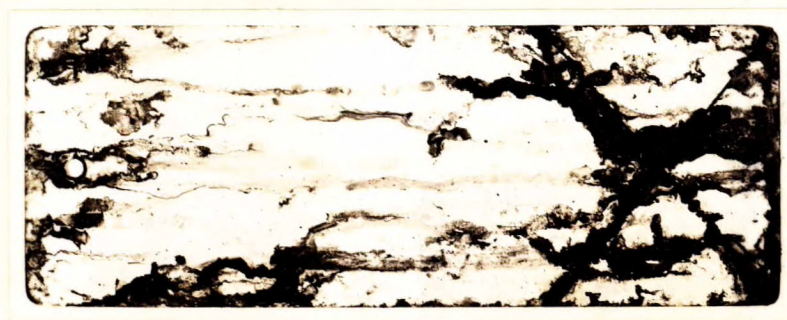
Figure 4.

No. 4 had light corrosion marks over the

complete surface. The bottom two inches was one-quarter covered with corrosion (see Figure 4). The surface appeared to have corrosion under the paint.

No. 4. There was very slight cracking at the edges and at a few spots on the surface.

No. 4. The paint peeled at most places on the surface.
