DEPARTMENT OF MINES AND RESOURCES

BUREAU OF MINES

Investigation No. 2187.

Examination of Fractured Weld in a 35-15 Stainless Steel Retort.

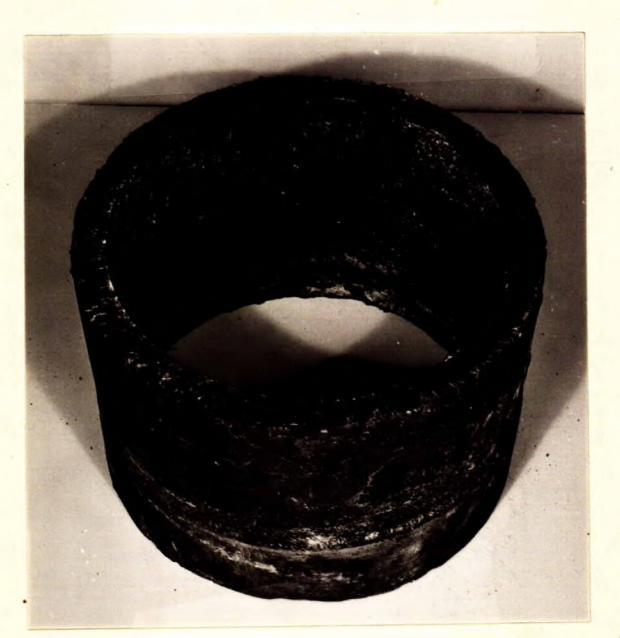
The section submitted was wire-brushed and given a careful visual examination. No visual cracks were detected other than that which failed. The section as-received is shown in Figure 1. Figure 2 is a photograph showing the fibrous nature of the fracture.

RETORT SECTION AS-RECEIVED. Barrel extension piece upward to show weld fracture.

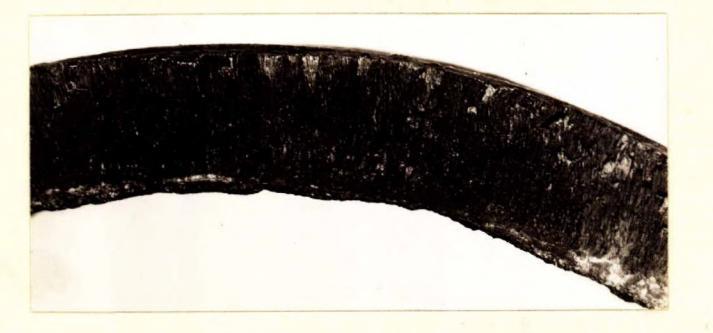
Figure 2.

FRACTURED WELD SURFACE. Note fibrous nature of the fracture.

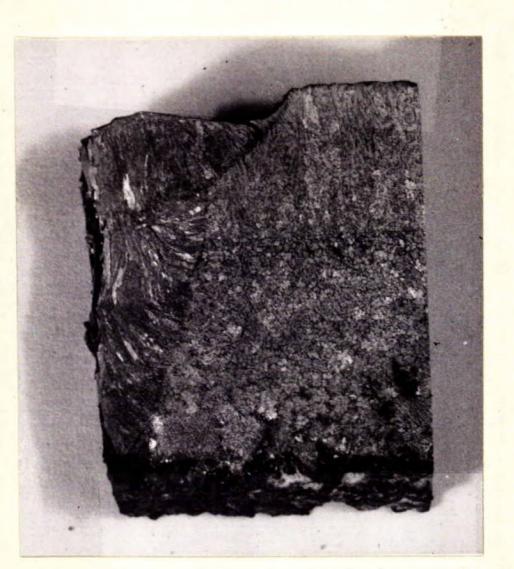
Figure 3.

A sample was cut at the fractured area and etched in aqua regia to show the cross-section of the weld. A small crack can be noticed at the toe of the weld (see Figure 3). Such incipient cracks were found to be relatively infrequent in this section. The crack which caused failure passed directly through the centre of the weld.

X2, etched in aqua regia. MACROSTRUCTURE OF WELD CROSS-SECTION.

Note small crack at toe of the weld (top centre of photograph).

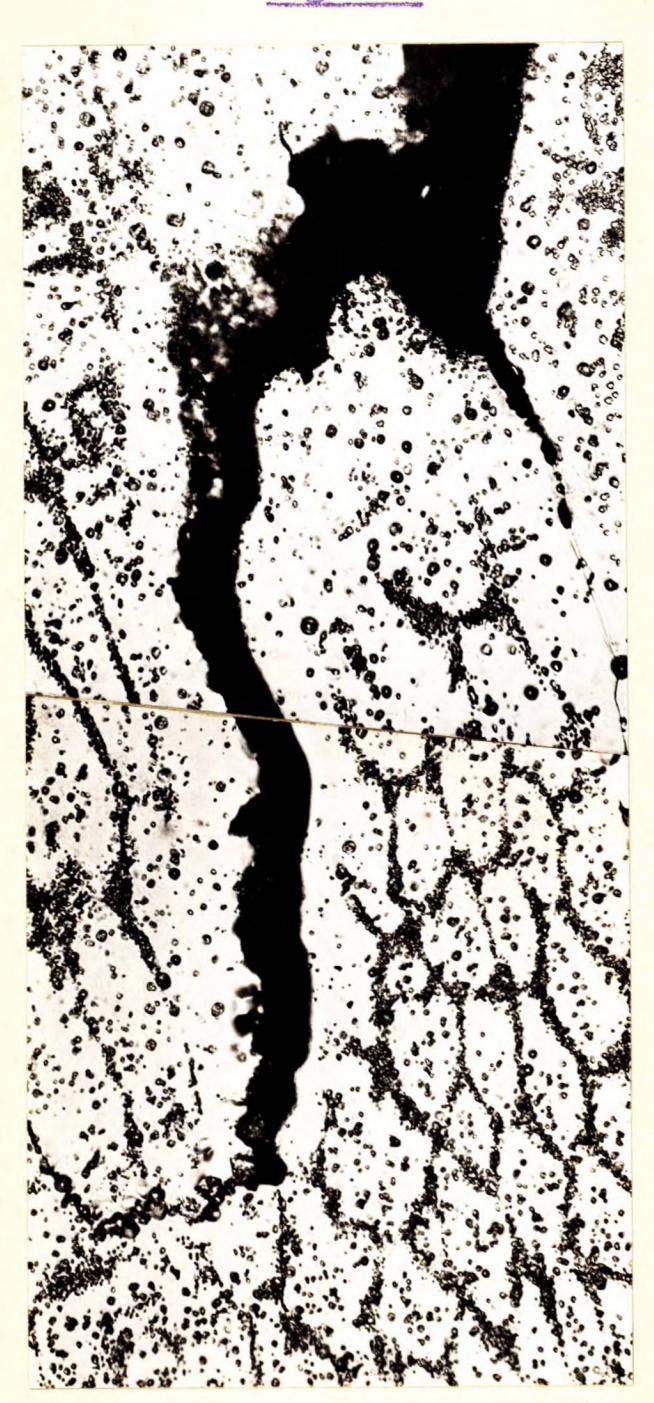
Figure 4.

X500, electrolytic NaCN etch. TERMINATION OF A CRACK IN THE WELD. Note intergranular type of fracture.

A previous investigation of similar failures in 35-15 Mi-Cr retorts<sup>®</sup> outlines the damaging effects of this temperature range on the structural stability of the weld metal. Corrosion resistance and weld ductility are consequently impaired. Figure 4 is a photomicrograph showing the intergranular path of fracture of a weld crack. In accordance with the "chromium depletion" theory, corrosion proceeds most rapidly at the grain boundaries, thus initiating "notch" effects and finally resulting in intergranular failure.

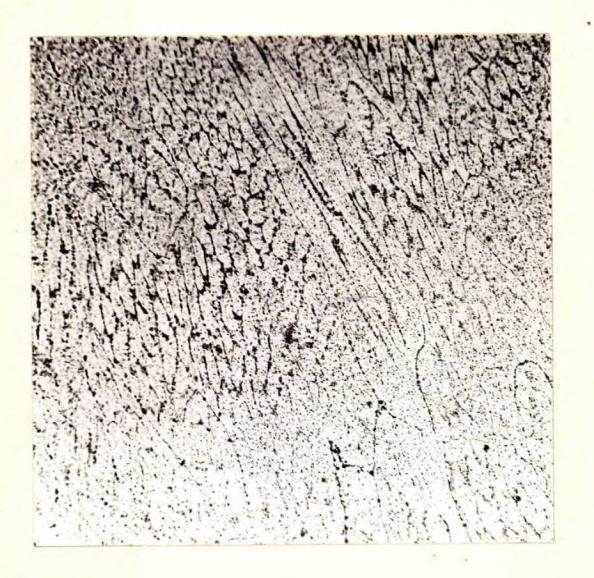
Figure 5.

X100, electrolytic NaCN etch. MICROSTRUCTURE OF WELD METAL. Note distribution of carbides in austenite.

Microscopic examination (Figures 5 to 8) revealed massive carbides within the grains and along the grain boundaries. While data on the service conditions are not at hand to confirm the fact, the size and distribution of the carbides would indicate that the weld zone had been held for prolonged periods within the carbide precipitation temperature range of 800 to 1600° F. Referring to Figure 9 below, it can be seen that the weld area in service must have been between 21 inches and 26 inches from the open end of the retort, a critical location. These linear measurements are true only if the insulation conditions of the furnace are similar to those investigated during the summer of 1945, the time the data used in the graph were compiled.

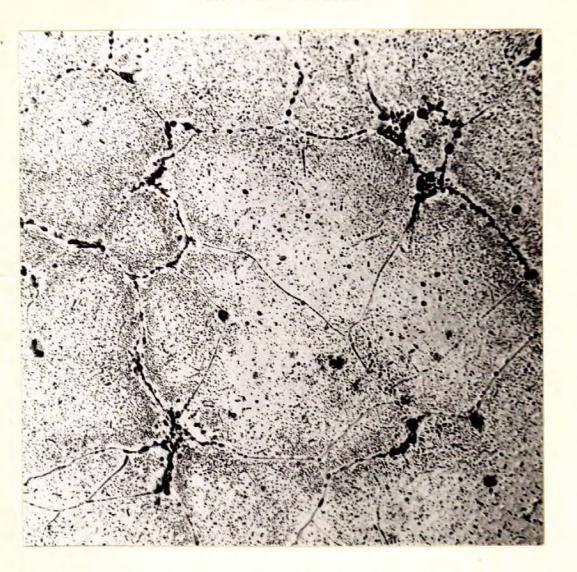
# Figure 6.

X100, electrolytic NaCN etch. MICROSTRUCTURE OF PARENT METAL. Note distribution of carbides in austenite.

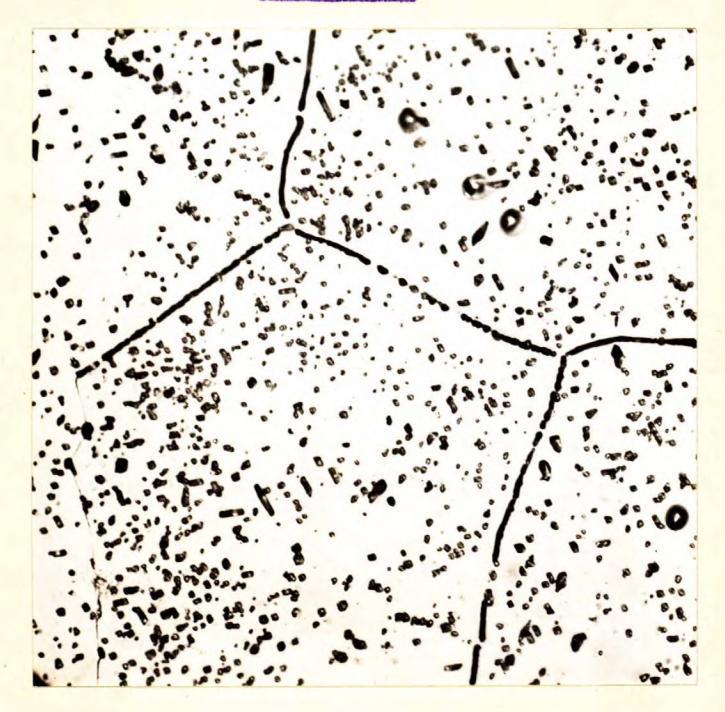
# Figure 8.

X500, electrolytic NaCN etch.

MICROSTRUCTURE OF PARENT METAL - SAME AS FIGURE 6.

Note the coalesced nature of the carbides.

2. The size and distribution of the carbides present would indicate that the weld zone had been at a service temperature within the carbide precipitation range of 800 to 1600° F. at some time in the course of service.

That the results of Investigation Report No. 1924 be adhered to, 1.e., that the location of the welds be such that in service they fall either below or above the limits of the carbide precipitation temperature zone.

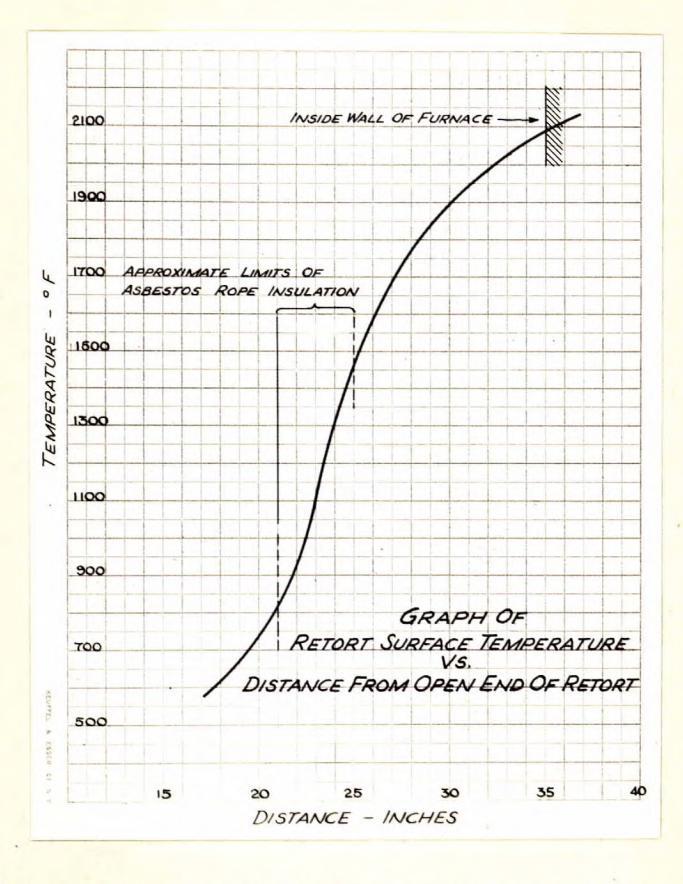
Figure 9.

GRAPH<sup>®</sup> OF RETORT SURFACE TEMPERATURE VS DISTANCE FROM OPEN END OF RETORT.
