MINES BRANCH INVESTIGATION REPORT IN 68-13

# INVESTIGATION OF A QUARTZITE DEPOSIT ON THE M.GREGOR BAY INDIAN RESERVE AT BIRCH ISLAND, ONTARIO

## F.E. HANES

**FEBRUARY** 19, 1968

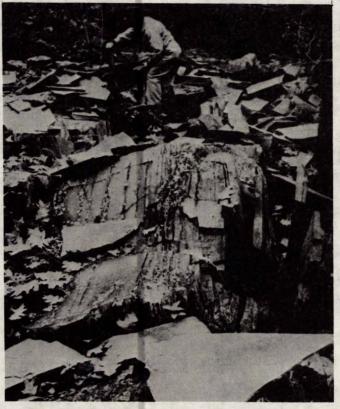
One outcrop visited was located on a small hill behind the Chief's house, not far from the community hall. Figure 1 shows this small quarry and clearly shows considerable cleavage on the outcrop surface. The shallow pit in which Dr. Irwin stands indicates the degree to which this outcrop has been quarried. Cleavage in the rock is not a continuous feature.

Not all cleaved rock was found suitable for use. Some of the rock-surface showing in the foreground of Figure 1 was weathered, with the result that some of the exposed surface crumbled readily. Not all occurrences of cleavage on the outcrops showed weathering, however; in fact, most of the rock outcropping in the area is quite sound. A selection of quartzitic slabs gathered from the above quarry was stockpiled between the quarry and the Chief's house. All of the slabs were sound and were 3/8 to 5/8 inch thick.

Figure 1. Shallow pit showing boulders with prominent cleavage. Dr. A.B. Irwin in background.

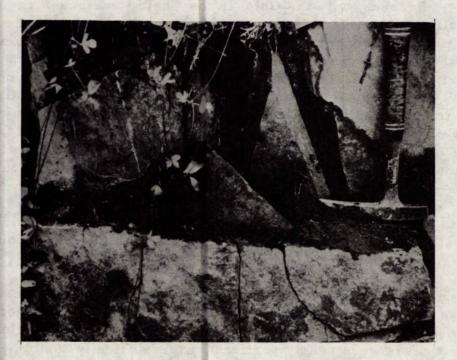
Note the outcrop shown in Figure 2, where no indication of cleavage appears; massive blocks can be recovered by selective quarrying from this type of outcrop. According to the Chief, a small local demand exists for this type of block.

Figure 2. Beds of massive blocks lacking in orderly cleavage and showing irregular fracturing.

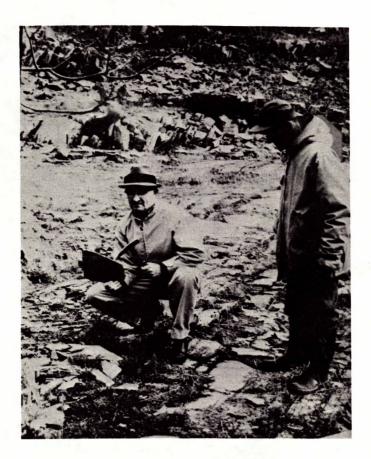
An example of sporadic cleavage is visible on the outcrop shown in Figure 3, where, over a large area in the vicinity of the two figures, only a spot at the Chief's left foot shows the characteristic cleavage.

Figure 3. Chief Nahwegahbow (right) and Dr. A.B. Irwin examining a thin slab of quartzite. Note dip of quartzite slabs (cleavage planes) in background, and cleaved rock (surface indication) at the Chief's left foot.

in assessing the suitability or extent of any rock deposit simply from surface indications. Note the hopelessness of trying to assess the potential value of the cleaved rock shown at the Chief's left foot in Figure 3. It was pointed out that, in many areas, tremendous amounts of rock might have to be removed to recover small pockets of suitable material. Ridges, such as exist in the background of Figure 3, afford one means of visually locating pockets of suitable rock.

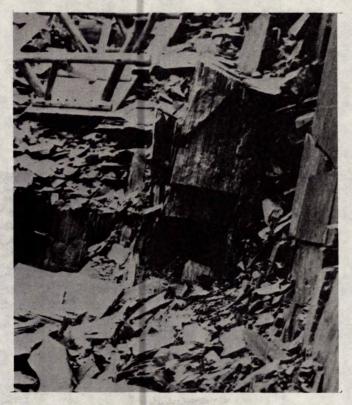
The large outcrop shown in Figures 4 and 5 illustrates a quarrying operation where a considerable volume of cleavable rock is available. Figure 4, showing the overturned picnic table, gives some idea of the size of the slabs that can be recovered. Figure 5 illustrates an ideal working face for this type of quarry operation; slabs can be readily removed from left to right in succession. The degree of fracturing visible in the general area suggests, however, that the recovery of large, unbroken or crack-free slabs will be minimal. This quarry is ideal for substantial production of slabs ranging in thickness from 1/4 inch up to blocks of 12 inches and greater. Figure 5 shows thicker slabs, in place, that could be quarried for heavier building blocks or thick-dimensioned building stones. Slab thickness varies greatly, as can be seen from waste pieces lying near the quarries and from exposed rock in situ, illustrated in Figures 1, 3, 4 and 5.

Figure 4. View of cleavage characteristic of rock in the area. Large quarry (compare size of slabs with overturned picnic table).

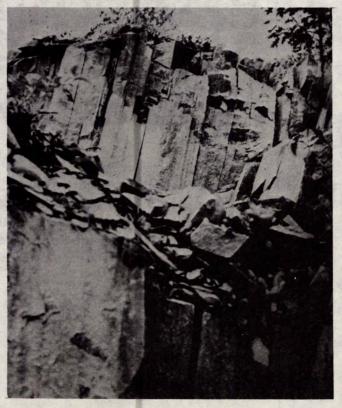
Figure 5. Upper portion of the large quarry, immediately above view in Figure 4. Well defined cleavage and massive slabs prominent.

Probably the most suitable means of quarrying this type of rock would be to locate, in addition to indications of reasonably good cleavage, a deposit so structurally located that a face could be readily opened for quarrying, i.e. a side-hill exposure. Such a deposit is shown in Figures 4 and 5. It is evident that a large quantity of rock has been removed and that a large reserve remains available to quarrying.

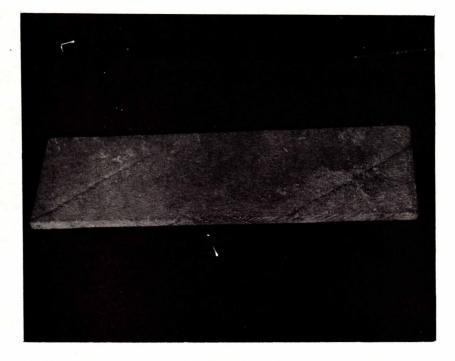
The rock's aesthetic quality is due to the staining, which is mottled in all shades of buff-yellow to deep brown-red. Added to the beauty of this mottling is the natural roughness of the cleavage surface. In some cases, outlines of the original bedding planes appear across the cleavage plane; these are visible as ridges across the face of the stone in sufficient relief to cast a shadow, depending on the direction of light (see Figure 6).

Figure 6. Bedding planes in relief on cleavage plane.

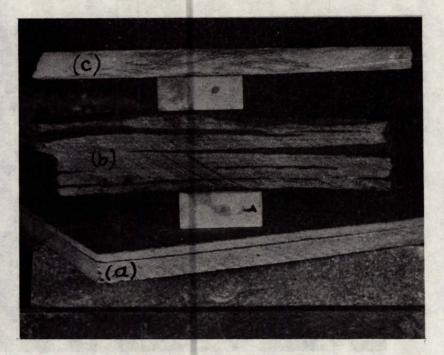
Single-thickness slabs of sound material should be used, in order to eliminate such defects as are shown in Figure 8 (a, b and c). The lower slab (a) shows a parting developing in what appeared to be an otherwise sound slab. The separation is along a less well-defined cleavage plane. Careful examination shows a potentially similar plane of weakness about one third of the slab's thickness from the bottom. The middle sample (b) shows a composite slab to illustrate the multi-layer characteristic often encountered in this outcrop (the cleavage planes have been accentuated by soaking the sample in water). Finally, the third slab (c) in Figure 8 illustrates the presence of oxidized iron-rich minerals interfingered between cleavage planes in the thin slab. Staining will continue to develop from these oxidized minerals as the surface is either worn or dressed to greater depth.

Figure 8. Three slabs showing (a) parting within a prepared slab, (b) multi-layer slab, (c) a zone of oxidized iron-rich minerals within a thin quartzite slab.

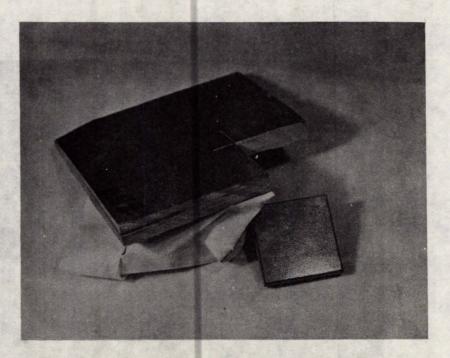
Figure 9 shows a polished, 1 1/2-inch-square sample cut from a deep brown-red oxidized slab. Zones or layers containing concentrated iron oxide can be seen outlined on the side of the larger sample of rock, at the corner near the number '359'. Numerous small spots of oxidized iron-rich minerals can be seen on the surface of the polished square, by binocular microscope or hand lens.

Figure 9. A 1 1/2-inch square cut from a thin, highly oxidized brown-red slab and polished to a high gloss (note glare from light on the small sample).
