MINES BRANCH INVESTIGATION REPORT IR 66-86

METALLURGICAL EXAMINATION OF WELLAND CANAL LOCK GATE ANCHOR PIN

D. R. BELL AND D. A. MUNRO

DECEMBER 30, 1966

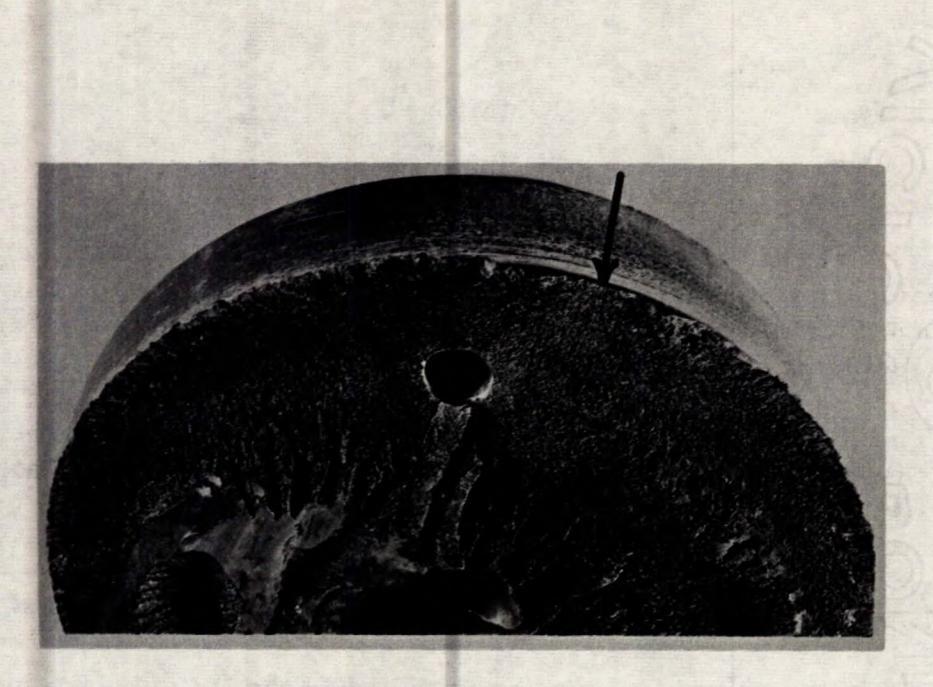
Examination of the fracture surface showed no evidence of fatigue crack markings. The features were characteristic of brittle fracture. The chevron markings showed a single point of fracture initiation, Figure 1. Longitudinal cracks were evident on the surface of the pin in the area of fracture origin, Figure 2.

Given the combination of an impulsive load (of unknown magnitude) low temperature, the notches formed by the extensive weld cracking, and the poor notch toughness of the steel, brittle fracture would be expected. In fact, the notch toughness of the steel was so low that brittle fracture would be expected if the same abnormal loading had been applied in the summer.

Figure 1. Oblique view of fracture face. Arrow shows origin of fracture.

- 1. Replacement pins be made of a low alloy machinery grade of steel such as Atlas Ultimo 200.
- 2. In the event of repair welding of any nature, great care be exercised to ensure the successful employment of the precautions required to guard against cracking.

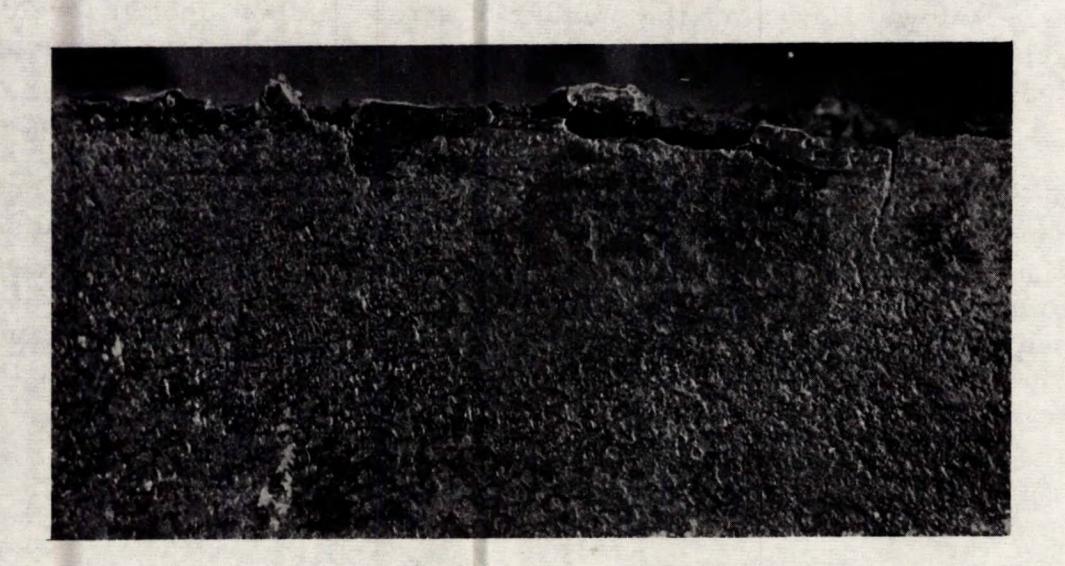
Figure 2. Surface of pin at fracture origin. Note longitudinal cracks.

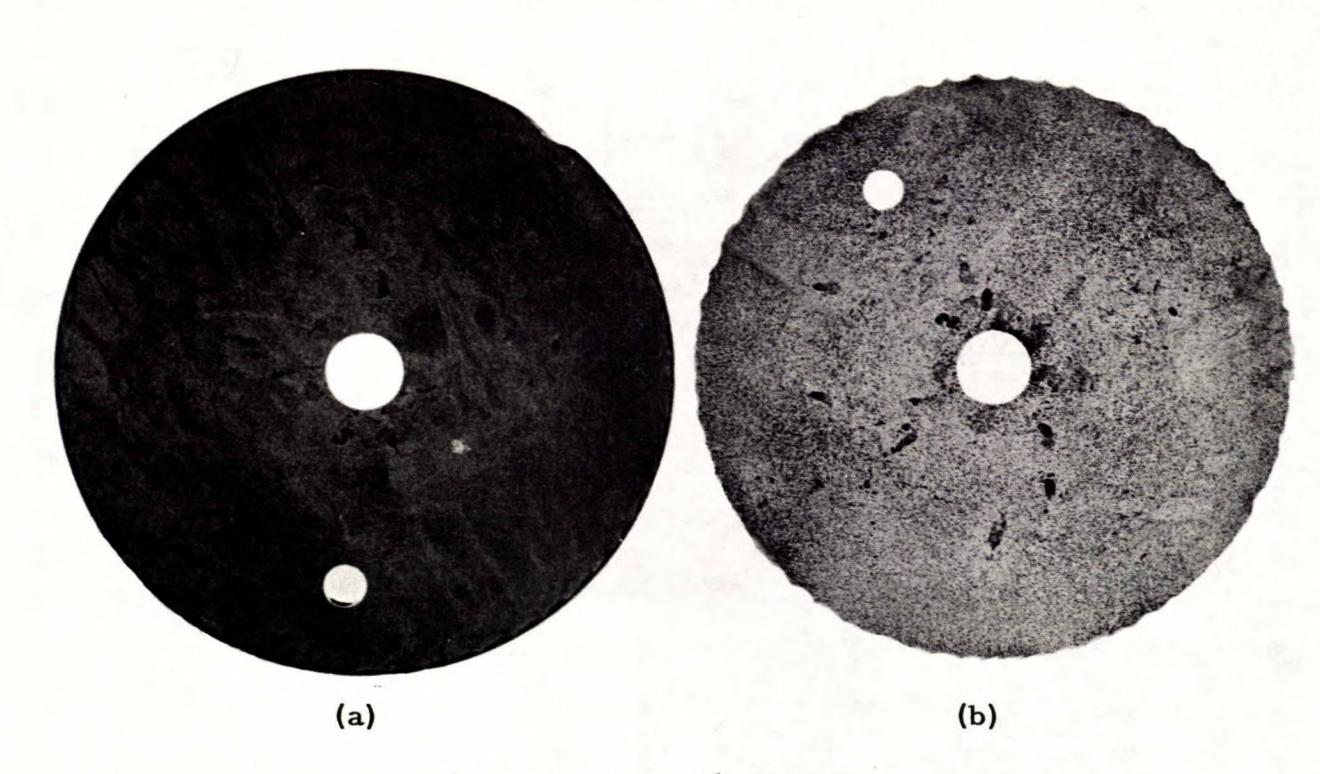
Deep etching in hot 1:1 HC1 and water, and sulphur printing, of a full transverse section showed a high degree of heterogeneity, Figure 3. Flow lines in a deep etched partial longitudinal section showed the pin had been forged rather than rolled, Figure 4.

The silicon content is much below usual commercial practice and suggests this pin was made from steel from an over-oxidized heat. Such material can be expected to have inferior notch ductility. The degree of heterogeneity is excessive by normal commercial standards. Despite these metallurgical deficiencies the pins stood up to the normal service requirements for an extended period of time.

Figure 3. Full transverse section adjacent to the fracture.

(a) Shows results of deep etching in hot 1:1 HCL and water.

(b) Is a sulphur print of the same section.

Both show a high degree of heterogeneity.

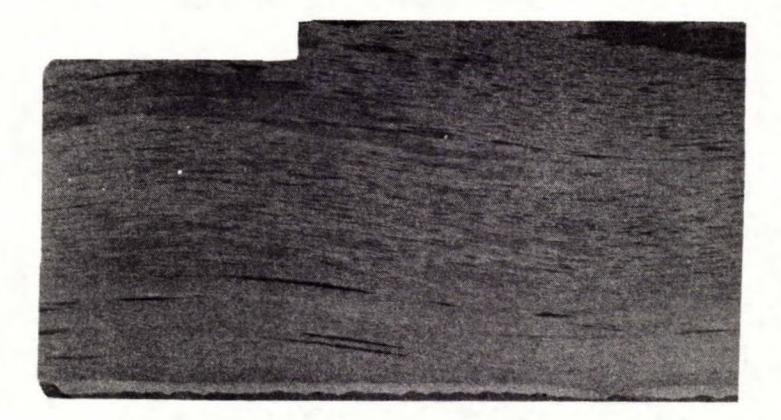
Figure 4. Half longitudinal section, deep etched in hot 1:1 HCL and water. Curved flow lines indicate the material had been forged rather than rolled. Again, marked heterogeneity is evident.

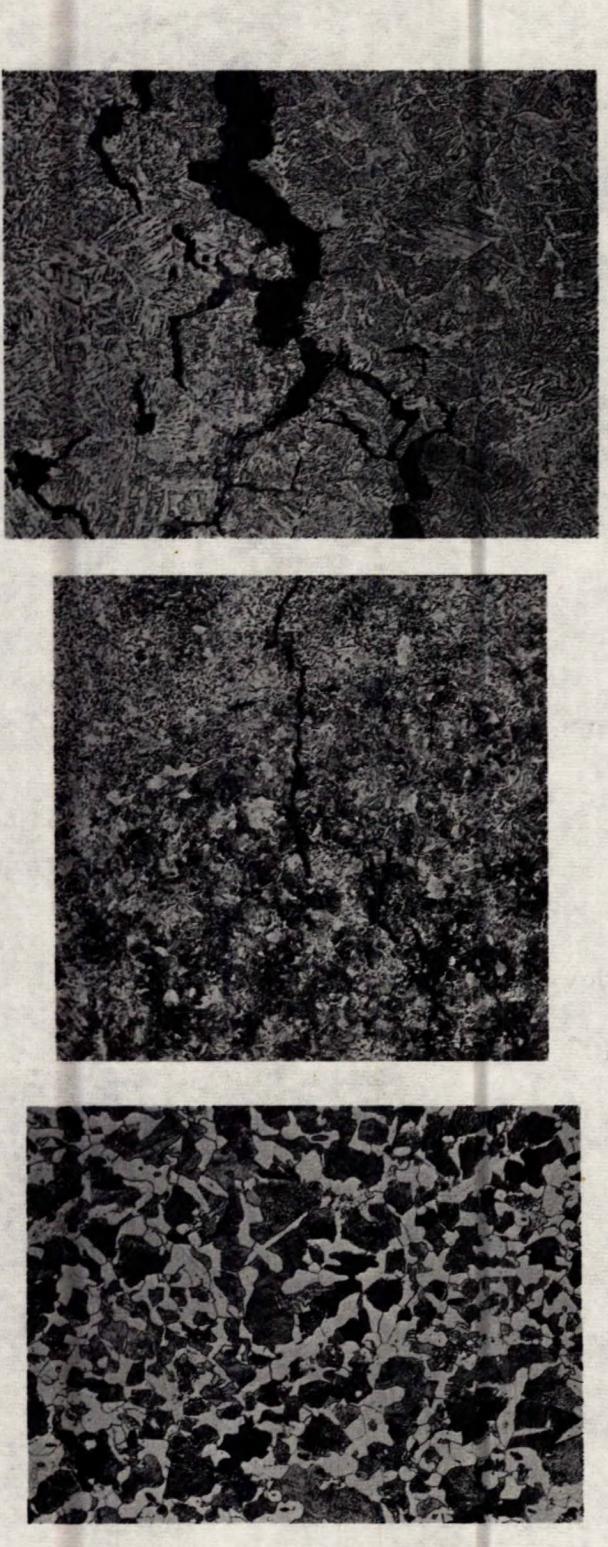
Microexamination revealed numerous cracks in both the weld metal at the surface and in the heat-affected zone in the parent metal, Figure 5. The general microstructure consisted of rather coarse-grained ferrite and pearlite characteristic of normalized, medium-carbon steel.

In considering the degree of hazard from the various deficiencies and stresses, first place must go to the weld cracks. The sharp notches so formed constitute the best crack starters for brittle fracture, and are potent fatigue crack initiation sites. It is recommended that all possible precautions be taken in future to guard against cracking, including under-bead cracking, when weld repairs are carried out. Even the relatively modest mechanical properties of this pin may have been sufficient to give extended further service in the absence of such severe defects.

(a) Weld metal.

(b) Weld metal at top and heat-affected zone of parent metal at bottom.

(c) Parent metal.

Figure 5. Transverse section adjacent to the fracture origin. Note the severe cracking in the weld metal, (a), extending into the under-lying heat-affected zone (b).
