MINES BRANCH INVESTIGATION REPORT IR 58-92

# THE DEVELOPMENT OF IMPROVED ZINC-BASE DIE CASTING ALLOYS (Project Zn-6). Phase II(a): Preparation of Model 1000 ABC Die Casting Machine for Production of Die Cast Test Pieces.

**H. GUTTMAN**

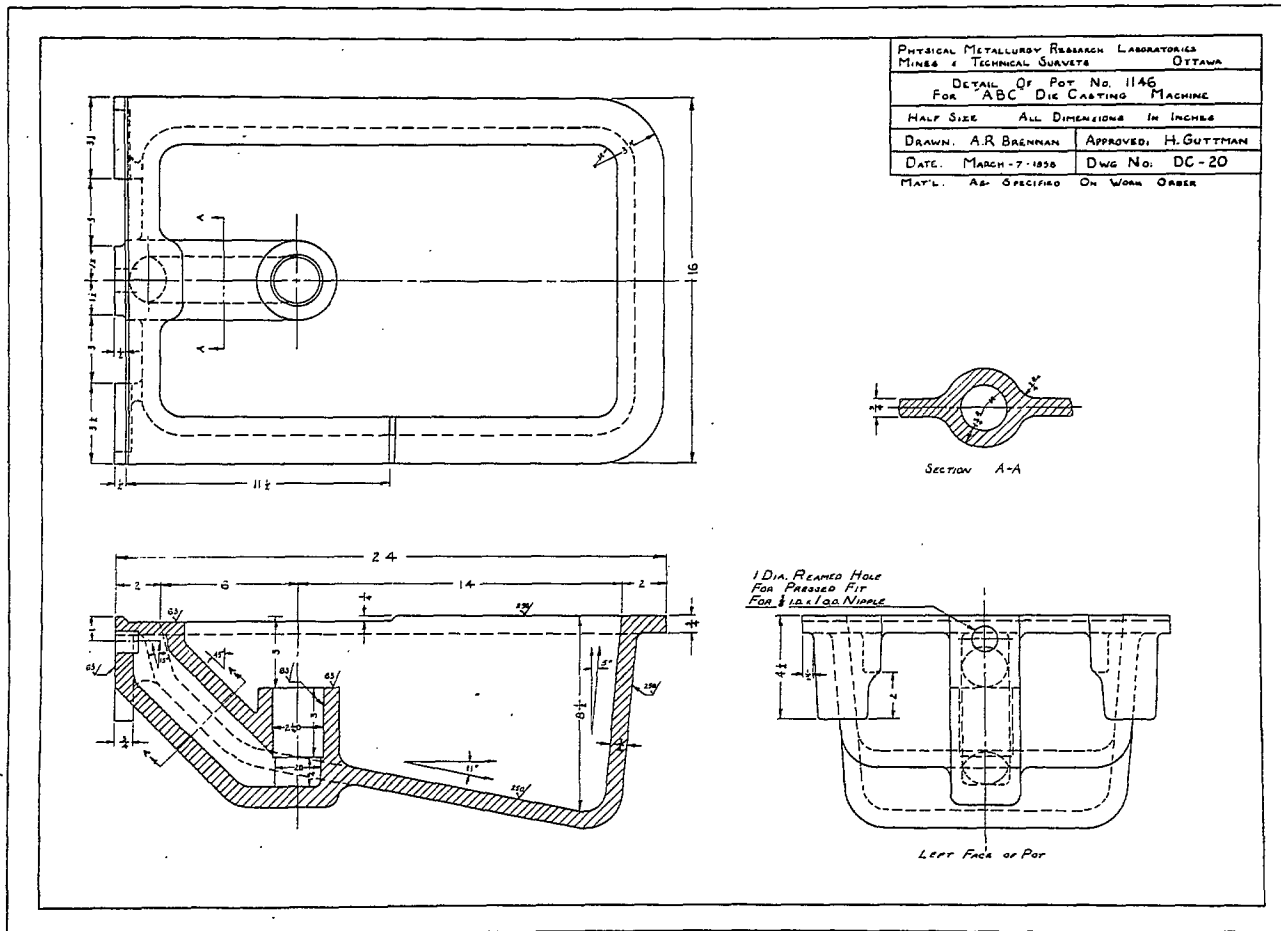
Fig. 3. - Drawing of pot for ABC die casting machine.

(b) Soon after the first few casting runs were made, leakage of alloy from the pot, at a point immediately below the vertical gooseneck cylinder, was noticed. The pot was removed from its setting and examination revealed the presence of a crack approximately  $5/8$  in. long. Since the leakage was not excessive, the pot was placed back into operation until a replacement was obtained. The leakage appeared to occur only during the melting down of the charge, indicating that the

crack opened up on cooling, and sealed itself on heating. Extended use did not appear to aggravate the leakage or cause the crack to grow appreciably in size. The replacement pot was examined on receipt and was found to have no surface flaws. However, after a very short period of use this second pot developed a similar type of leak in the same location.

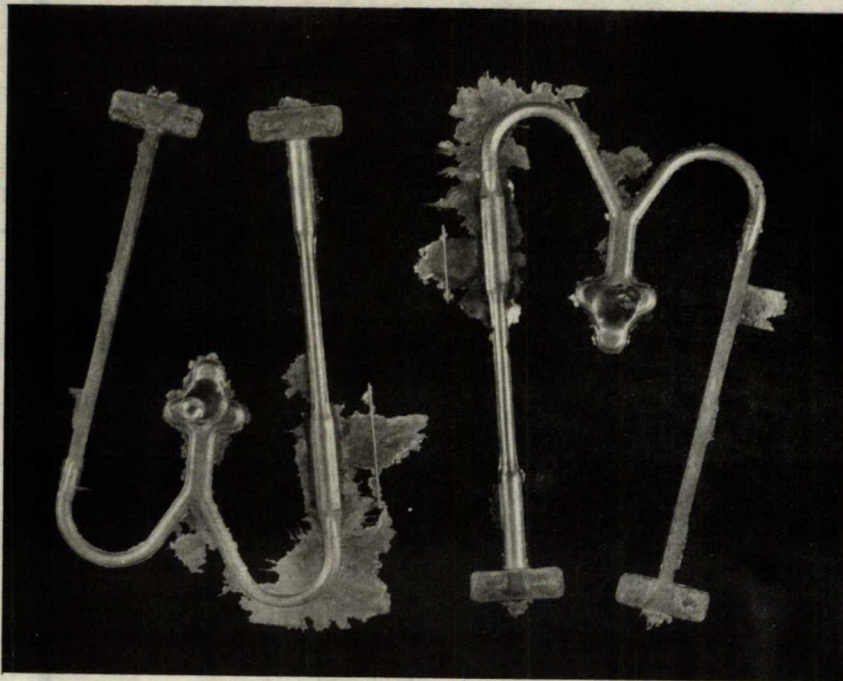
During the early stages of die break-in, excessive flashing occurred in the area of the tensile bar gate runner. Figure 4 shows two typical castings with this defect. This type of flashing was practically eliminated by installing set screws in the previously mentioned stiffener bar, which butt up against the machine base casting. By proper adjustment of the set screws, movement of the lower corner of the die block was prevented, and satisfactory castings resulted. This did not eliminate excessive flashing in the area of the impact bar overflow well. This flashing, which occurred fairly frequently, was not of a serious nature and no efforts were made to overcome it.

Fig. 4. - Test bar castings, showing excessive flash.

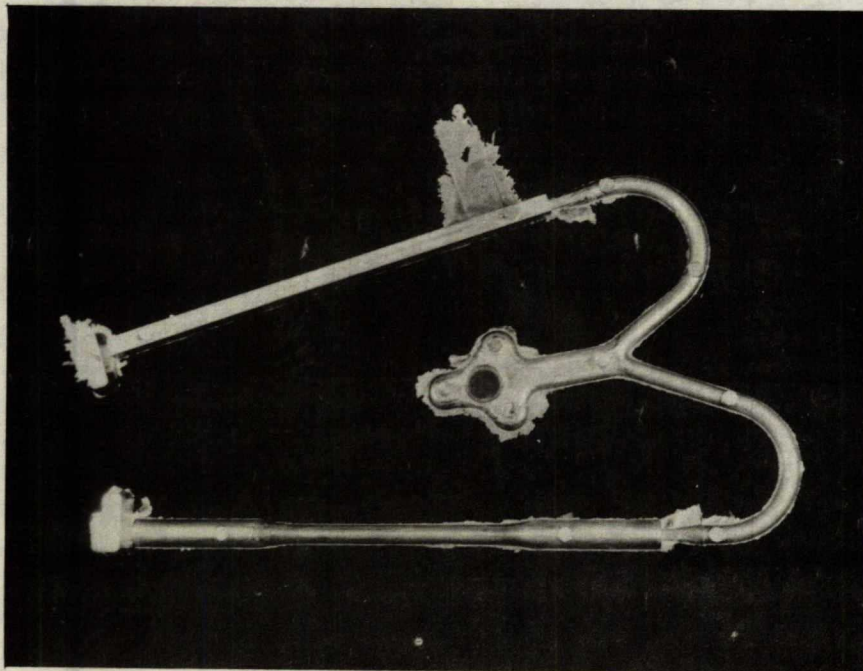
Figure 5 shows the ejector side of a typical casting produced from the test bar die as originally designed. Evident in this picture are the sizes of the overflow wells and of the gates leading into the test bar cavities. As will be discussed later, it was necessary to modify the design considerably in order to obtain reasonably sound

Fig. 5. - Test bar casting as originally designed (ejector surface).

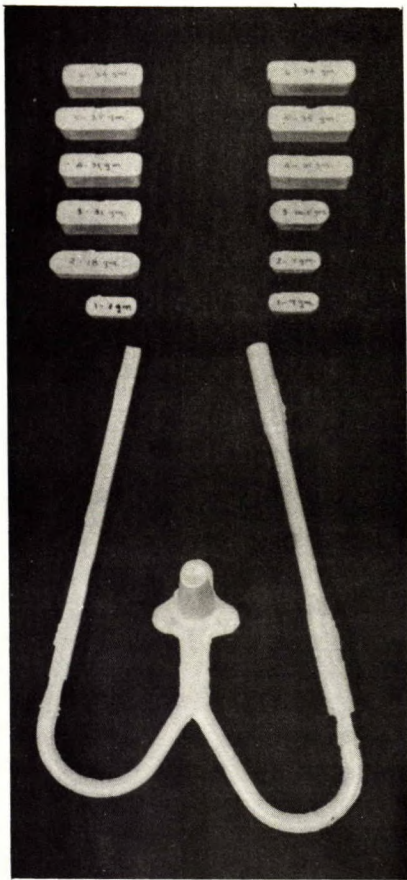
The initial work was concentrated mainly on increasing the sizes of the overflow wells, although some changes were made in the gate sizes at the same time. Figure 9 illustrates the steps by which the overflow wells were enlarged. As can be seen, the improvement of the impact bar was the first consideration. The maximum size and projected area allowable was approached at step 3, with subsequent changes being made in an effort to effect easier ejection of the casting and to impart strength to the runner joining the impact bar and the overflow well. The maximum size of the tensile overflow well was reached at step 5, the increase between steps 3 and 4 being the major one.

Fig. 9 - Overflow well enlargement.

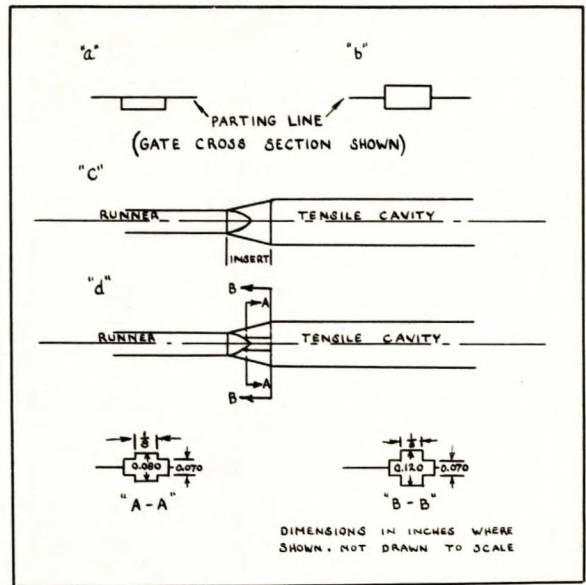
Changes were made to the type of gating on the tensile cavity side, and these were eventually effective in at least confining the porosity to the grip section and away from the gauge length section. The changes made were as illustrated in Figure 10. The first change was from type "a" to type "b". In type "b", half of the gate is cut into each die block. This change was made in order to discharge the metal into the cavity in such a manner that the stream would be less likely to strike the cavity wall in the gauge length section. However, it was not until the type "c" gate was installed that indications of improvement became apparent. The improvement seemed to be due to the fact that the turbulent flow was confined to the grip section at the gate end, and entrapped air was prevented from entering the gauge length section. The type "d" gate was installed after flow lines were noticed lightly etched on the gate insert faces at the location of the added vertical grooves. However, this change had harmful effects and the type "c" gate was reinstalled. The die design was finalized with this type of gate.

Fig. 10. - Types of tensile gates.

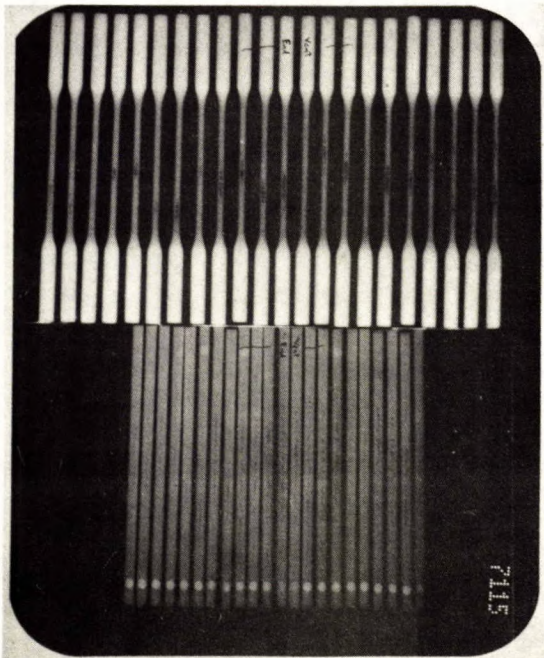
Improvements were not noted radiographically until enlargement of the overflow wells was attempted. Figure 11 shows the radiograph of

test pieces from cast 12. Prior to making this cast, the impact overflow well was increased in size from 7 to 18g. On the impact bars, porosity is confined to a centre line distribution, with some variation in the width of this line. On the tensile bars, porosity is evident in both grip sections and in the gauge length section. It should be noted that, because of underexposure, the radiograph does not give a true indication of the severity of porosity in the thicker grip sections. The extent of porosity in the gauge length section is clearly evident. Most bars show gross porosity in the central portion, and some gross porosity at the gate end where the cross-sectional area changes.

Fig. 11. - Radiograph of bars of cast 12.

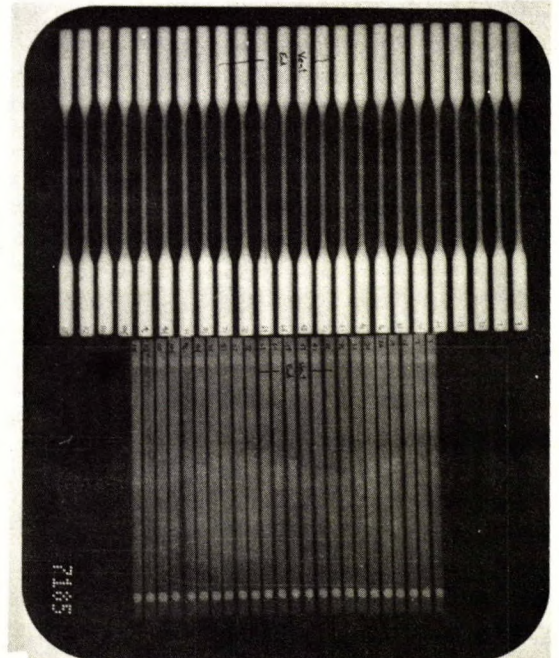
Since testing results were rejected only if porosity was present at the fracture surfaces, once the radiographic quality of the test bars approached that shown in Figure 12 it was no longer

Fig. 12. - Radiograph of bars of cast 24.

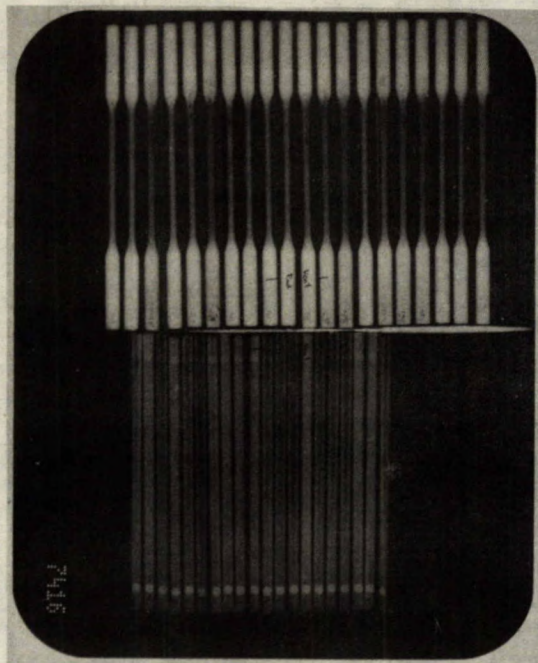
Radiography and mechanical testing indicated that, at this stage, satisfactory castings could be produced and the casting of the titanium series of alloys was therefore commenced. However, considerable difficulty was encountered. The first five casts were carried out with the die temperatures in the lower range, previously discussed. In subsequent casts it was necessary to adopt the higher temperatures as being standard. Also, during the first ten casts of this series the effects of improper bath level were first noticed. The radiograph of cast TI, shown in Figure 13, is typical for test bars made during these runs. In a large number of the test bars examined, the porosity extended from gate to vent end. In many cases, holes were present at the vent ends, and could be seen on visual inspection. In Figure 13, the gross porosity in the grip sections is clearly visible. The test pieces have been so arranged that the gate ends of the tensile bars are at the top of the radiograph and the gate ends of the impact bars are at the bottom.

Fig. 13. - Radiograph of bars of cast TI.

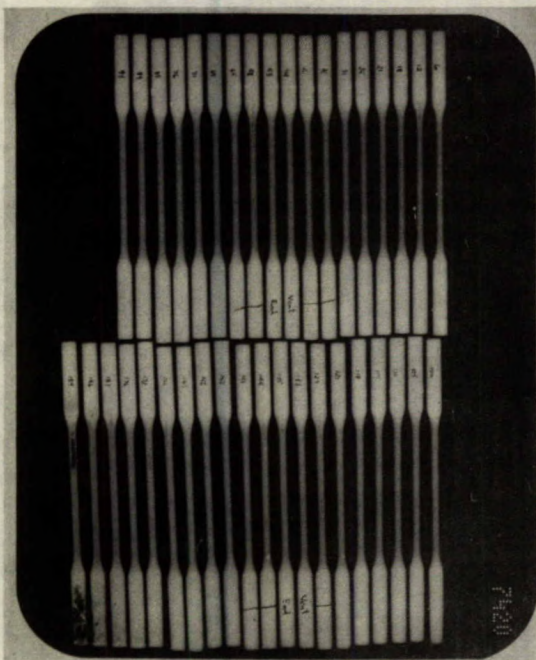
It was discovered that the gross porosity was due to improper bath level control. During the first cast of the zirconium series (ZA), an attempt was made to control the level of the metal in the pot at a point where air and dross could not be sucked into the gooseneck. The radiographs of Figures 14 and 15 show the importance of level control, and its effects on the quality of the test pieces. In these radiographs, the test pieces have been arranged in the order of production. In Figure 14 (tensile bars), the sequence starts at the upper right and ends at the lower left corner. In Figure 15 (impact

Fig. 14. - Radiograph of tensile bars of cast ZA.

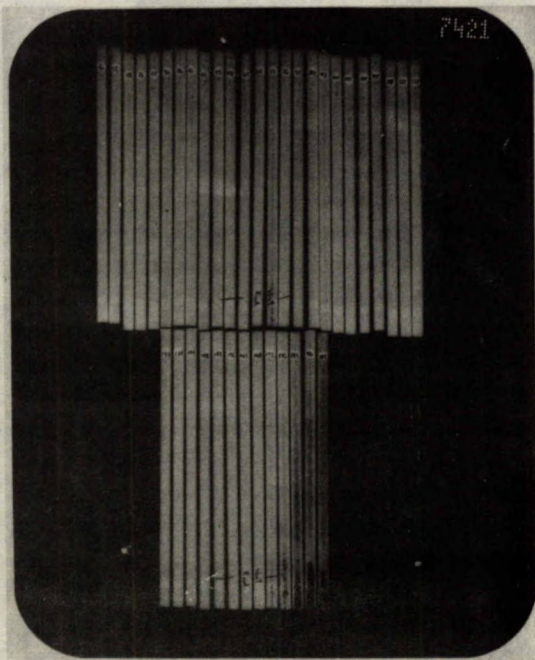
Fig. 15. - Radiograph of impact bars of cast ZA.
