MINES BRANCH INVESTIGATION IR 59-23

# INVESTIGATION OF FAILURE OF TIMKEN ROLLER BEARINGS

# R. F. KNIGHT

FEBRUARY 26, 1959

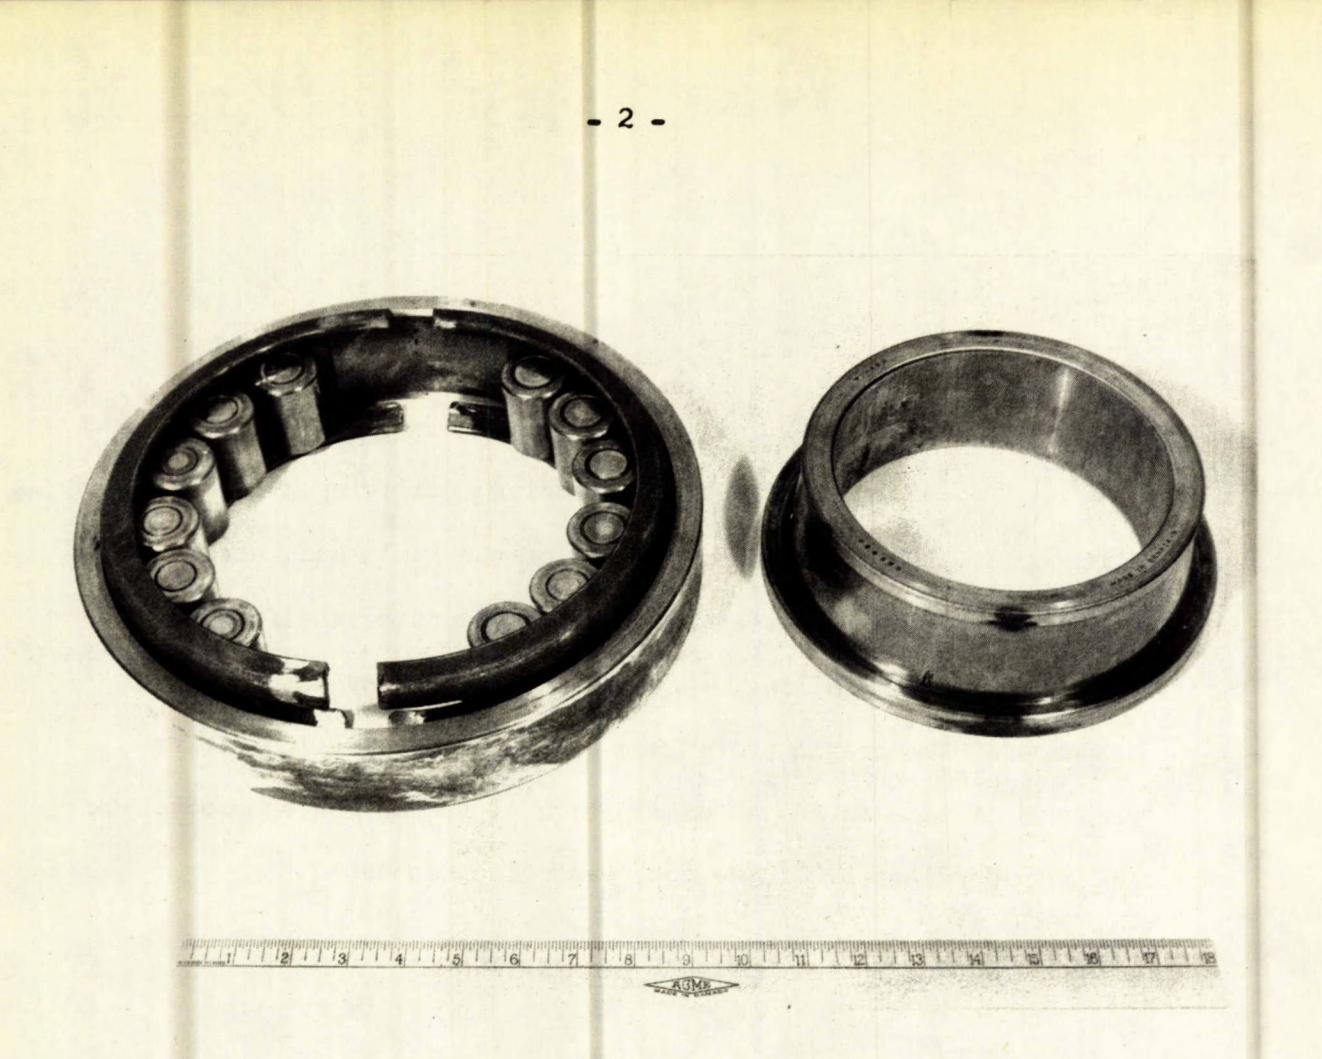
- 1. The outside diameter of the cup showed two relatively rough, dark areas surrounded by polished regions.
- 2. The raceway of the cup had two shallow spalls and a large number of small, smooth-bottomed depressions. The spalls were in the same section of the cup as the larger of the dark areas on the outside diameter.
- 3. The raceway of the cone showed severe spalling at the flange edge of the raceway. Numerous small smooth indentations were also present.
- 4. The rollers showed many small, smooth depressions, but no spalling was evident.

Figure 1 - Bearing No. 1. Shows dark patches on outside diameter of cup (at left), two spalls on raceway of cup (12 o'clock), and large spall on raceway of cone (7 o'clock on right-hand part).

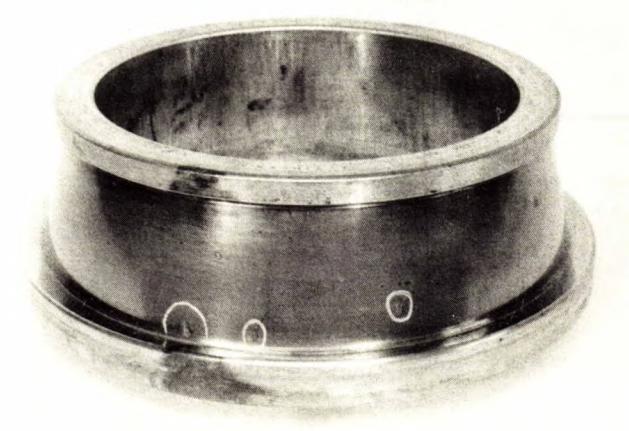
Figure 2 - Cone No. 2. Illustrates three spalled areas (circled) on the raceway of the cone. Spall at right (5 o'clock) was sectioned for microscopic examination.

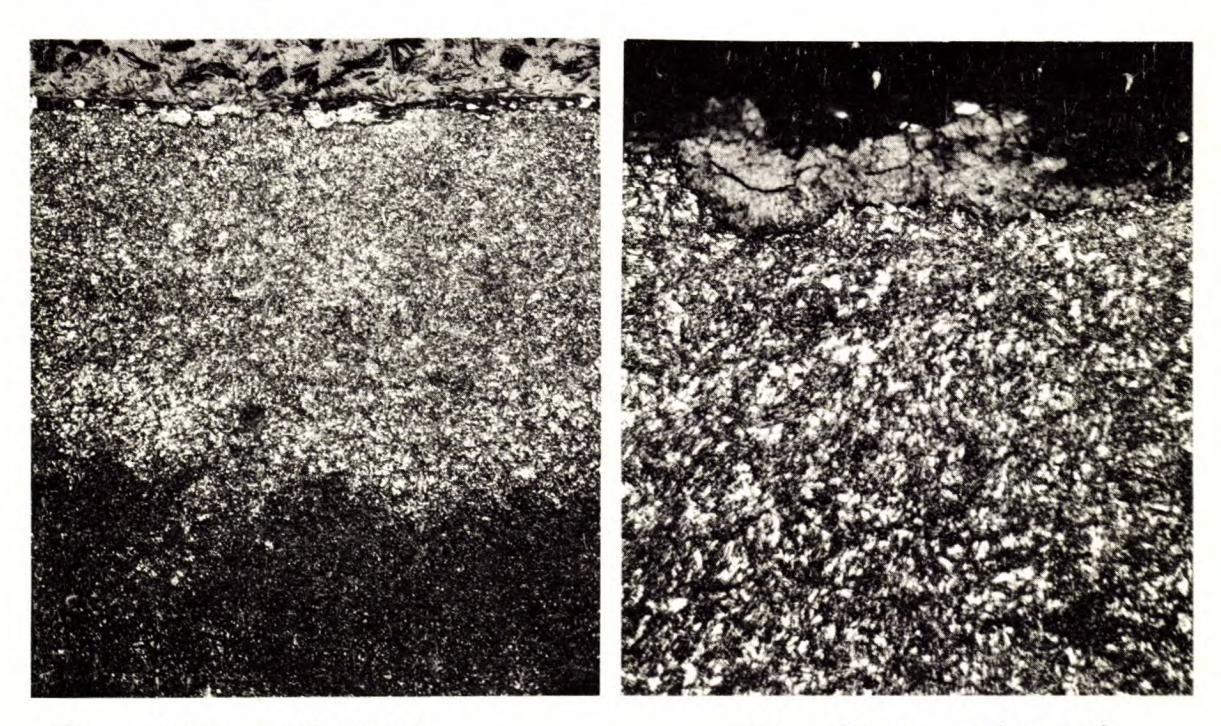
Figure 3 - Shows scale and surface roughness at outside diameter of cup. (Mag. X500; 2% Nital)

Figure 4 - Shows same area as in Figure 3.

The general appearance of the corrosion product on the outside diameter of the cup was similar to that found when fretting occurs. X-ray identification showed the corrosion product to be a typical fretting product. The outside diameter appeared to have been roughened considerably at the areas showing the corrosion product.

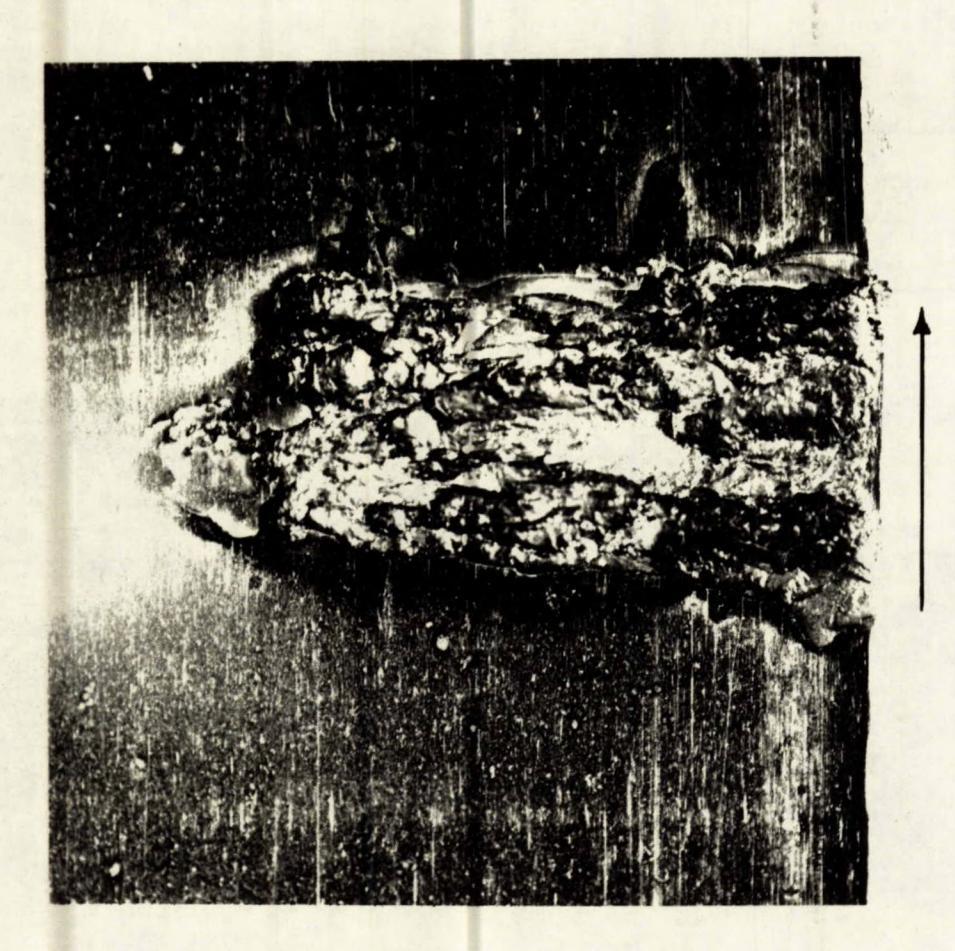
Figure 5 - Multiple spall on raceway of cone No. 1 (7 o'clock in Figure 1). Note transverse cracking at upper surface. Arrow indicates suspected direction of rotation.

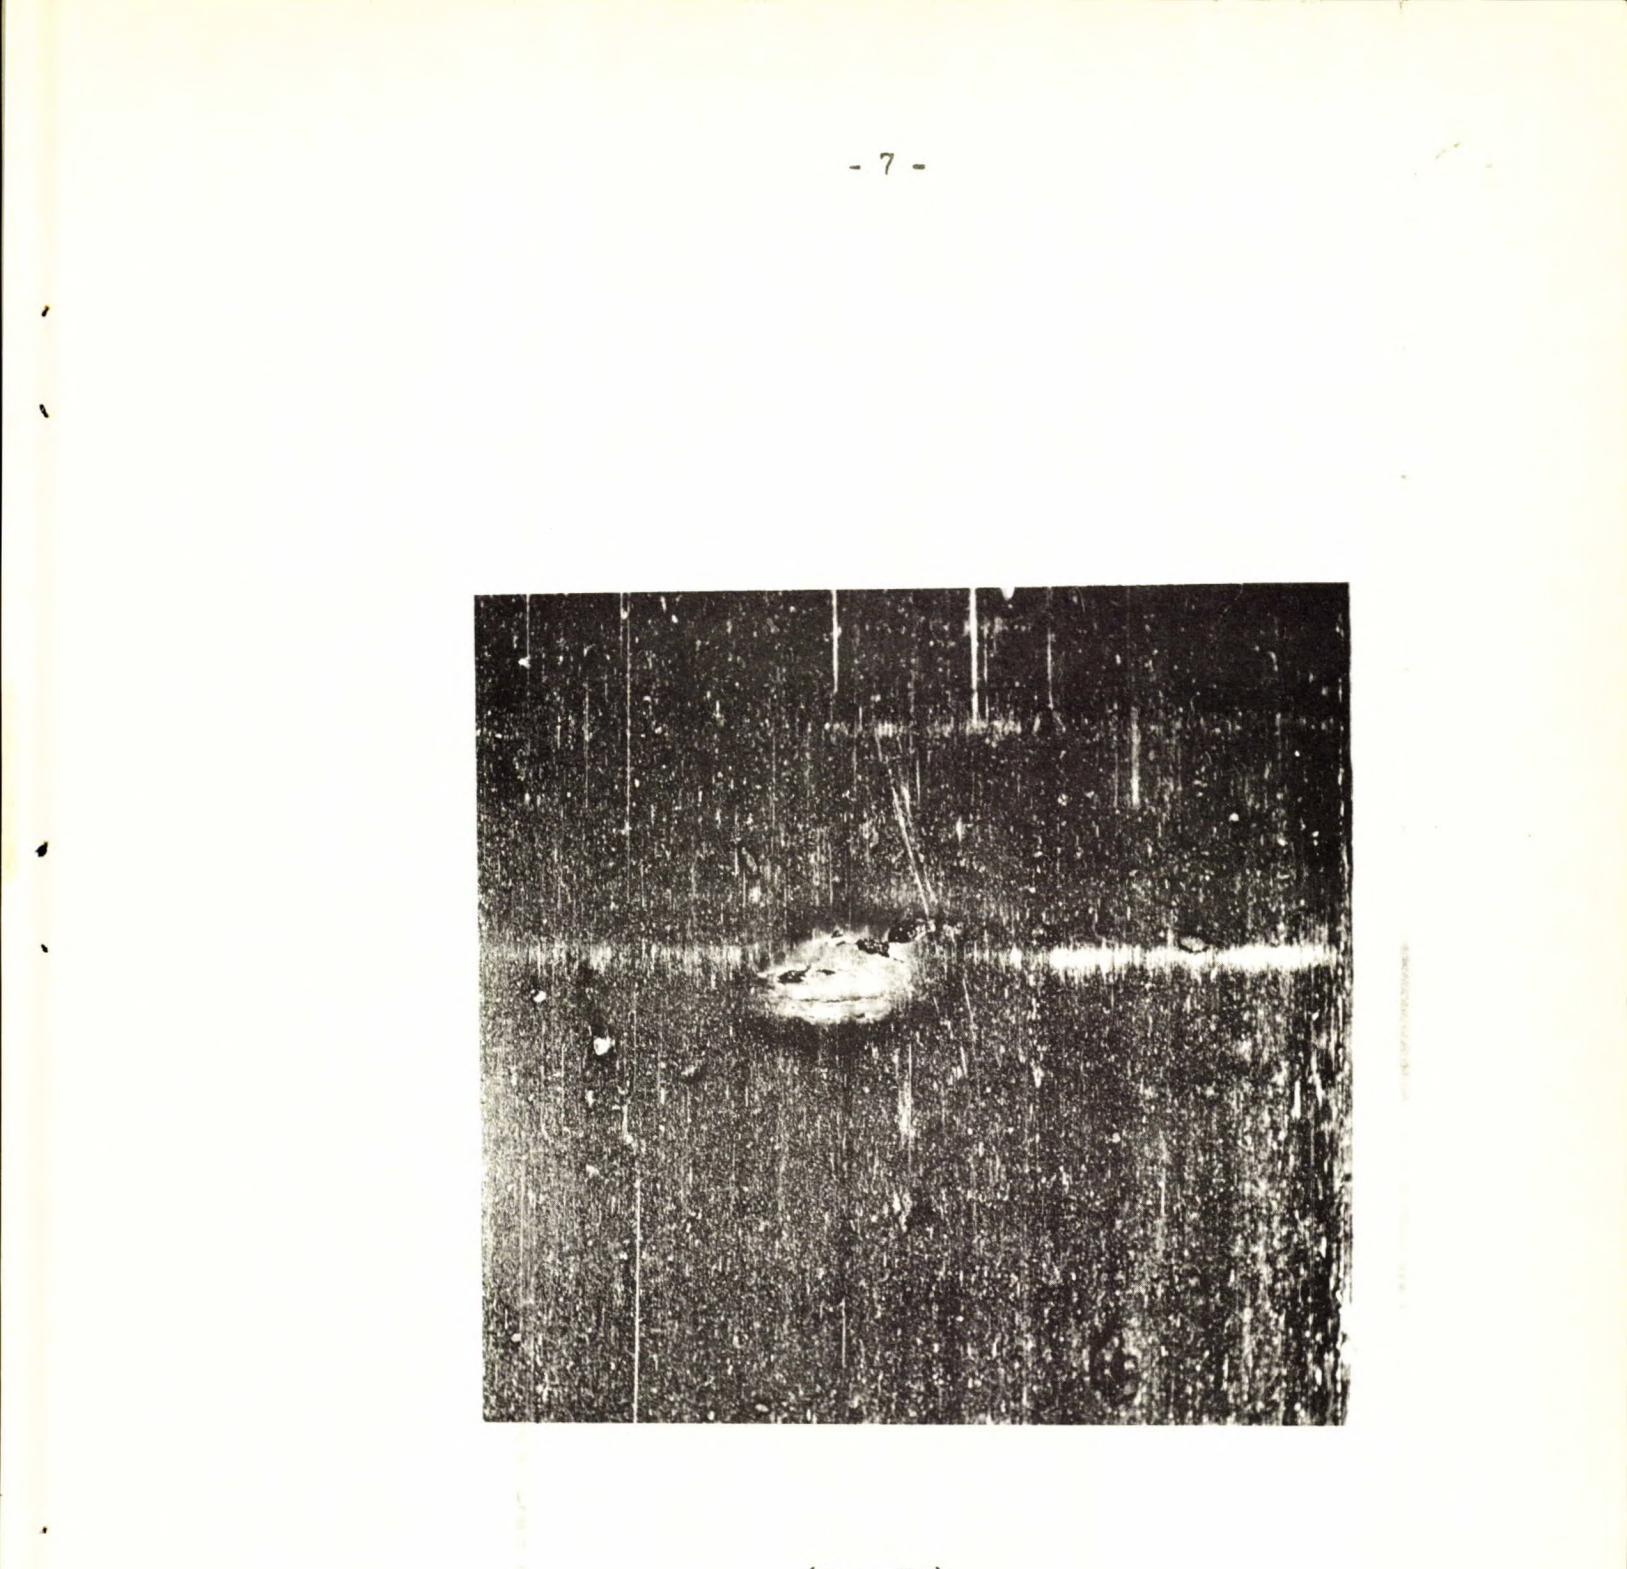
Figure 6 - Incipient spalling on raceway of cone No. 1 at same distance from thick rim as spalling shown in Figure 5. This spall is located at 11 o'clock as oriented in Figure 1. This defect was cross-sectioned for microscopic examination.

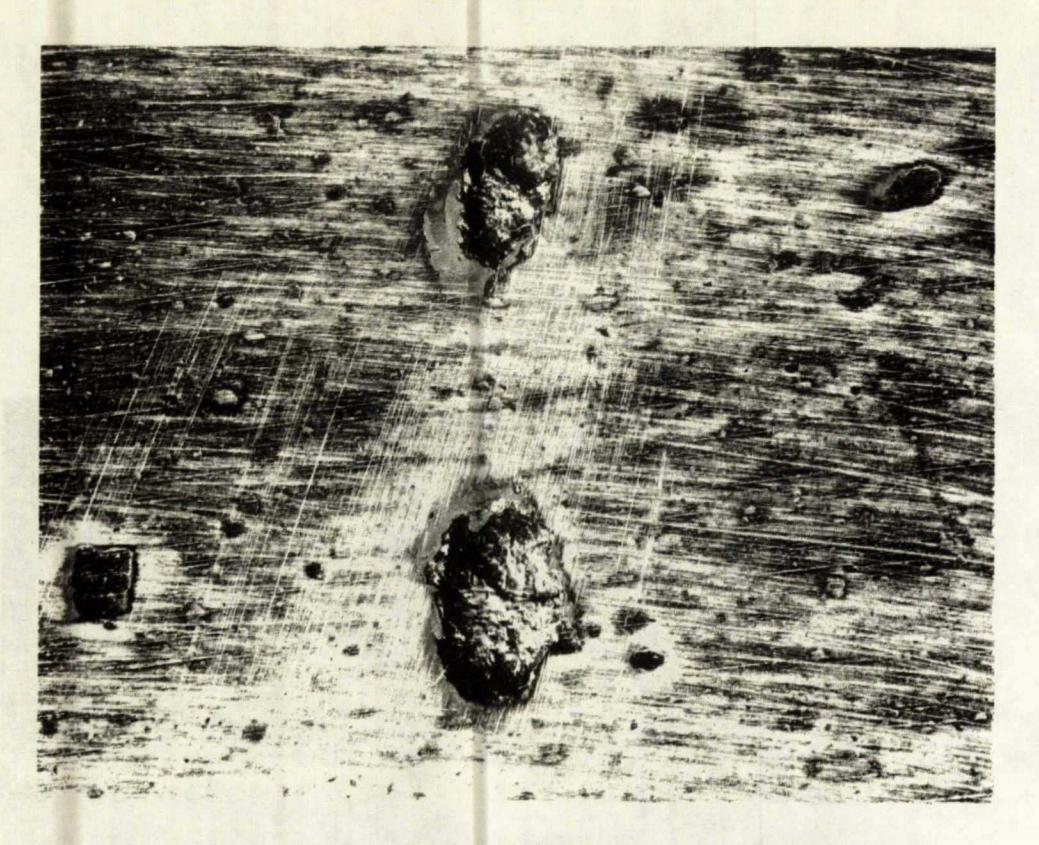
Figure 7 - Spalls on raceway of cup No. 1. See 12 o'clock position in Figure 1. Microspecimens were cut at, and adjacent to, these defects.

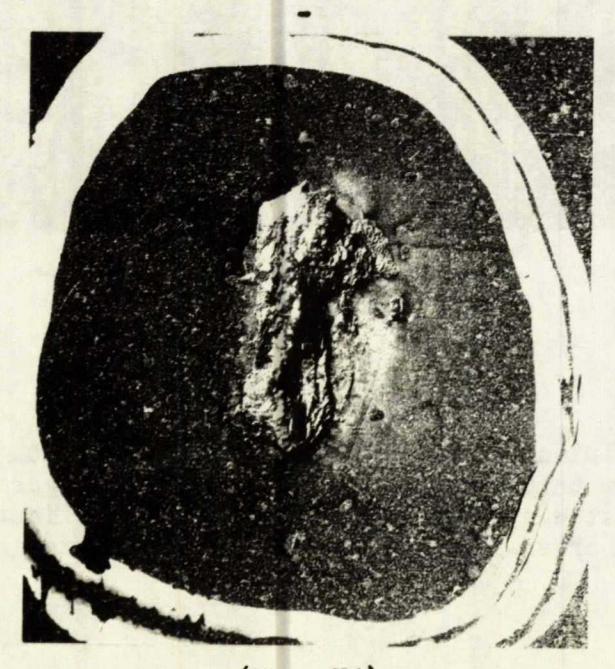
Figure 8 - Spall shown at 5 o'clock position of cone No. 2 (Figure 2). This defect was cross-sectioned for microscopic examination.

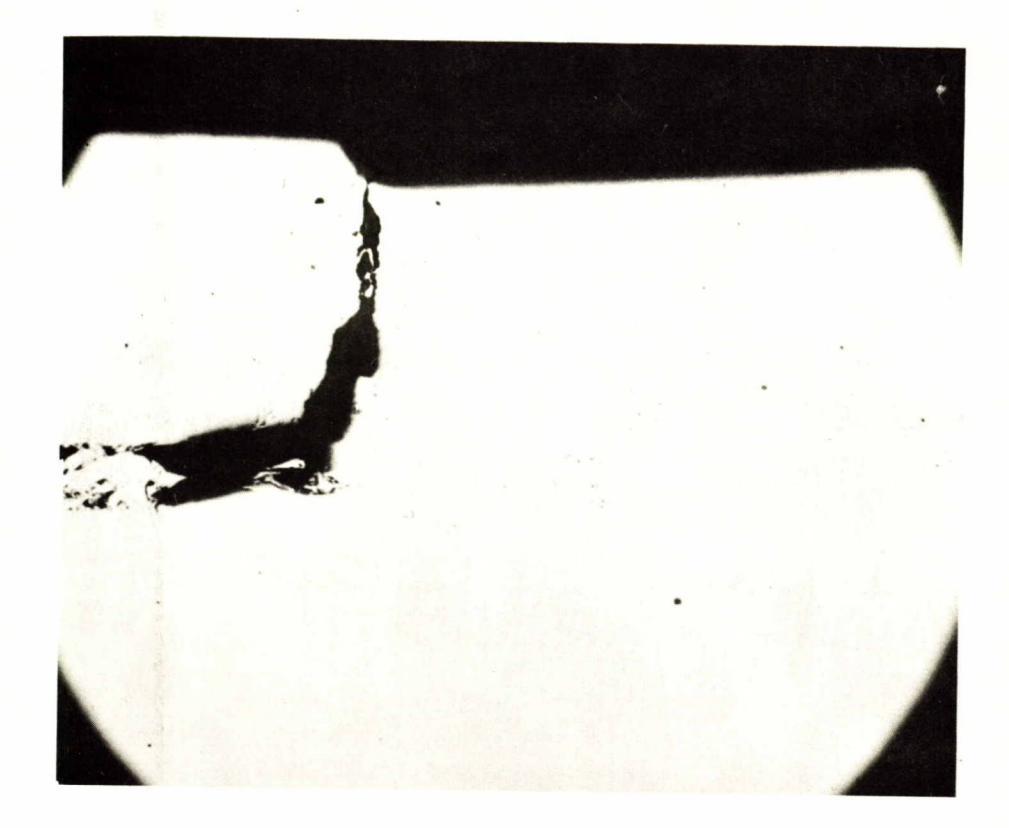
Figure 9 - Cross-section at incipient spall shown in Figure 6. (Cone No. 1).

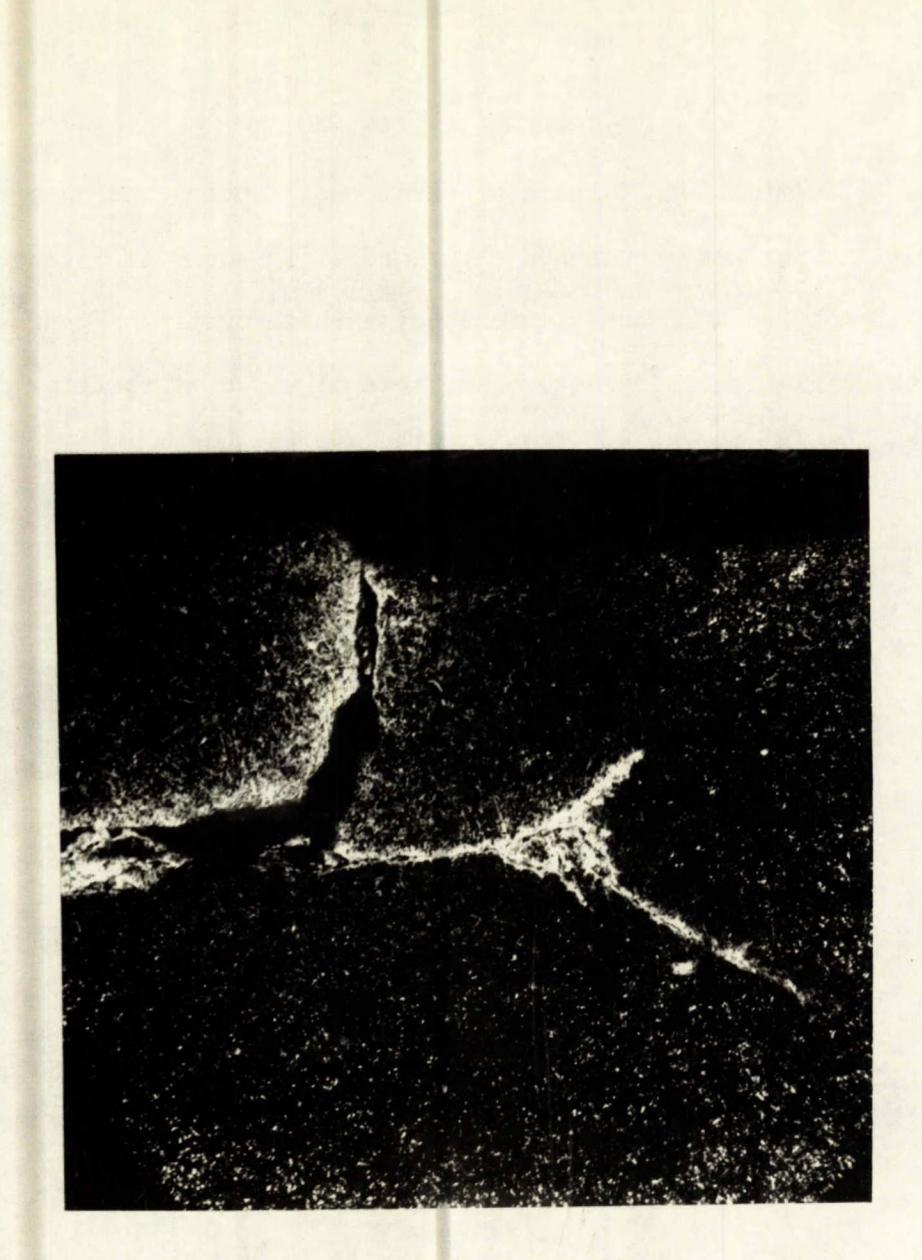
Figure 10 - Same field as in Figure 9. (Cone No. 1).

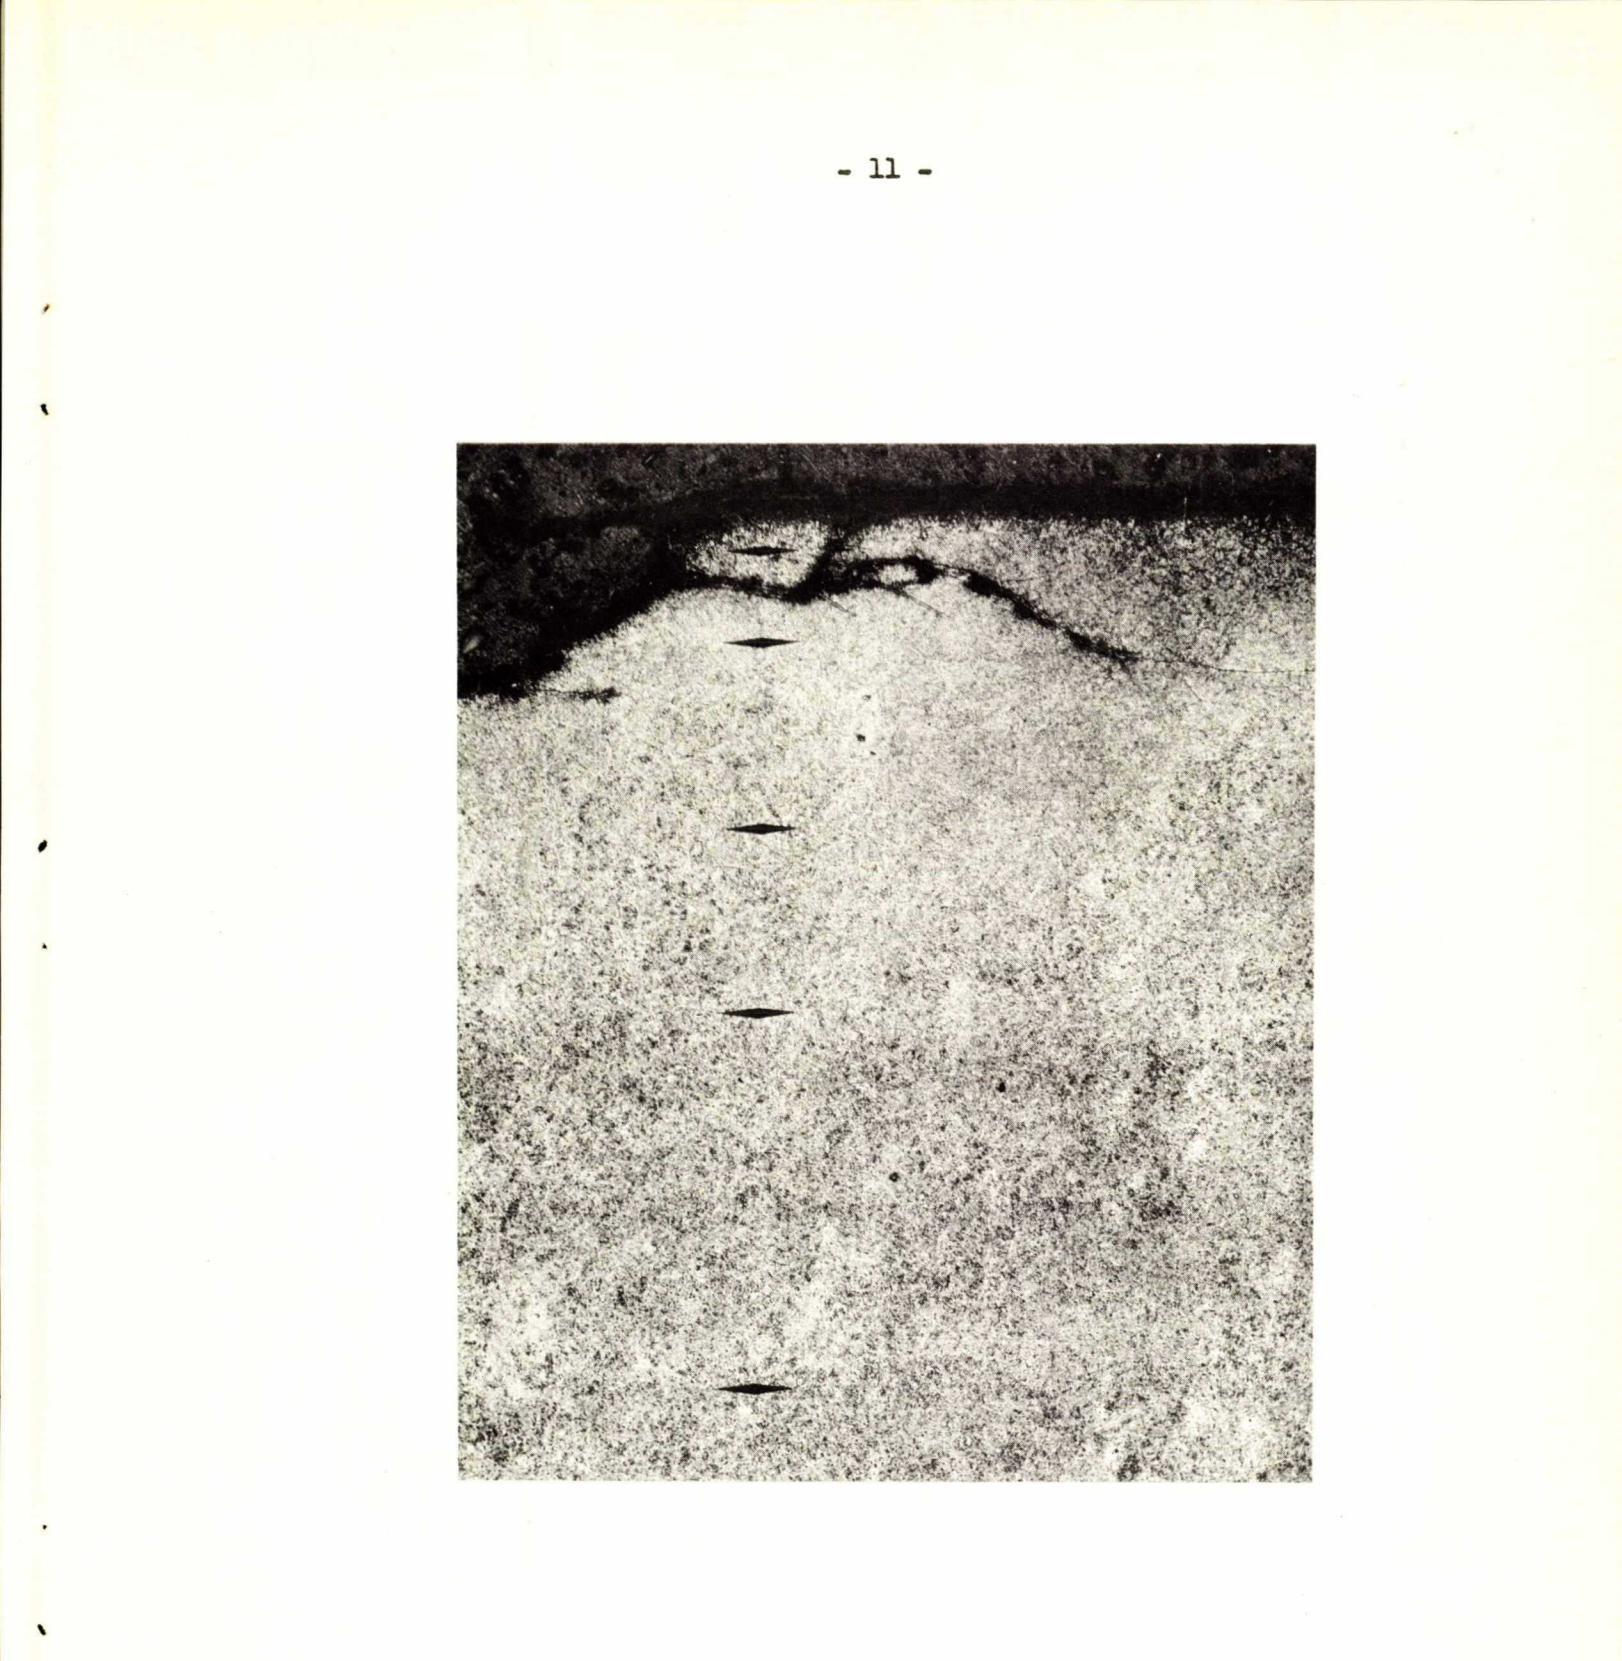
Figure 11 - Cross-section at edge of largest pit seen in Figure 6. Shows single spall developing into multiple spall. Hardness impressions shown indicated Rc hardnesses of 61, 57, 57, 56 and 60 from the edge inward.

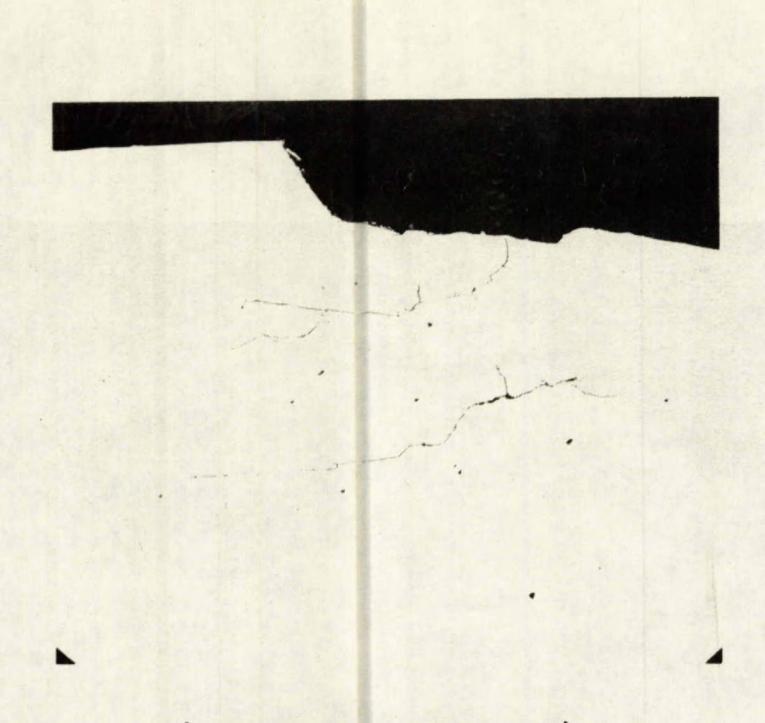
Figure 12 - Cross-section at the edge of the spall shown in Figure 8. (Cone No. 2).

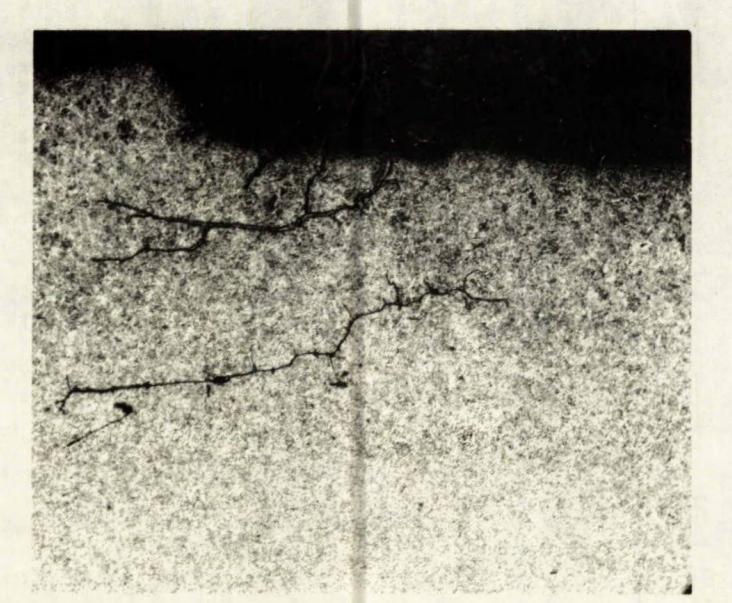
Figure 13 - Etched view of the same field shown in Figure 12. (Cone No. 2).

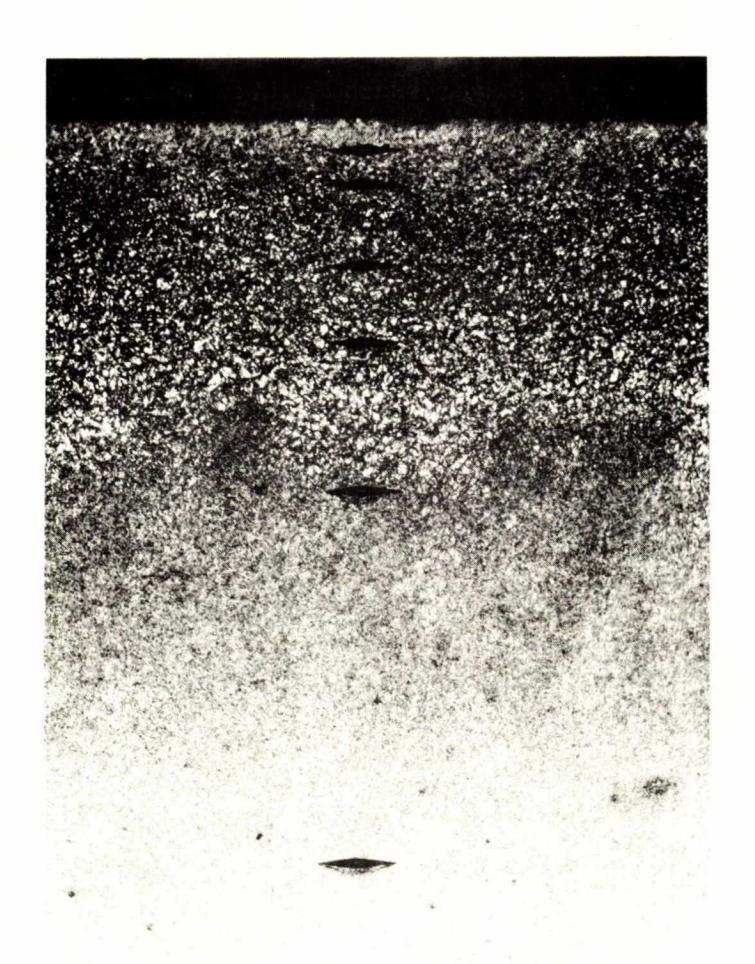
Figure 14 - Shows varied microstructure through case. Photomicrograph taken at outer surface of cup. Hardness values from surface inward are Rc 56, 56, 56, 55, 56 and 55. The core hardness was Rc 42. (Cup No. 1).

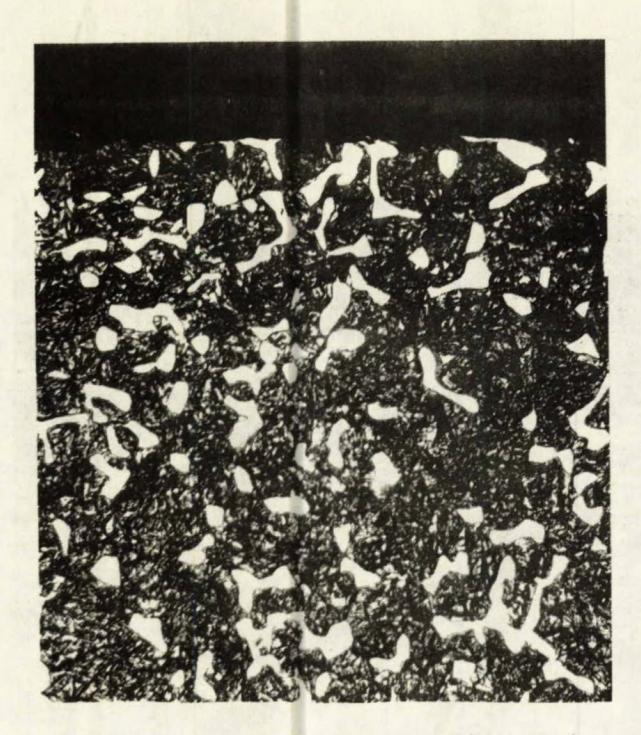
Figure 15 - Shows microstructure present at the corners of the cup. Free carbides in a matrix of martensite. (Cup No. 1).

The examination of the one cup sample available showed it to have an abnormal microstructure. The presence of excess carbides at the corners of the part (Figure 15), and the absence of this condition in the cone samples, indicated that the cup may have been carburized to a higher surface carbon content. The presence of a layer, of varying depth, of retained austenite (Figures 17, 18) was the major microstructural difference. Examination of Figure 18 reveals some light etching, untempered martensite, as well as the dark etching needles. The light etching

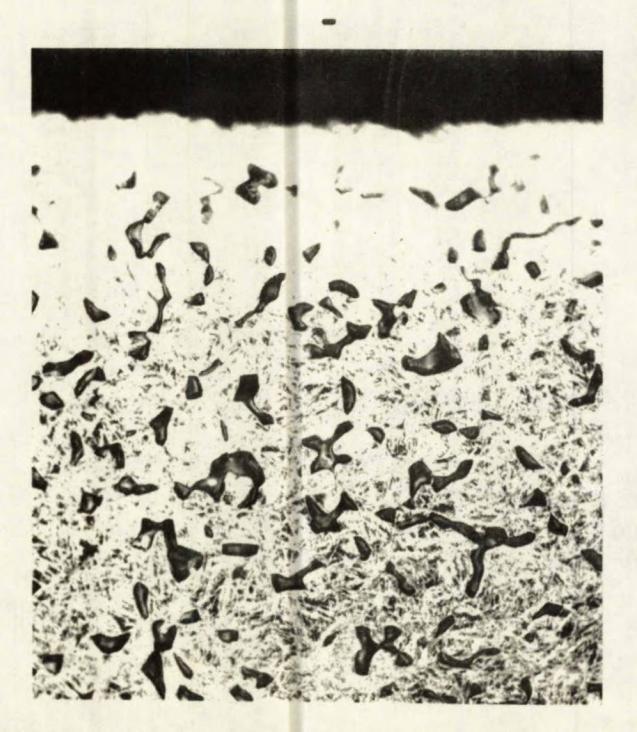
(Mag. X500; Etched 10 minutes in boiling alkaline sodium picrate) Figure 16 - Shows carbides are removed by etchant. (Cup No. 1).

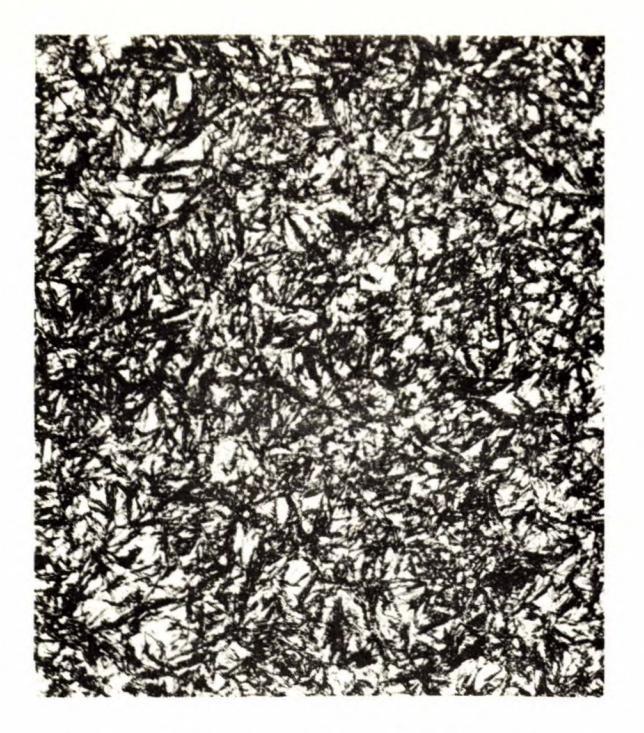
Figure 17 - Shows structure in region of 3rd and 4th hardness impressions (approximately 0.01-inch below surface) of Figure 14. Structure is retained austenite in a matrix of martensite. This area averages about 0.02 inches in depth but varies between 0 and 0.05 inches. (Cup No. 1).

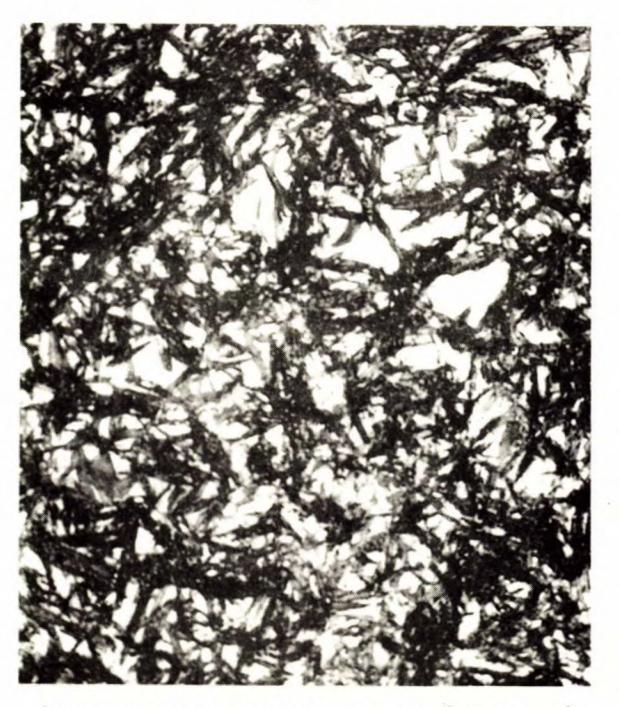
Figure 18 - Shows structure at same depth as Figure 17. The retained austenite in some areas appears to have begun to decompose into martensite (lighter gray plates). (Cup No. 1).

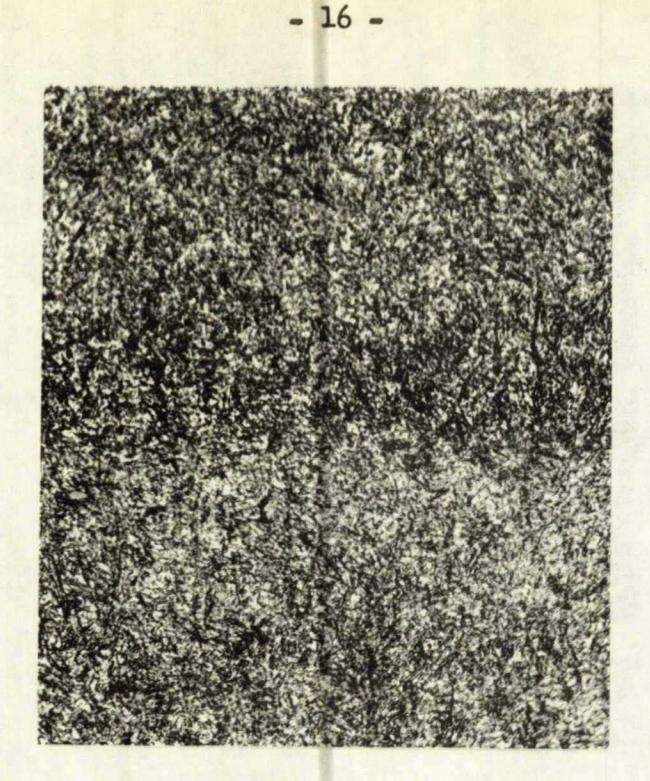
Figure 19 - Shows structure at about 0.04-inch below surface (near 6th impression in Figure 14). Structure appears to be tempered bainite. (Cup No. 1).

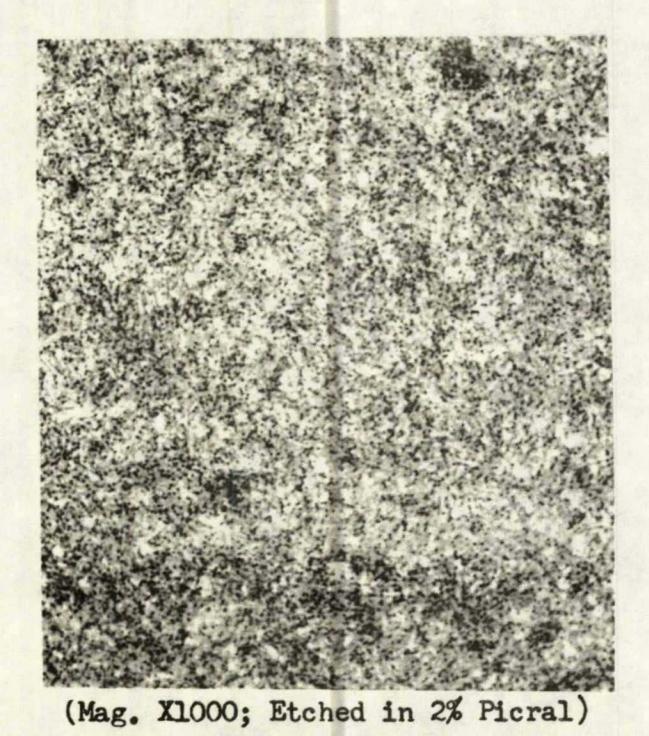
Figure 20 - Shows structure at same depth as Figure 19. (Cup No. 1).

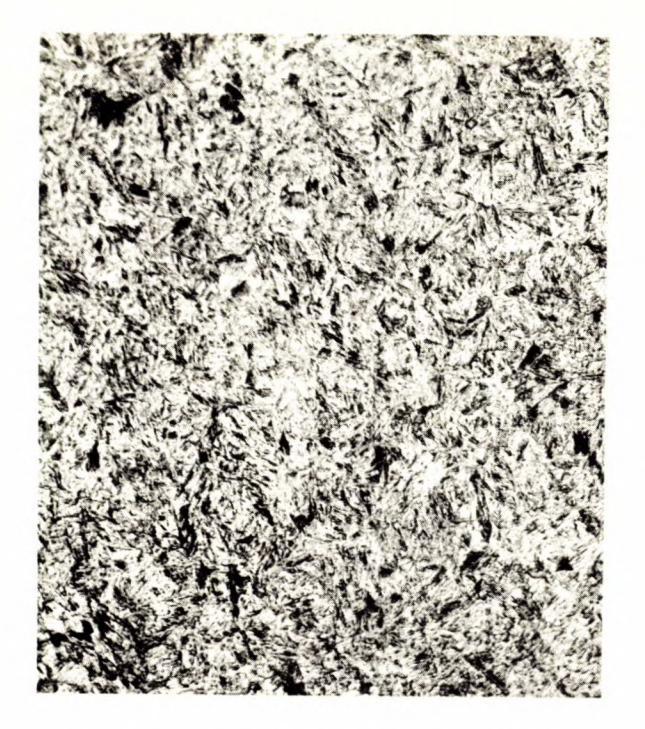
- (Mag. X500; Etched in 6% Nital)
- Figure 21 Shows martensitic structure at depth of about 0.08-inch. (Cup No. 1).

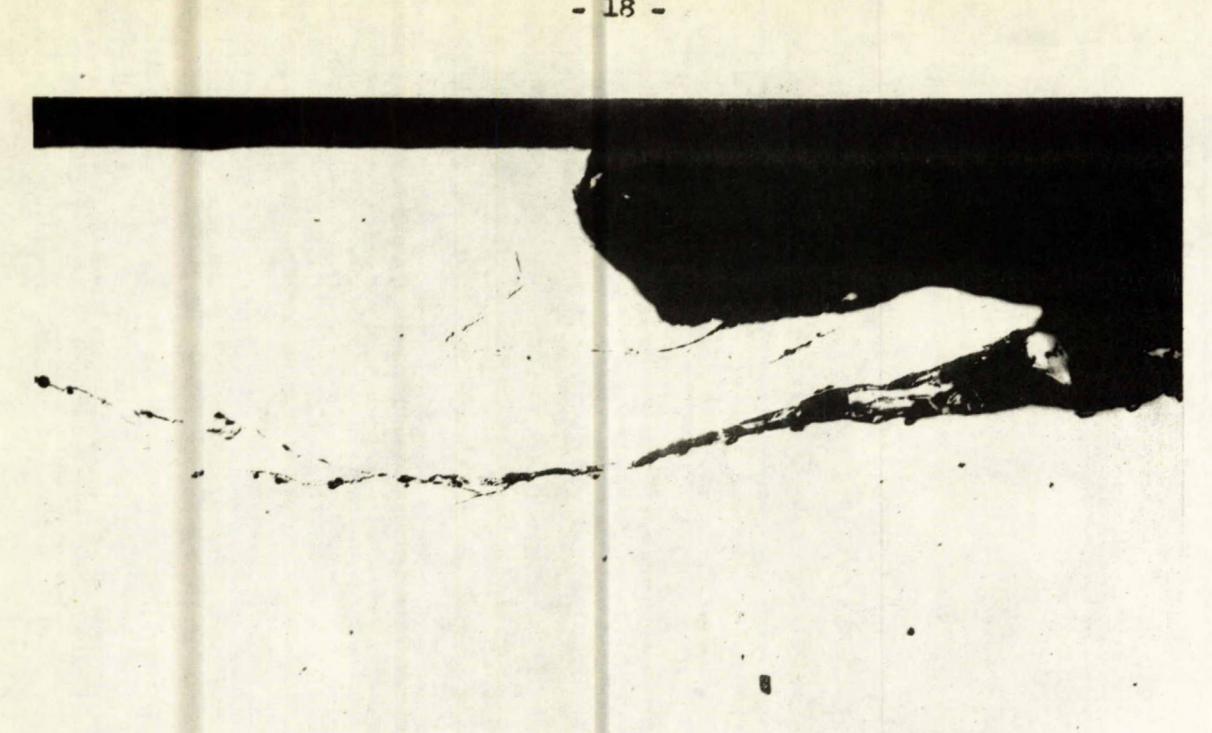
Figure 23 - Shows appearance of partial unetched cross-section at the side of the larger spall on the cup race (as in Figure 1 and enlarged in Figure 7). (Cup No. 1).

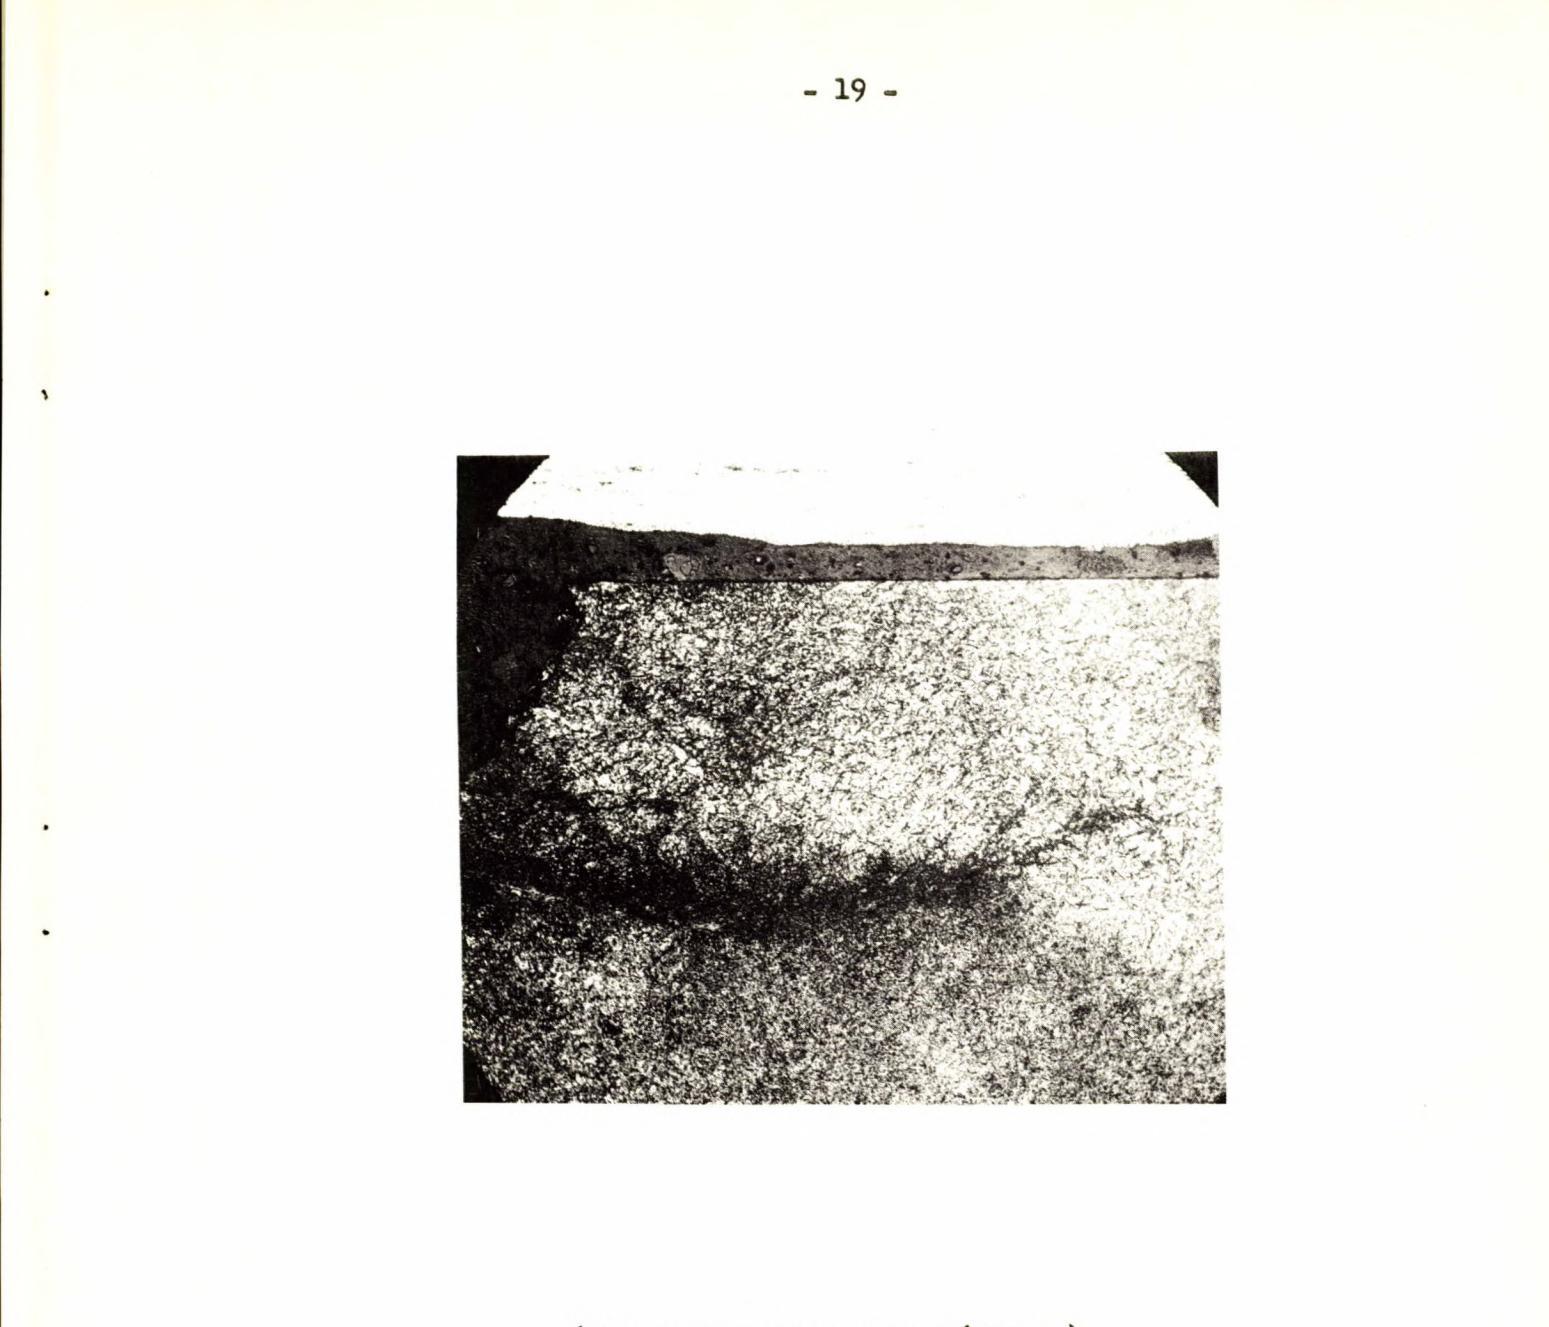
Figure 25 - Shows edge of largest spall. Spall depth seems to be equal to the depth of the retained austenite zone, and cracking seems to follow the layer where the microstructure changes. (Cup No. 1).

martensite probably formed by decomposition of some of the retained austenite some time after the final fabrication, probably in service. Such an effect would be responsible for considerable distortion. Under this circumstance spalling and cracking can be definitely related to the microstructure of the case. The spalls tend to penetrate in depth, to the junction of the retained austenite zone with the area having a normal microstructure. Figures 25 and 26 illustrate that the cracks related to the spalling in general follow the above junction.

The presence of rétained austenite in carburized components for this service should be avoided, or minimized by adequate stress relief subsequent to hardening of the case.

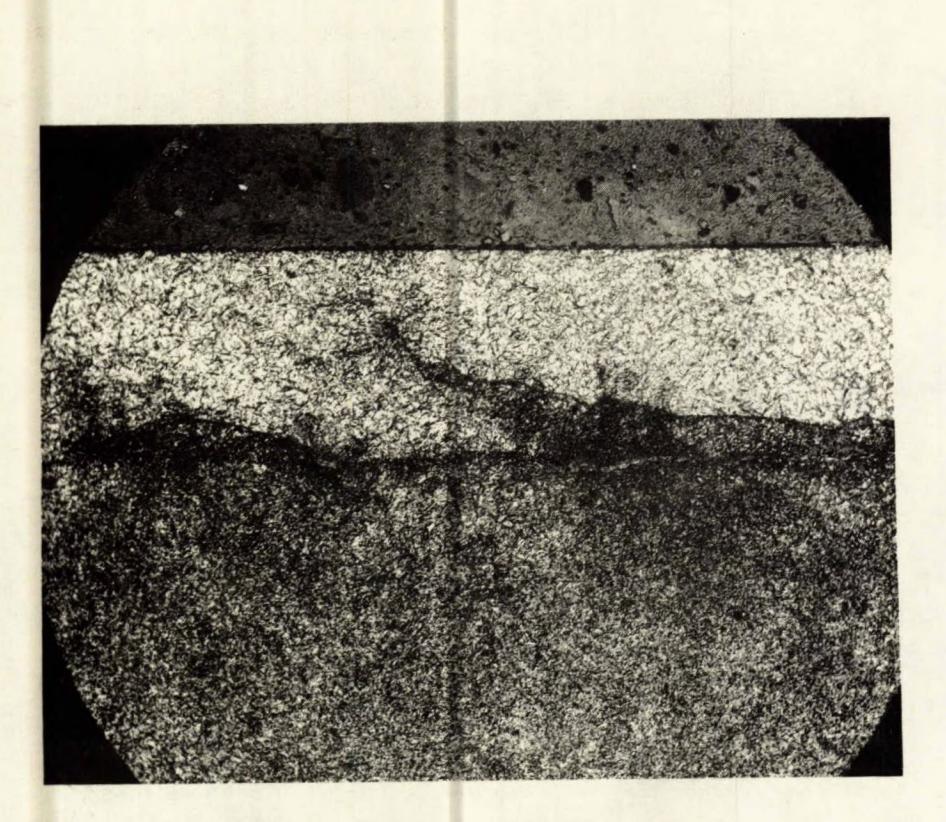
Figure 26 - Shows area close to smaller spall on cup race. Cracking tends to follow layer where the microstructure changes, i.e. below the zone containing retained austenite. (Cup No. 1).
