MINES BRANCH INVESTIGATION IR 59-23

# INVESTIGATION OF FAILURE OF TIMKEN ROLLER BEARINGS

# R. F. KNIGHT

FEBRUARY 26, 1959

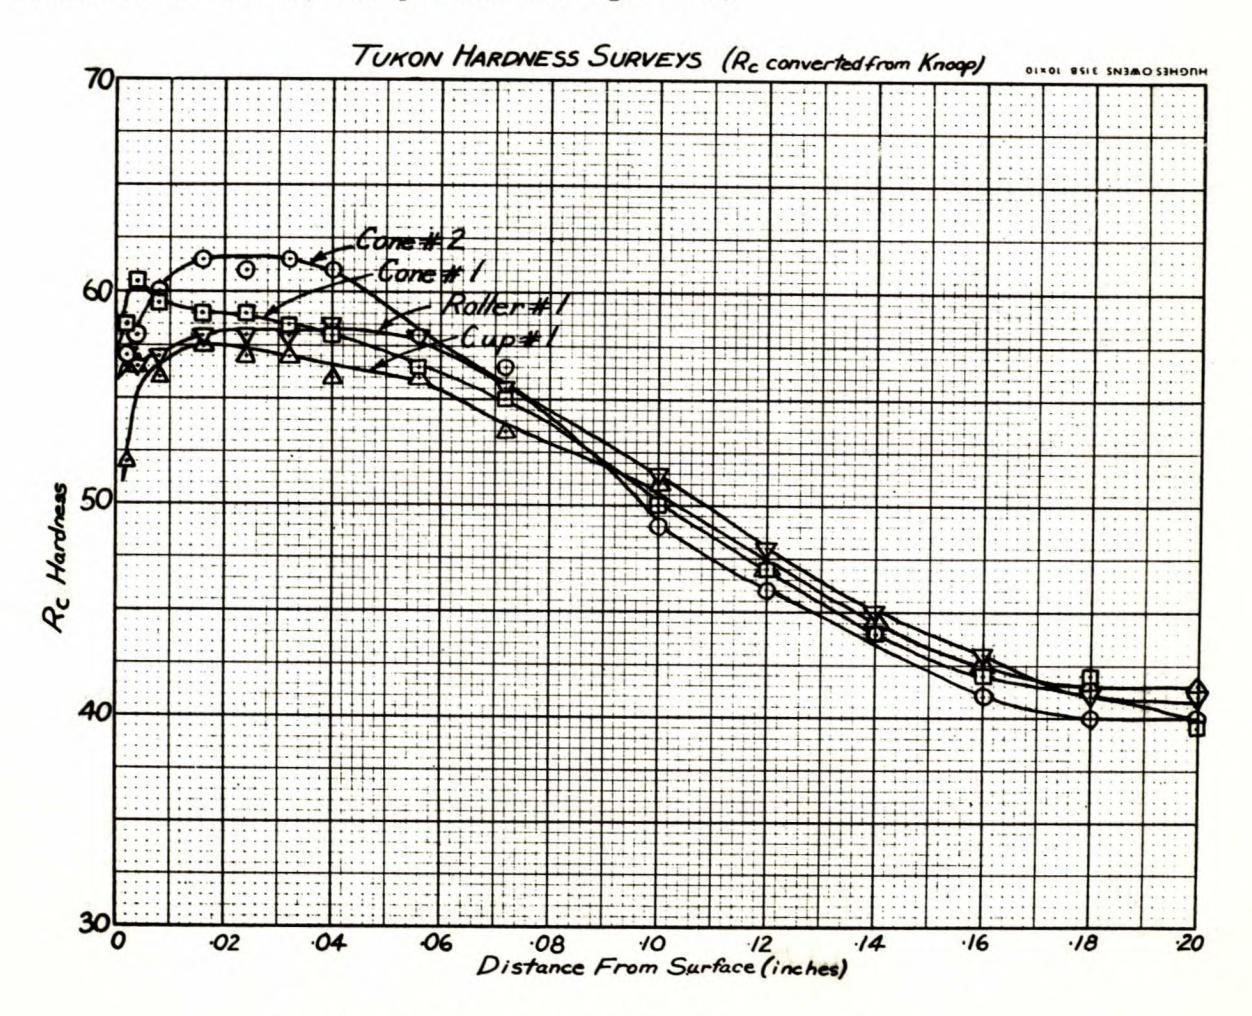
Figure 27 - Results of hardness surveys.

The hardness surveys showed the cup sample to have the "oftest case. This softer case was shown to result from the presence of the soft austenite phase. Hardness surveys after tempering, and temper liquid nitrogen quench treatments, demonstrated a hardness increase due to the quench even after tempering for  $\frac{1}{2}$  hour at 400°F. Up to this tempering temperature there was no change in the core hardness. Thus, tempering the part at 300 or 400°F would have made the structure much more stable with no sacrifice in hardness. The increase in hardness caused by tempering at 220°F for  $\frac{1}{2}$  hour, or even the tempering due to mounting the sample in bakelite, show that the part was probably put into service in the as-quenched condition with little or no stress relief.
