MINES BRANCH INVESTIGATION REPORT IR 63-20

EXAMINATION OF BROKEN SHAFT FROM PRETORIA AVENUE BRIDGE OTTAWA, ONTARIO

PHYSICAL METALLURGY DIVISION

FEBRUARY 21, 1963

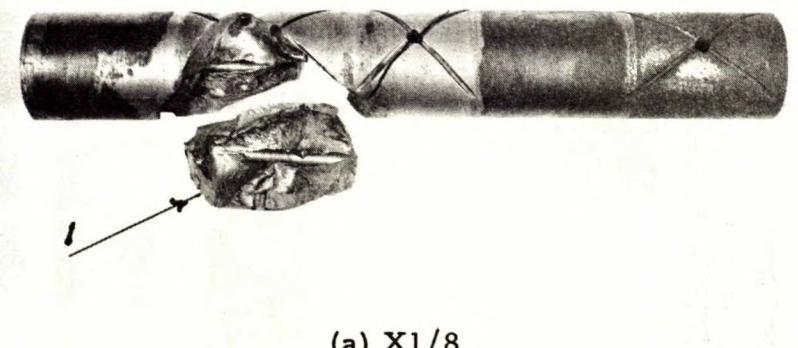
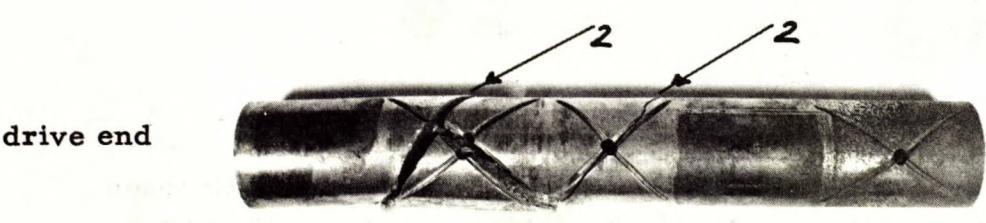
The shaft illustrated in Figure 1 had been in service from 1919 until June 1962, when a triangular fragment broke out of the shaft allowing one corner of the bridge to drop about two feet and causing jamming of the lift mechanism.

The appearance of the broken shaft containing a helical crack at 45 deg to the axis of the shaft is illustrated in Figures 1 and 2. Figure 3 illustrates the appearance of the crack surfaces at the end of the helix remote from the drive end. Part of this crack was open and exposed to oxidation prior to the final rupture. Figure 4 illustrates a helical fracture described (1), as characteristic of fractures due to alternating torsion.

The fracture, illustrated in Figure 1, appears to have commenced at the corners of the radial grease holes and to have propagated in both directions along a helical path towards the ends of the shaft.

Figure 1. Broken Shaft from Lift Mechanism of Pretoria Avenue Bridge. The view shown in Figure 1 (a) illustrates the helical fracture, bore-hole, radial holes, grease grooves and the fragment that caused failure of the mechanism in June 1962. Figure 1 (b) illustrates the appearance of the broken shaft with the fragment fitted in position. The fragment (arrow 1) and the path of the helical crack (arrows 2) are marked.

- Replace the shafting with oil quenched and tempered steels having equivalent properties to those shown for SPS-245 or Ultimo-4 steels having yield strengths of 86,000 psi and 117,000 psi, respectively, combined with Izod impact strengths of the order of 70 ft-lb. These properties are obtained by oil quenching and tempering at 650°C (1200°F) in 4 in. sections.
- 2. Chamfer or countersink the intersection of the transverse grease hole and grease grooves.
- 3. The grease grooves should preferably have their long axis parallel to the longitudinal direction of the bar, rather than in the transverse or 45 deg helical positions, thereby minimizing the stress-raising effect of the grease grooves.

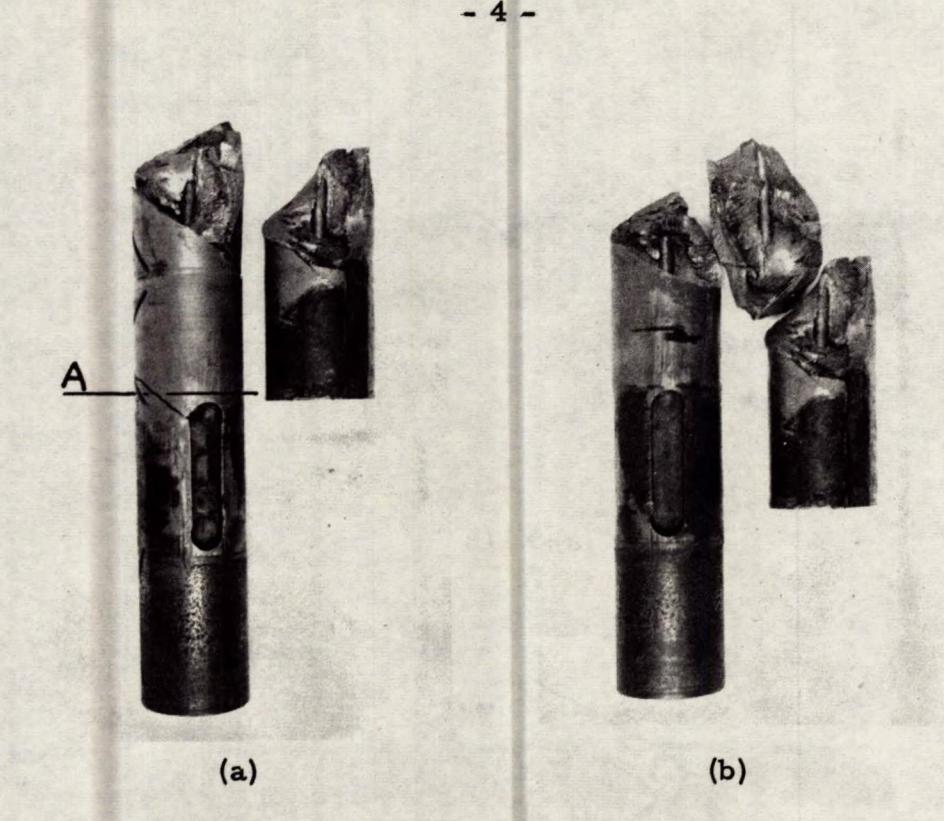
The appearance of the fracture surfaces is shown in Figure 2. The tip of the open helical crack was examined by cutting a 3/4 in. transverse slice at position A, Figure 2. The appearance of the fracture surfaces exposed by sectioning is illustrated in Figure 3. The oxidized (black) and bright parts of the fracture indicate that part of the crack was present prior to failure in June 1962.

Figure 2. Same Shaft as Figure 1, with Fracture Surfaces Exposed. A transverse slice, 3/4 in. thick, was cut at position A for inspection of the crack adjacent to the tip of the helix.

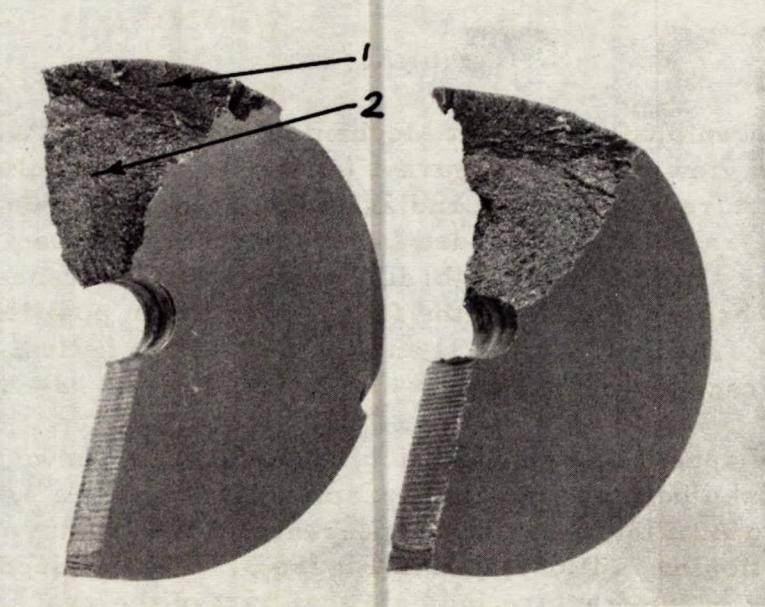
Figure 3. Transverse Section at Position A (Fig. 2) with Fracture Surfaces Exposed.

A dark (oxidized) area (arrow 1) and a bright area (arrow 2) are visible on the fracture surface indicating the presence of a crack in this region prior to the final rupture.

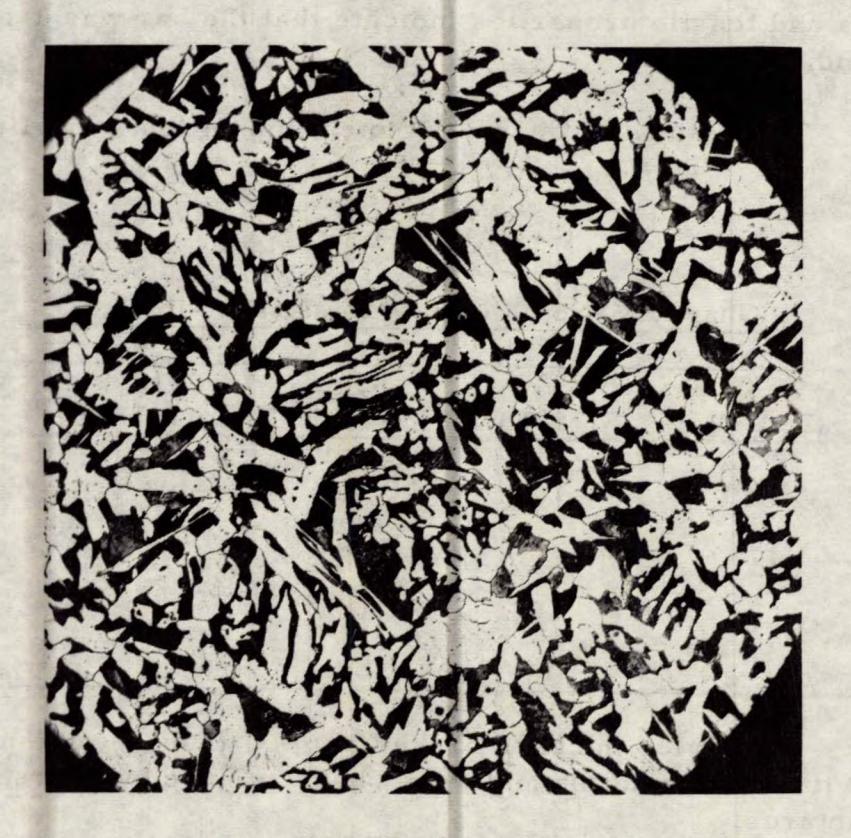
Figure 5. Typical Microstructure Observed in Broken Shaft. The structure consists of pro-eutectoid ferrite and fine pearlite and is typical of hot-rolled AISI-C-1034 steel in a 4 in. section.

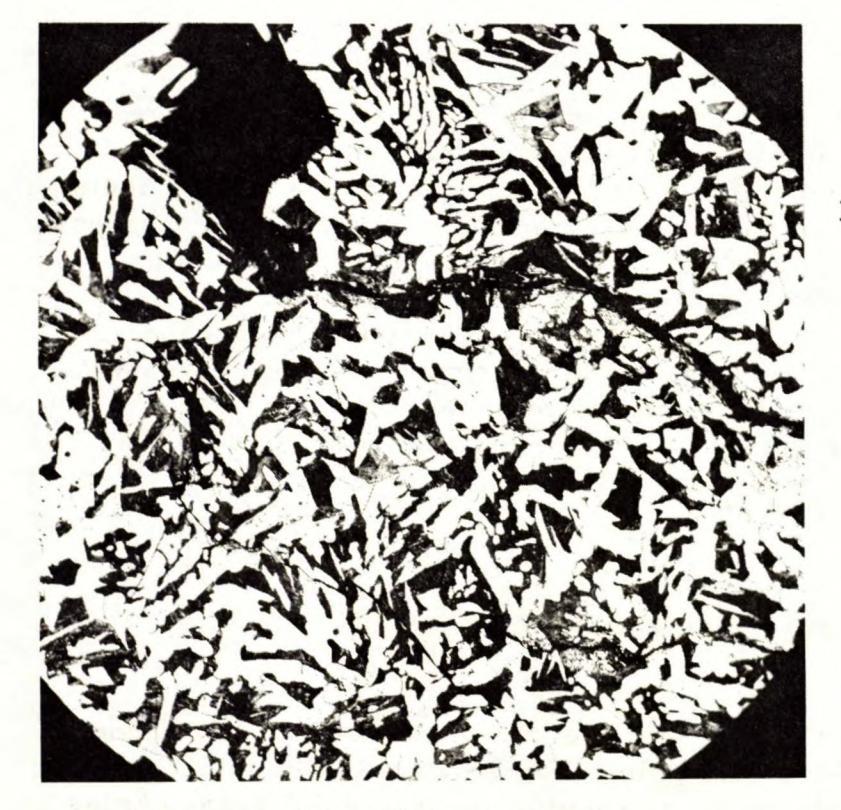
Figure 6. Transverse Section Through the Tip of the Helical Crack Remote from the Drive End of the Shaft. Secondary crack and ruptures are associated with the main crack.

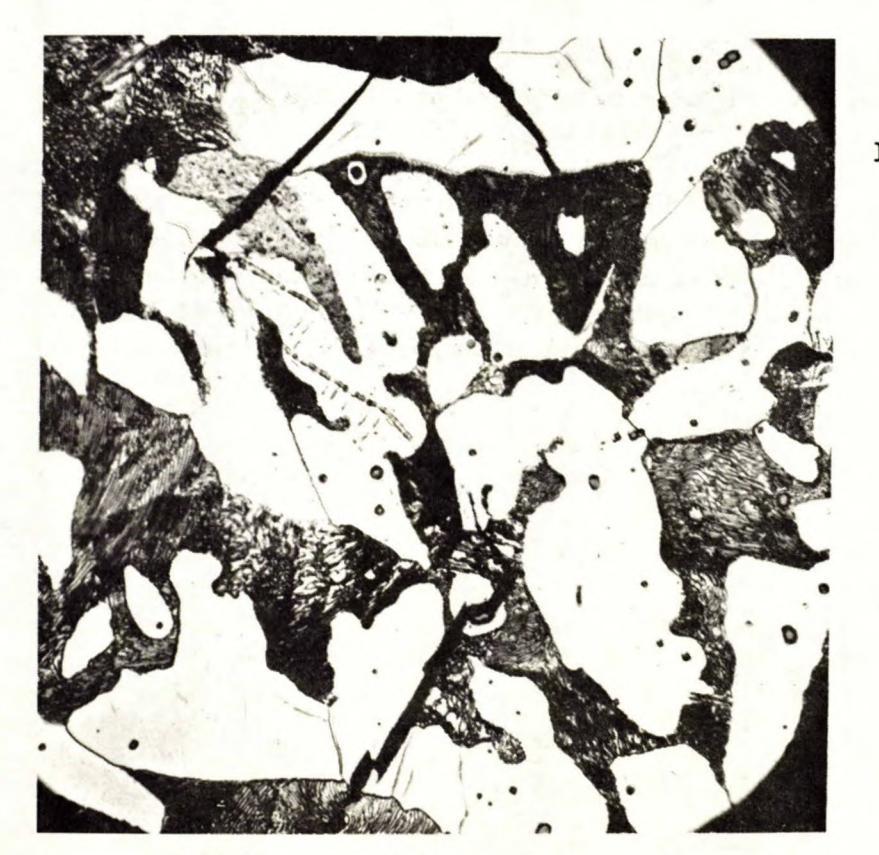
The appearance of an area containing ruptured ferrite grains in Figure 7 shows that stresses in excess of the yield point have been present in metal adjacent to the main crack.

Figure 7. Small Cracks (Ruptures) which Extend Through One or Several Grains and Indicate Stresses in Excess of the Yield Point.

> Small ruptures are present in numerous regions adjacent to to secondary cracks indicating overstressing and severe metal damage adjacent to the tip of the helical crack.
