MINES BRANCH INVESTIGATION REPORT IR 63-42

EXAMINATION OF FAILED SECTION FROM A BAILEY BRIDGE PANEL

W. P. CAMPBELL

APRIL 19, 1963

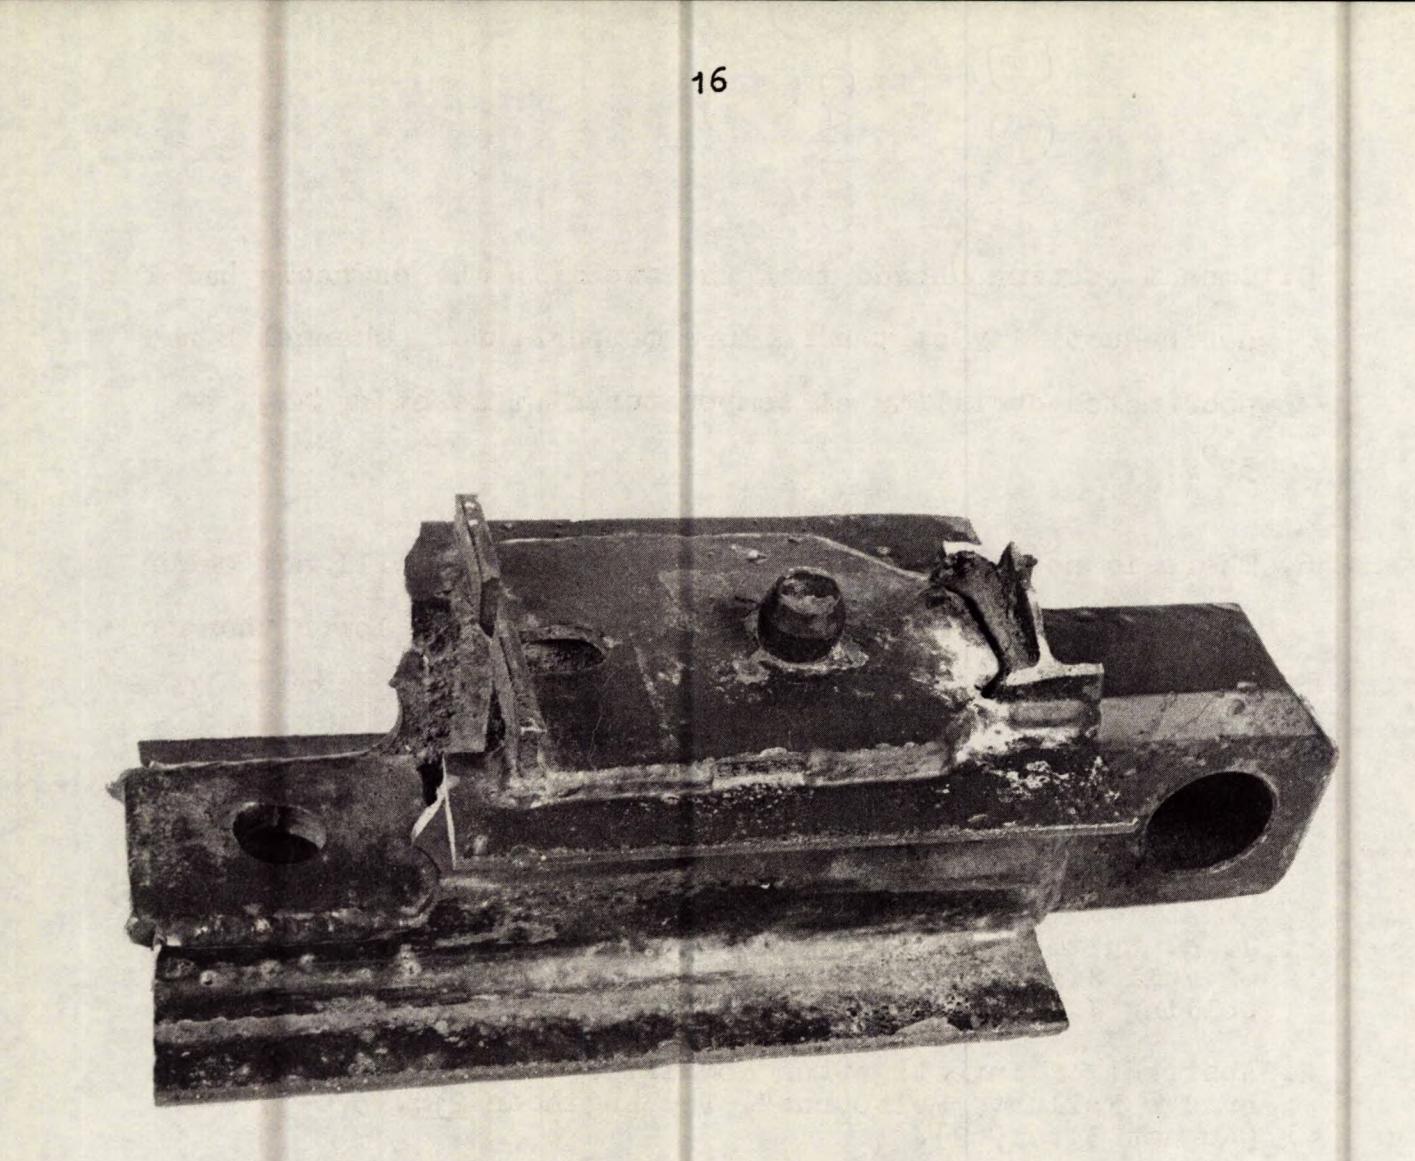
As shown in Figures 1 and 2, the failure of the end piece occurred as a result of two fractures forming in each channel; one fracture being above the slot and the other below. The fractures are near the ends of the straight portions of the sway-brace slots. It is evident in these two figures, and also in Figures 4 and 6, that the two lower fractures in each channel are at or very close to the ends of the fillet welds joining the channels to the central connecting plate. Closer views of the four fractures, illustrated in Figures 3-6 inclusive, indicate

Figure 1 - Side view of fractured end section About 1/2 scale.

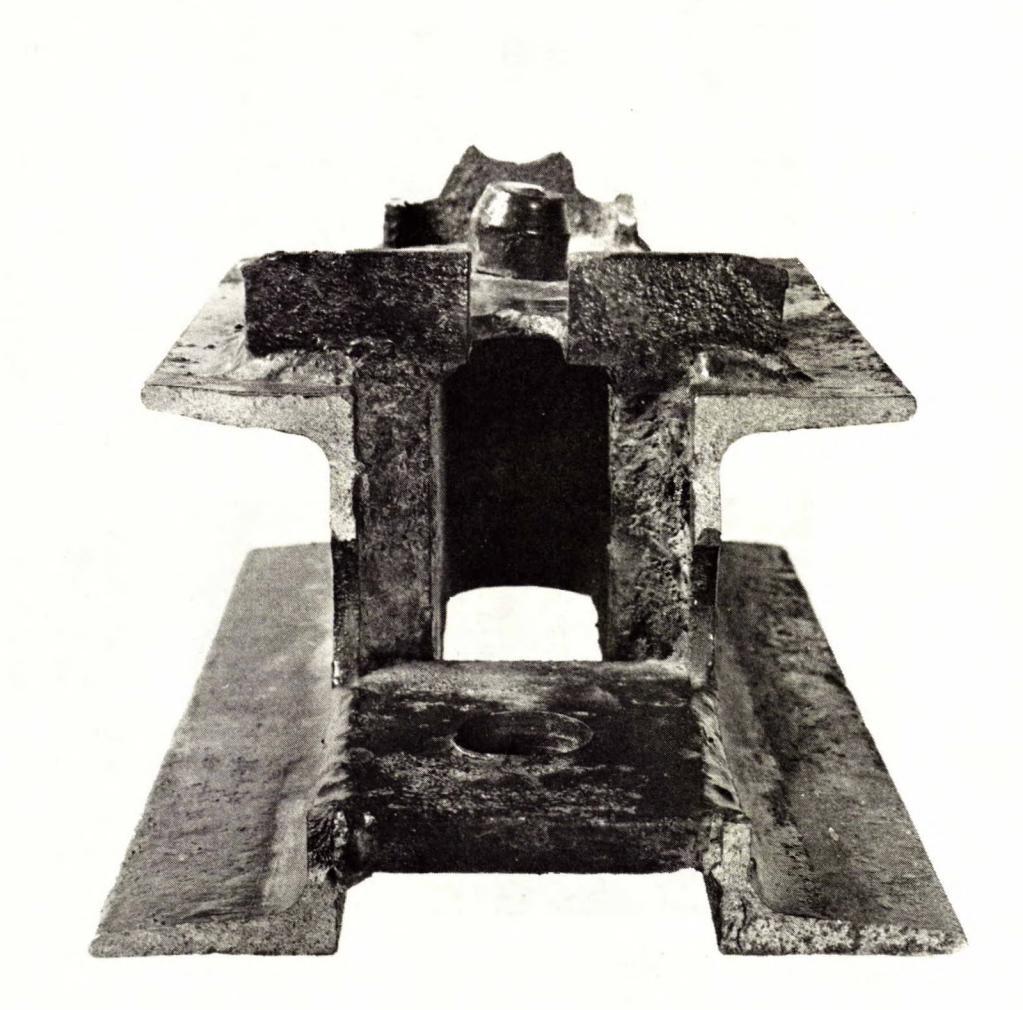
Figure 2 - Looking toward fractured surfaces of end section. Channel A is on the left and channel B on the right.

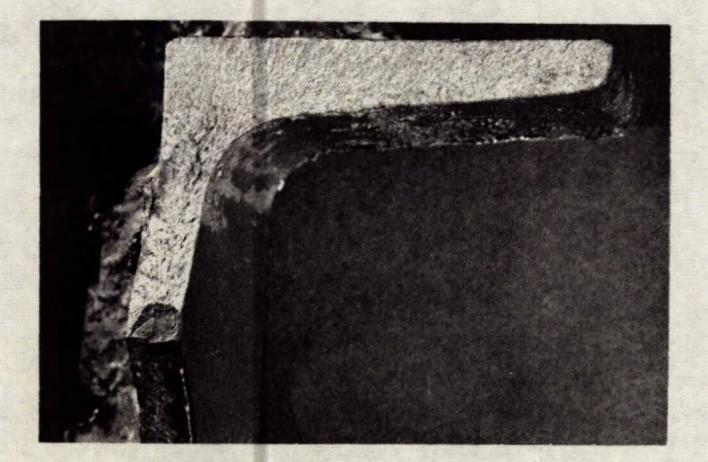
that they are of the cleavage type with little evidence of shear. Thus the fractures are typical of metal which has failed in a brittle fashion.

section with the slot, i.e., through the dark spot evident in Figure 3, was similar to that illustrated in Figure 9.

Figure 3 - Upper fracture in channel B. About full size.

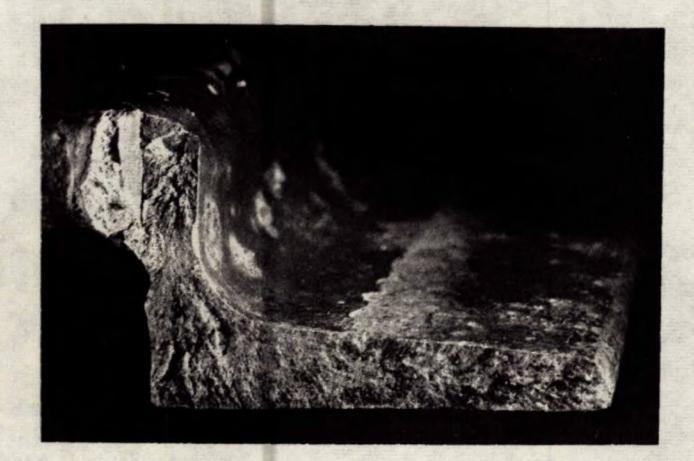
The fractured surfaces exhibit chevron markings which tend to point towards the intersection of the fractures with the slots. This is a definite indication that the fractures initiated at these locations. At the lower fracture in channel B, a dark spot, differing in colour and texture from the major portion of the fracture, is evident in Figure 4 at the fracture initiation point. A similar spot is seen in Figure 3 on the upper fracture in the same channel, although there is no evidence of weld metal, this having been retained with the portion of the end piece not submitted. No similar spots were noted at corresponding locations in channel A, although a small hole was noted at the upper fracture (See Figure 5). A very small amount of weld deposit was seen near this defect.

Figure 4 - Lower fracture in channel B. About full size.

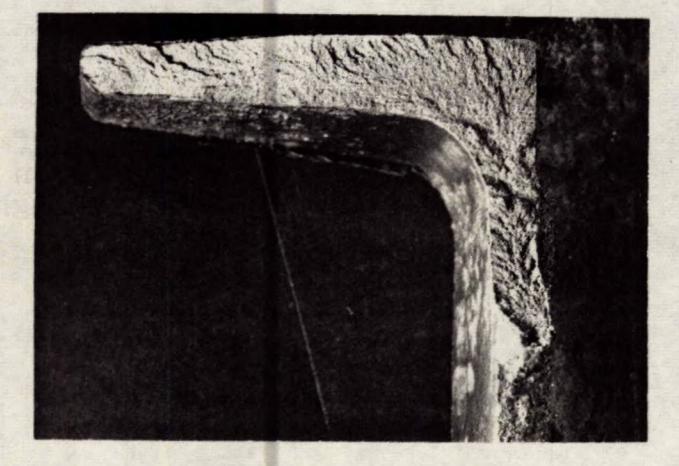
A section is shown in Figure 14 from the upper fracture in channel A illustrated in Figure 5. Some lack of fusion and entrapped slag were present in the small portion of weld metal remaining. No cracking was found in the heat-affected zone, nor was there any evidence of oxidation along the fracture path through this zone. However, it is possible that the fracture was initiated at some weld defect such as shown in this section.

Figure 5 - Upper fracture in channel A. About full size.

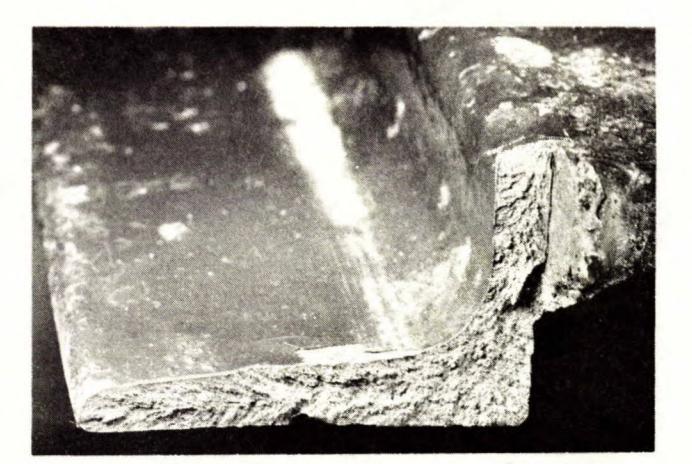
A section through the weld crater and intersecting the lower fracture in channel A (see Figure 6), showed that the weld crater was very shallow and that no cracks were present in the heat-affected zone.

Figure 6 - Lower fracture in channel A. About full size.

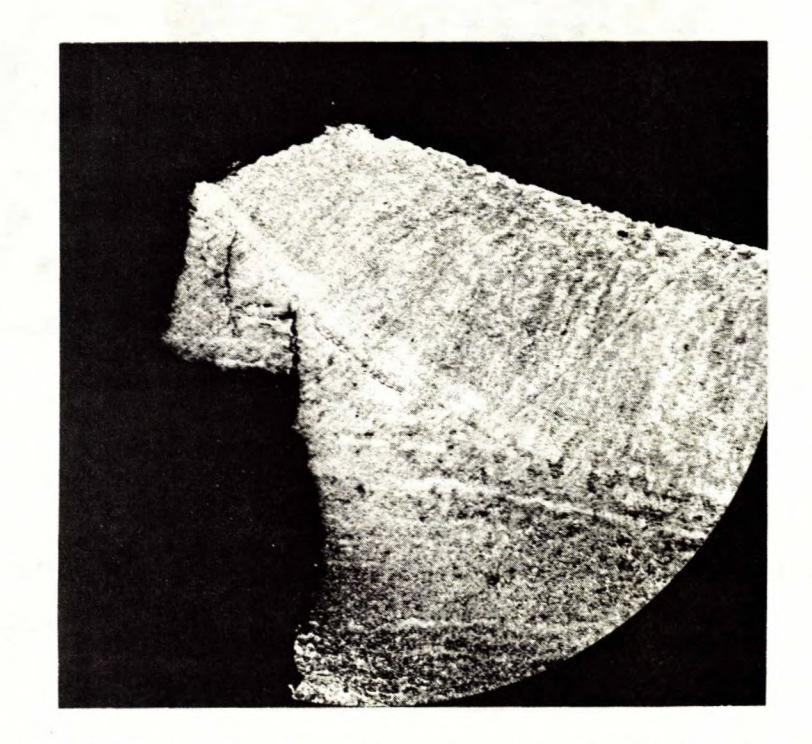
Figures 7 and 8 illustrate the site of fracture initiation in a section taken through the dark spot shown in Figure 4. It is apparent that the brittle failure was initiated by cracks close to the toe of the weld crater. The dark spot corresponds to the extreme left hand edge of the section, and to a small portion of the main fracture which is just below the right hand crack, with reference to Figures 7 and 8. A close examination of the fracture (See Figure 4) will show that this dark area at

Figure 7 - Cross section at end of weld, and part of brittle fracture in lower part of channel B. Etched 2% nital. X20.

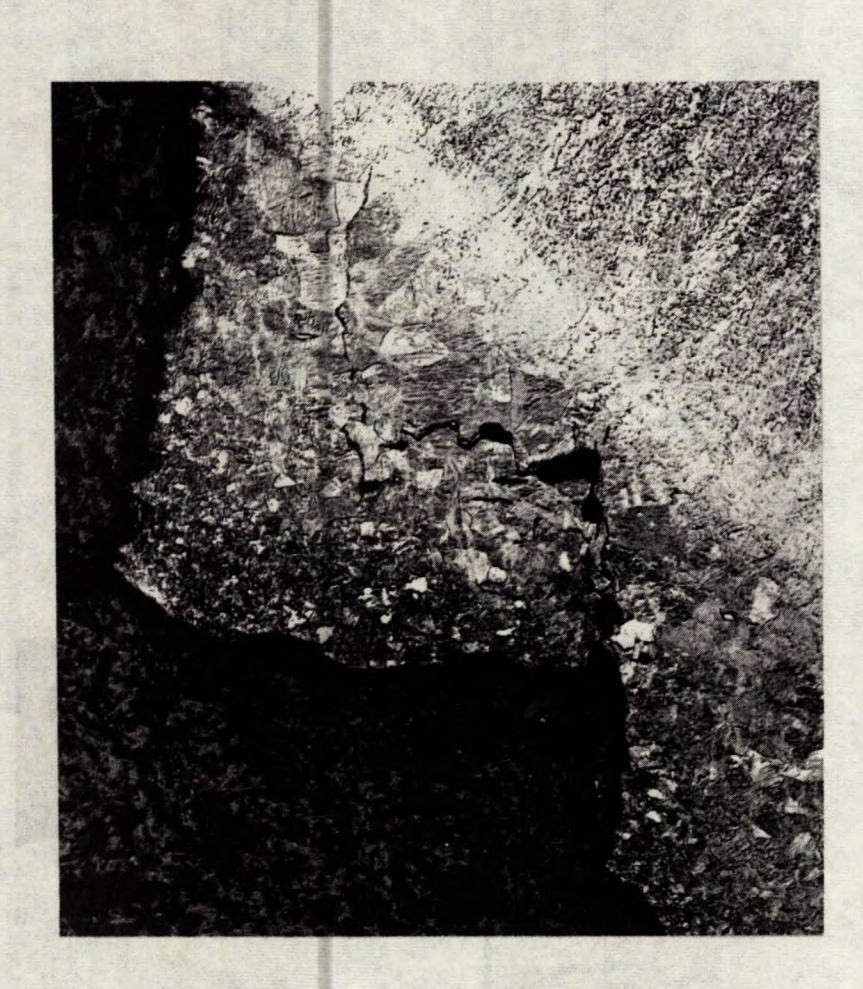
Figure 8 - Showing initiation point of brittle fracture in lower part of channel B. Etched picric-hydrochloric acids. X75.

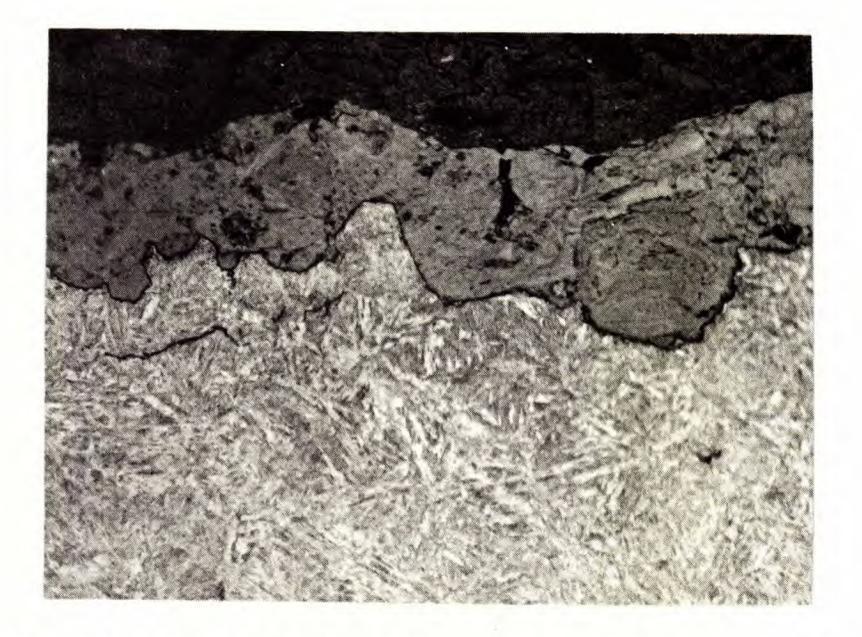
Figure 9 - Showing section through dark areas at initiation of fracture on lower side of channel B. See also Figure 4. Also representative of section through the dark area shown in Figure 3. Etchant 2% nital. X250.

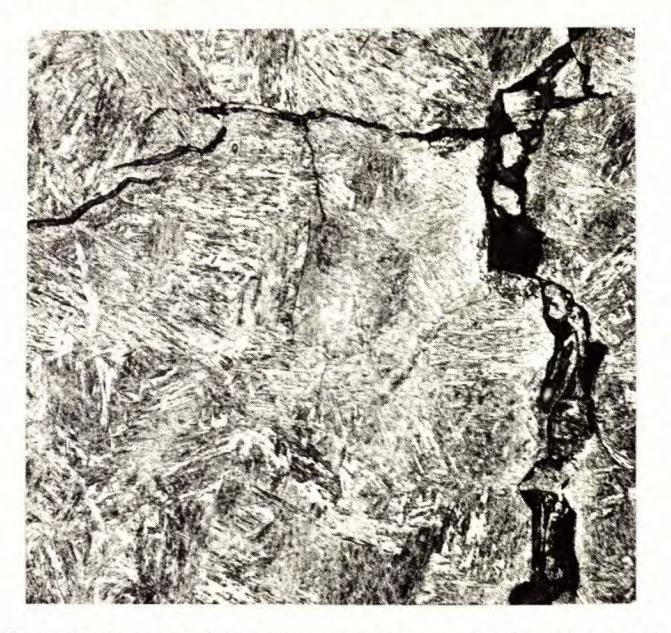
Heat-affected zone cracking such as illustrated in Figures 11 and 12 can result in certain steels if the cooling

rate in the heat-affected zone is sufficiently rapid to produce a predominantly martensitic microstructure and if the welding arc atmosphere is sufficiently high in hydrogen. It is evident that the welding procedure was inadequate, at least when some of the welds were made. The microstructure adjacent to most of the weld deposits was predominantly tempered martensite. As these welds were all single pass deposits, it is evident that the assembly must have been subjected to some post-weld heating, probably with the intention of stress-relieving the assembly and of tempering hardened heat-affected zones.

Figure 10 - Showing oxidized cracks at initiation of brittle fracture at lower side of channel B. The larger crack is in line with the main fracture as seen in Figures 7 and 8. Etched 2% nital. X250.

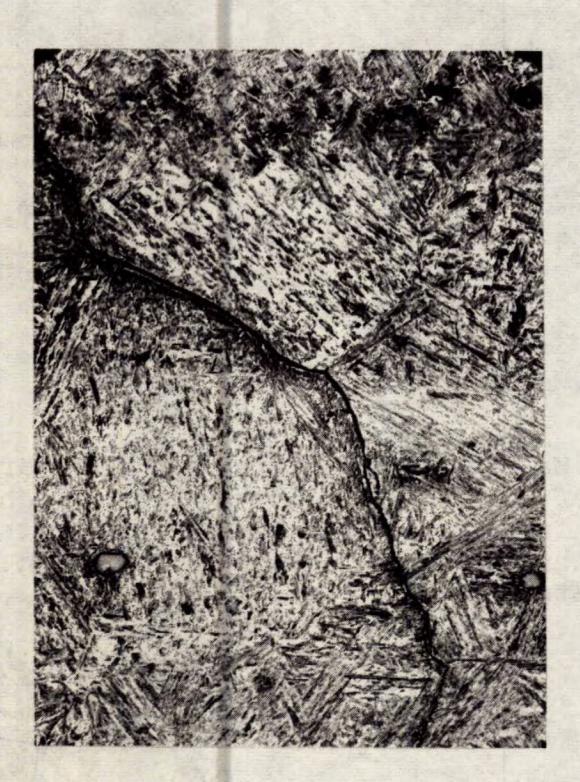
Figure 11 - Intergranular crack in heat-affected zone a short distance away from the fracture and cracks shown in Figures 7-to 10 incl. Weld metal is at top. Etched 2% nital. X250.

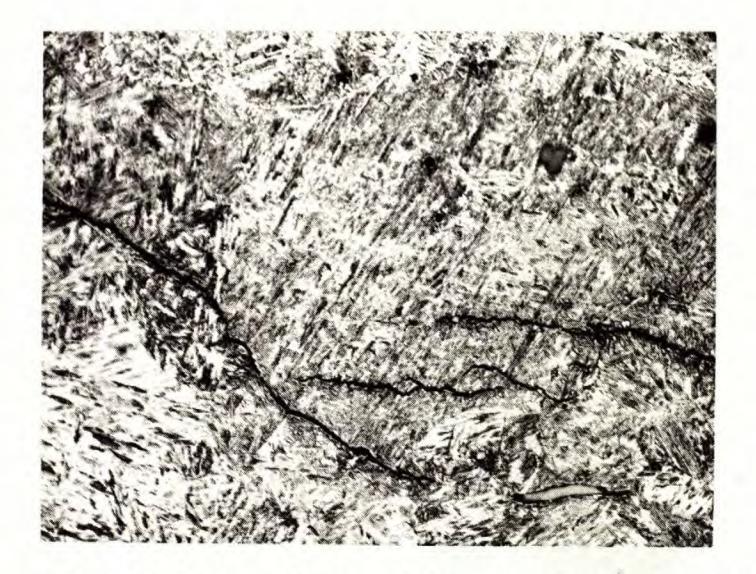
the initiation of the fracture really consists of two spots. at slightly different elevations on the fractured surface. A third crack, seen in Figure 7, between the extreme left edge and the right hand crack, did not extend to any appreciable extent. An examination at higher magnification, of the location on this specimen corresponding to the dark areas in Figure 4, revealed the presence of oxide scale, as seen in Figure 9. Figure 10 illustrates the crack which is in line with the main portion of the fracture, and this crack is also oxidized. Another crack. running parallel to the one just mentioned, was found further away from the fracture. This crack, shown in Figure 11, is intergranular in nature, and so tightly closed that it was not evident in the macro-examination of the section, e.g., it is not apparent in Figure 7. This type of crack probably initiated first as a hot crack at the austenite boundaries in the heat-affected zone at the weld fusion line and then extended as a cold crack when the heat-affected zone became martensitic. Other heat-affected zone cracks, which are transgranular and run more nearly parallel to the weld fusion line, were found a short distance away from the fracture, and are illustrated in Figure 12.

Figure 12 - Underbead cracking a short distance to the right of fracture and cracks shown in Figures 7 and 8. Weld metal is at top.

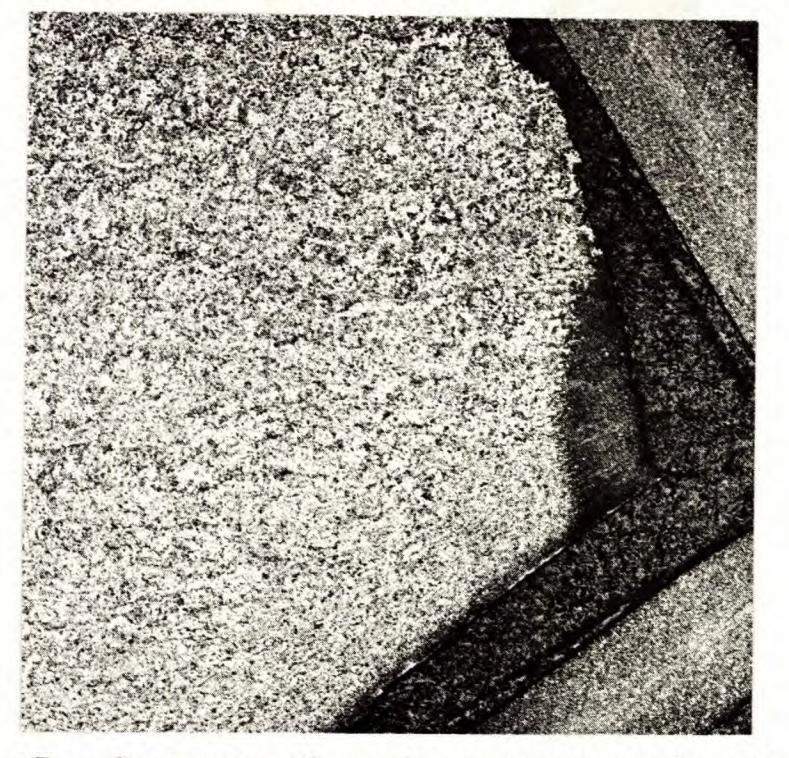
The upper fracture in channel B apparently occurred in a similar fashion. Figure 13 shows that the initiation of the fracture was in a weld heat-afrected zon.. Although no cracking was seen below the fractured surface, it was evident that a crack had occurred during welding and had been subsequently oxidized. The surface of the fracture immediately adjacent to its inter-

Figure 13 - Cross section at start of weld, and part of brittle fracture in upper part of channel B seen in Figure 3. Only the heat-affected zone remains, and the fracture extends upwards from its junction with the curve of the slot. Etched 2% nital

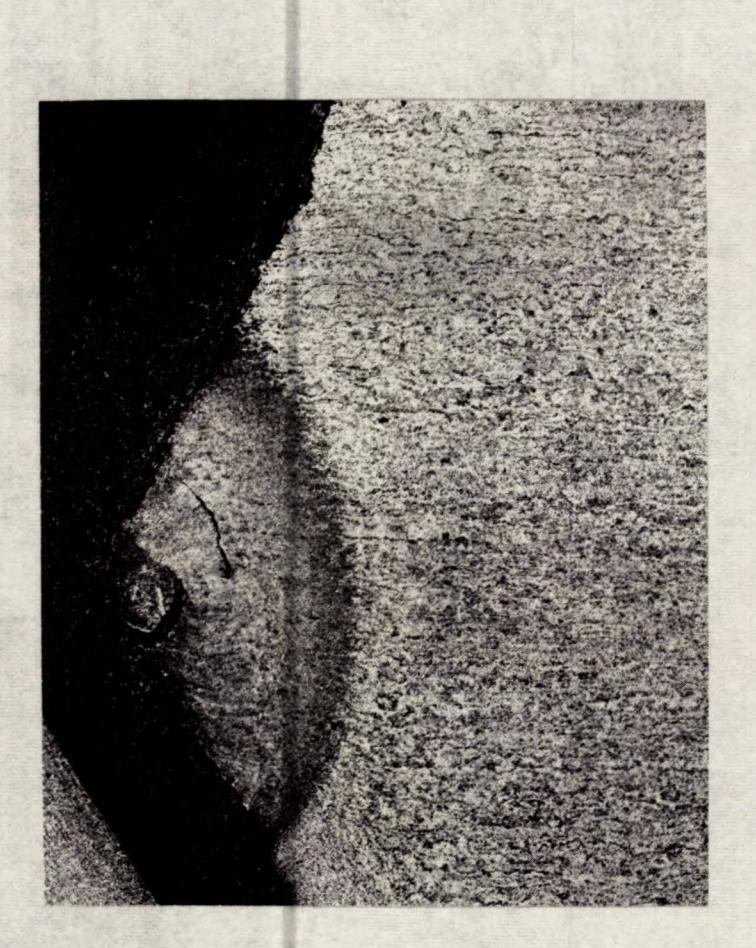
Figure 14 - Cross section at start of weld, and part of brittle fracture in upper part of Channel A seen in Figure 5. Some lack of fusion and entrapped slag is seen in the small portion of weld metal remaining. The fracture extends upward through the weld from its junction with the curve of the slot. Etched 2% nital. X7.

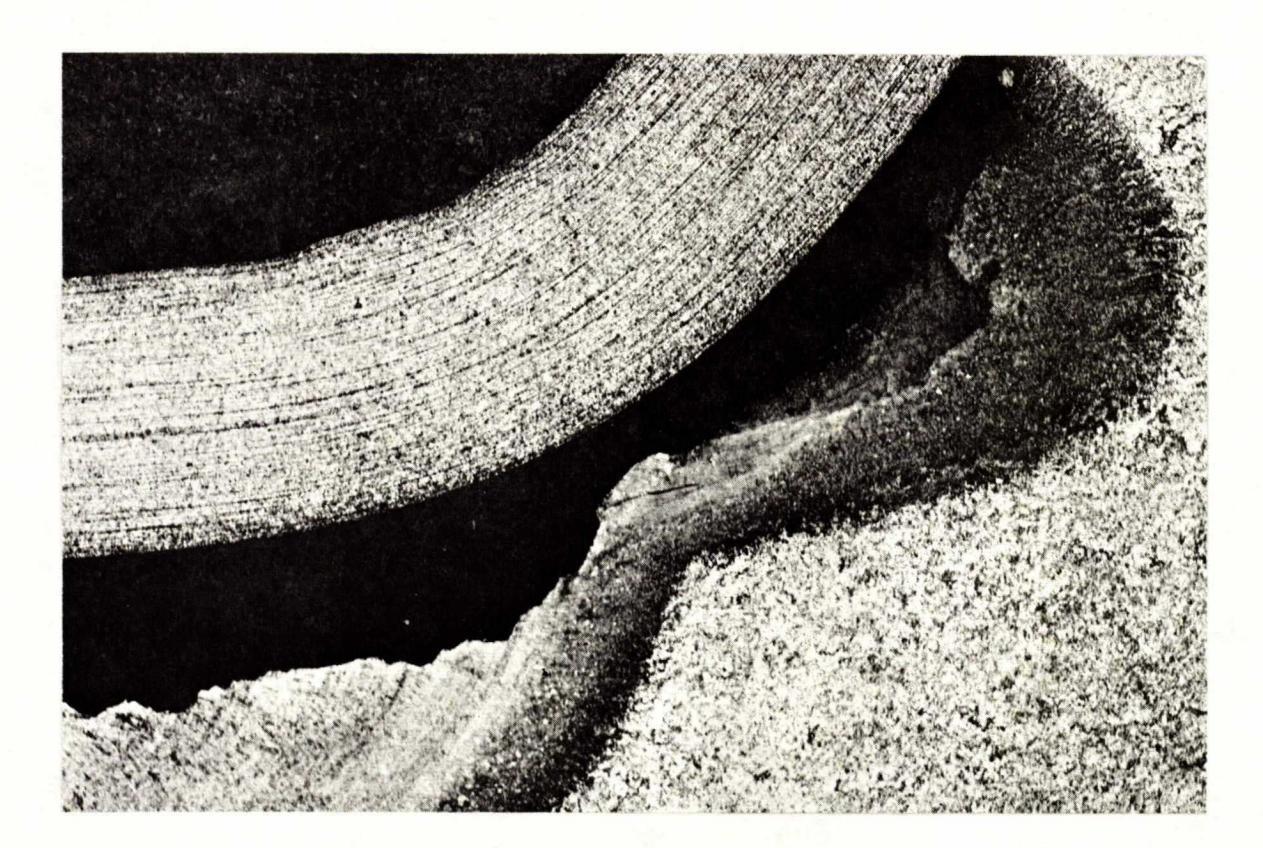
Sections were also examined at the starting point of the two lower welds where no fracture had been initiated in the channels. The heat-affected zones below the start of the welds were quite shallow, thus indicating rapid cooling rates. However, no cracking was found in these zones. The welding arc had melted a small shallow zone in channel A a short distance in advance of the start of weld deposition, as is shown in Figure 15. A very small crack, perpendicular to the edge of the channel, was found in the upper portion of this zone. Such a crack is favourably located to initiate a brittle failure.

Figure 15 - Cross section at start of weld on lower part of channel A, showing a small arc strike just above the start of the weld deposit which is at lower left. The dark zone in the arc strike is a remelted spot on the channel and contains a very fine crack perpendicular to the edge of the channel slot, extending about 2/3 the depth of the remelted zone. The presence of this crack was established by examination at higher magnification. Etched 2% Nital. X12.

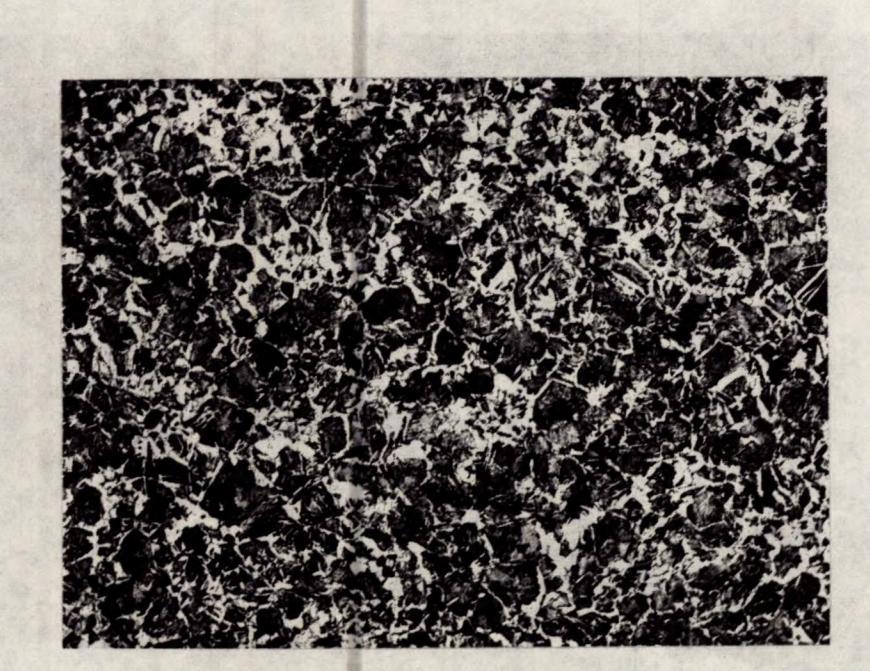
Figure 16 shows the microstructure typical of channel B, unaffected by welding heat. The microstructure consists of fine pearlite and ferrite. There was some banding in the steel, although this is not evident in the picture.

Figure 16 - Microstructure of channel remote from influence of weld deposits. Etched 2% nital. X100.
