This document was produced
by scanning the original publication.

Ce document est le produit d'une
numérisation par balayage
de la publication originale.

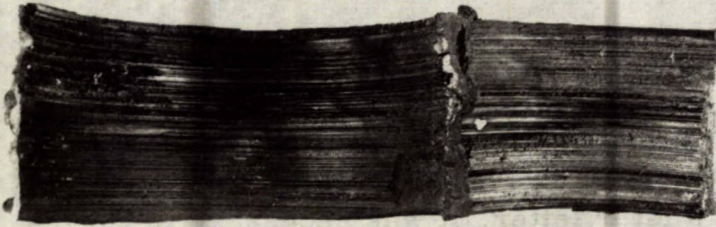
The surface of the inner race which had been in contact with the shaft was extremely heavily scored as shown in Figure 1. The raceways of the inner race were heavily brinelled and deformed as shown in Figure 2. The zone of maximum deformation appeared to be diagonally opposite the zone of least deformation. The rollers were flattened and deformed to various degrees, eight of the most severely deformed being shown in Figure 3. The outer race exhibited little damage.

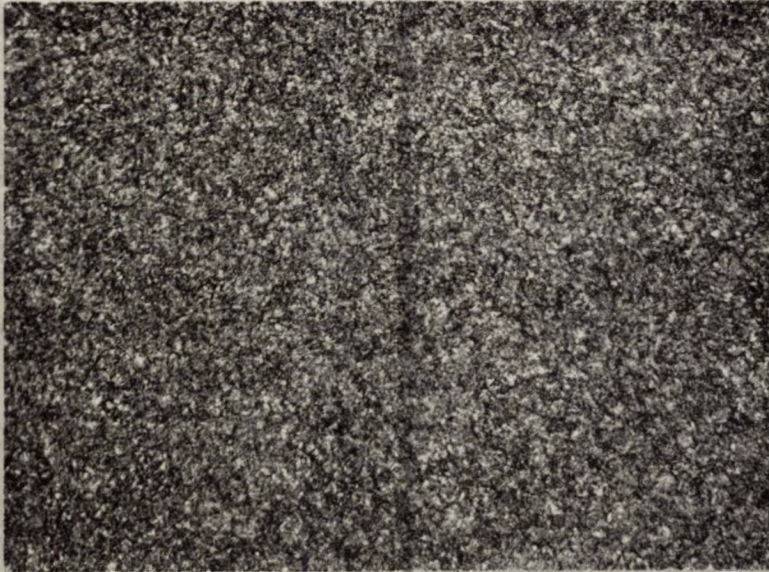
Figure 4. Microstructure of Outer-Race Material. Shows random distribution of fine carbides in a martensite matrix, which is the desired microstructure for bearings. The hardness was R_C 43. (X500 - Etched in 2% nital).

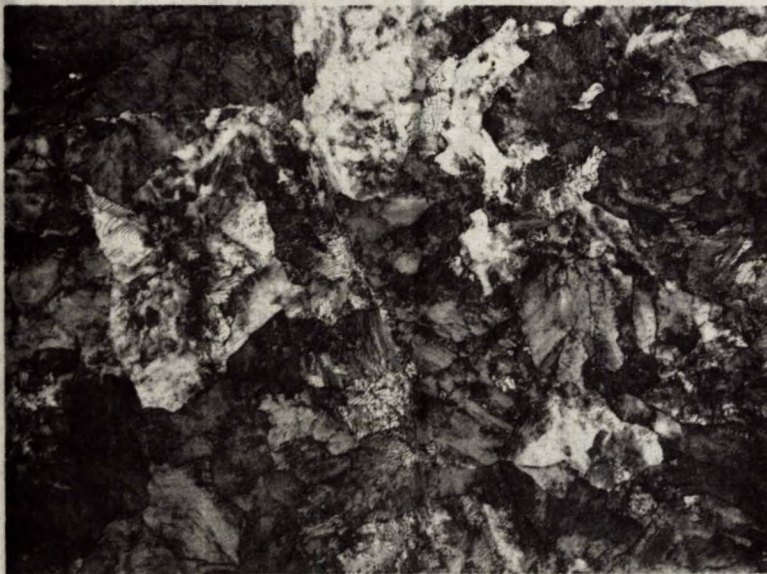
Figure 5. Microstructure of Inner-Race Material. Shows coarse grains of fine pearlite which have been formed by overheating during failure. (X500 - Etched in 2% nital).

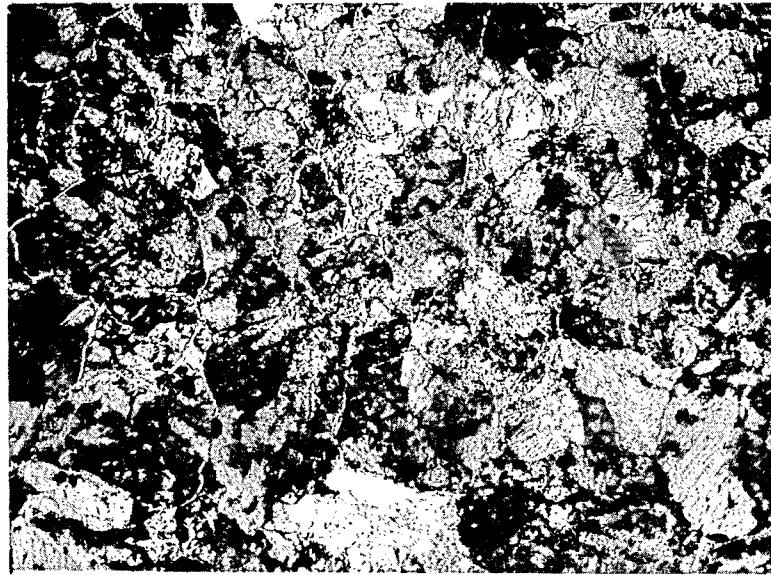
Figure 6. Microstructure of Roller Material. Shows essentially the same microstructure as the inner race material. Note presence of grain boundary carbides. (X500 - Etched in 2% Nital).
